Make an Old Deck Safe

Three days' work and \$600 in materials save this deck from a catastrophic ending

BY MIKE GUERTIN

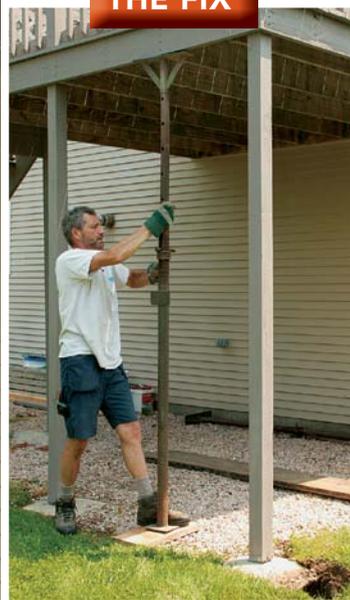
Starting at ground level, the first thing I noticed was that the footings appeared tilted and that the posts were sliding off the tops. I dug around a couple of footings and found that they didn't extend below the frost line. Combined with their mushroom-shaped tops and unstable surrounding soil, their shallow depth had led to frost heave.

Add temporary support. Before excavating the footings, brace the deck with temporary support columns. Set the columns plumb, and tack them in at the top with staging nails or structural screws.

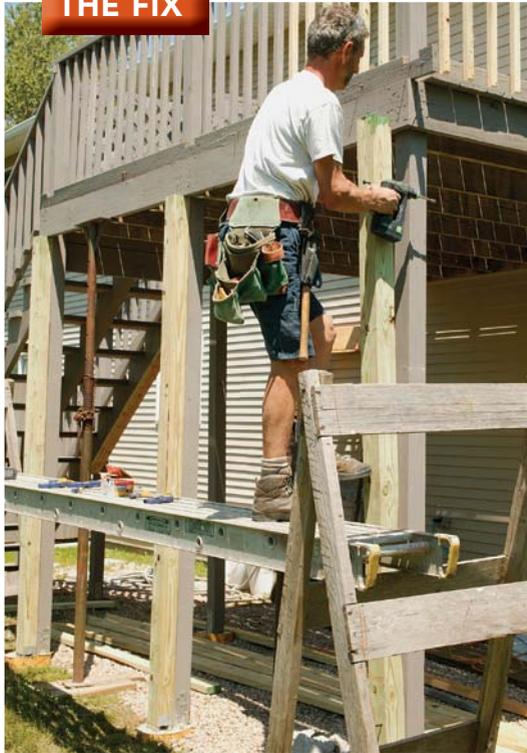
The single rim joist carrying the deck joists was face-nailed to the 4x4 posts, which extend up to become railing posts. Without additional support, nails have the potential to pull out. Ideally, the rim beam should be doubled and should rest directly on top of the support posts.

Double the posts. Attach new 4x4 posts to the existing posts with structural screws. The new posts are cut to the height of the rim and rest on galvanized post bases anchored to the new footings.

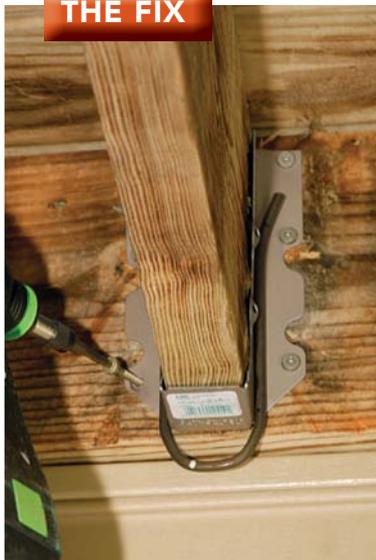
The ledger is inadequately attached to the house with washerless $\frac{5}{16}$ -in. lag screws and a few randomly driven structural screws. In addition, all the joist hangers are beginning to rust and are missing nails. Where there are nails, they're the wrong type (6d common nails and 2-in. roofing nails).

Will hang. The new joist hangers have two times the galvanized coating of the old hangers. The hangers mounted to the rim beam are nailed with 3-in. HDG common nails. The hangers on the ledger are face-nailed with $1\frac{1}{2}$ -in. 10d hanger nails or $1\frac{1}{2}$ -in. structural screws.

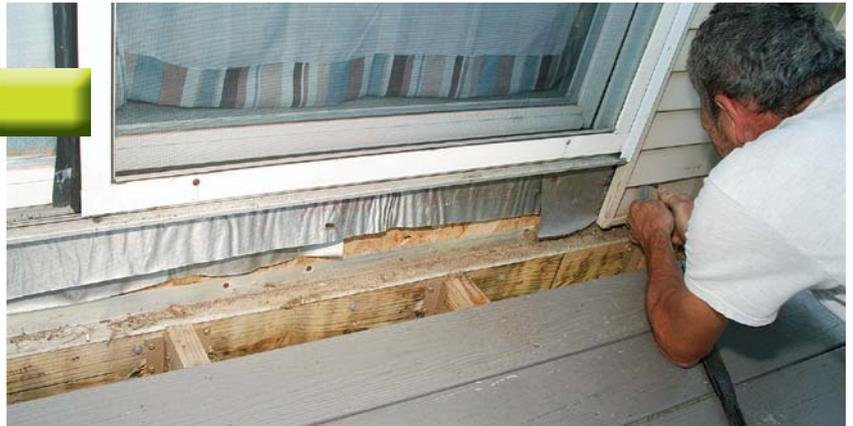
The thin aluminum ledger flashing is inadequate and is corroded in several spots. Left as is, the flashing will allow water behind the ledger, which in turn will cause rot and a potential deck failure. A more robust flashing system should include self-adhering membrane and flashing with a taller wall leg.

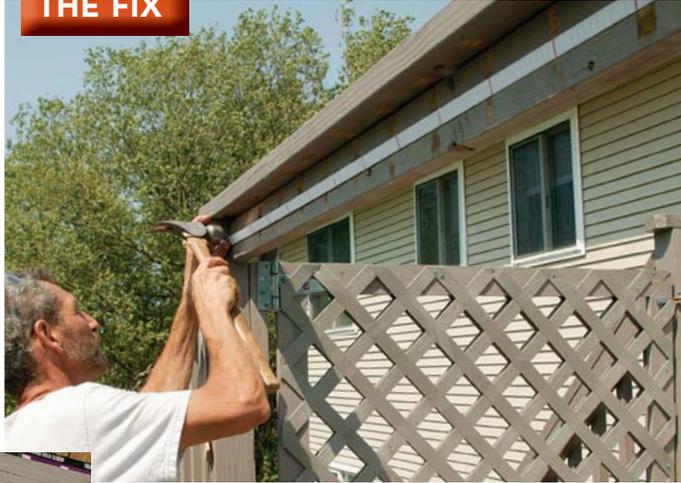
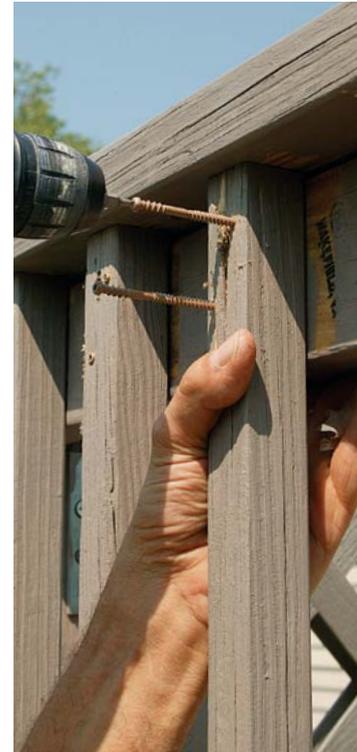
The spaces between most of the guard balusters are greater than the code limit of less than 4 in. Several balusters are warped or broken, and most are loose, attached only by a single nail at each end.

Secure the railing. Remove the balusters from each rail section, and replace the bad ones. For a better connection, drill pilot holes into each end of the balusters, and fasten them to the 2x4 rails with four screws, two at each end.

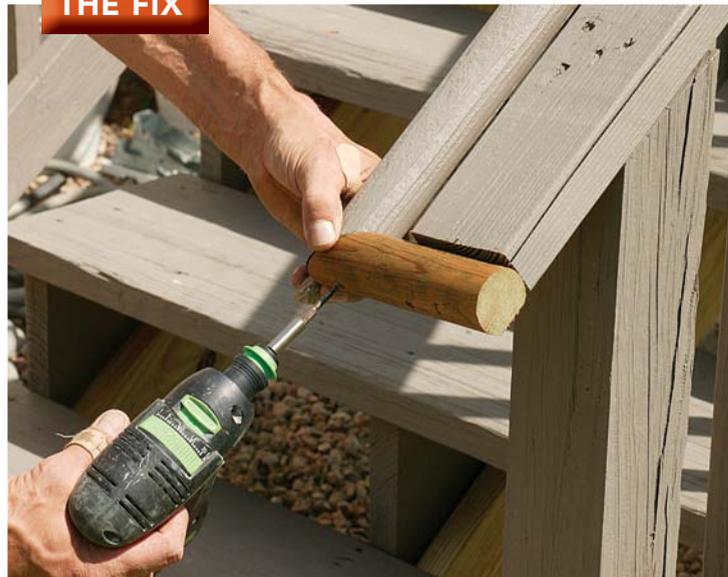
According to code, stairs need at least one handrail continuous from top to bottom and whose ends either terminate onto newels or return safely. Here, the handrail ends run long and don't have safety returns onto the guardrail.

Return for safety. The author trimmed the extralong handrail and guardrail, then mitered the handrail to make a safety return. He glued and screwed the top and bottom returns to the rail to wrap around the end of the guardrail.

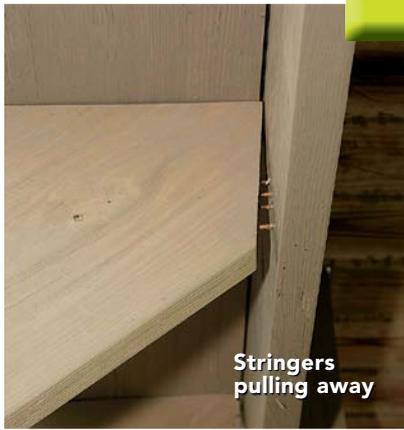
Stringers pulling away

After a quick inspection, I found a handful of problems with the stairs. The tops of the stringers had pulled away from the header. The stringer cuts extended past the notches into the structural area. (The DCA-6 requires an uncut structural area of at least 5 in.) The stringer's span was too long and spaced too wide without intermediate support. Finally, the stringer header itself had no supporting jacks and was nailed only to the posts.

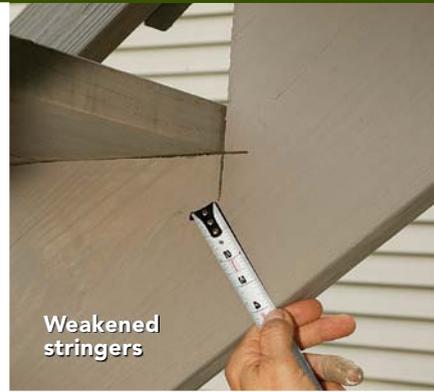
Weakened stringers

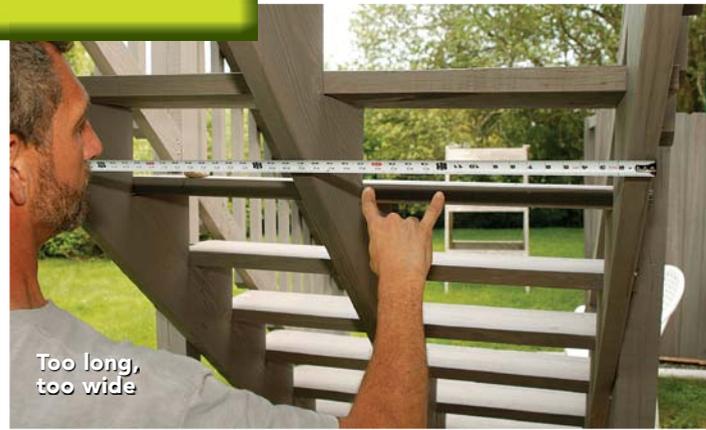
Too long, too wide
