Replacing Rotted Sills

It's a dirty job, but somebody's got to do it

by George Nash

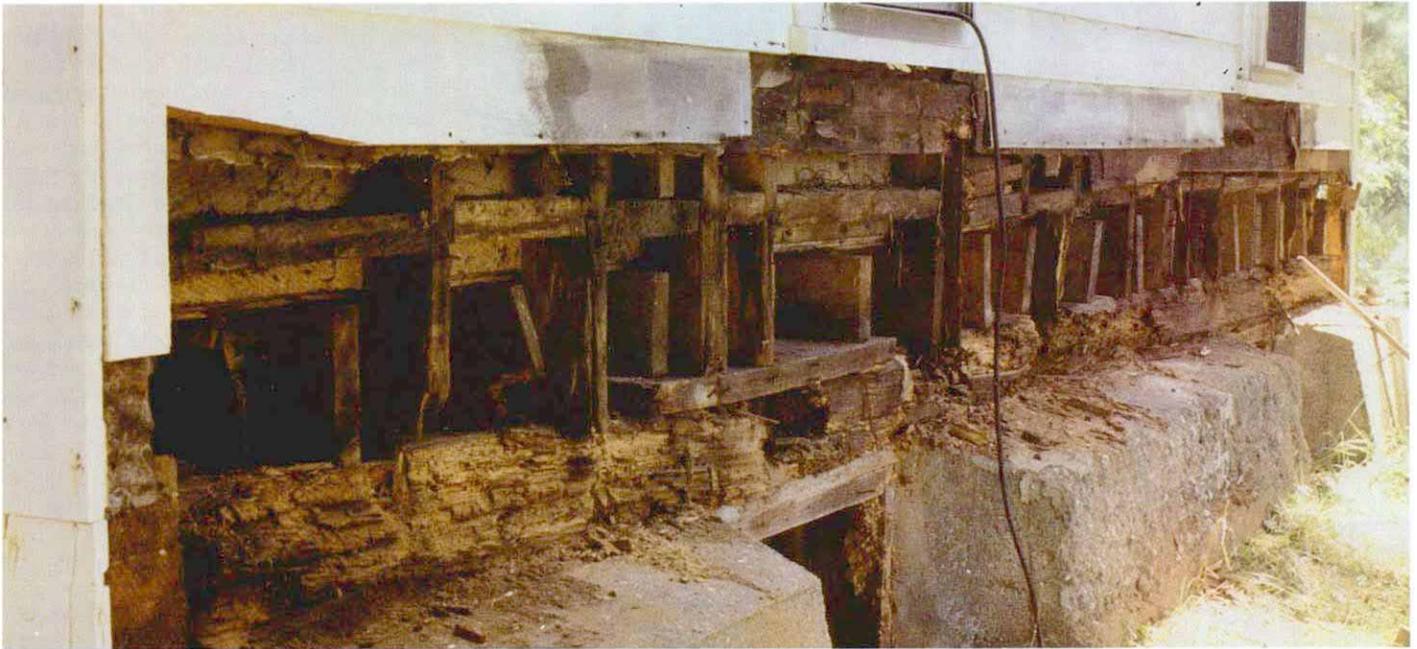
When probed with an awl from inside, the sills pictured above felt solid, but mildew and signs of decay on the clapboards outside suggested otherwise. The concrete wall, used to buttress the old stone foundation, had no flashing or drip cap on top of it, so water seeped behind the wall and into the sills, joists and studs.

With a nail-eating carbide blade in the circular saw, I sawed along the bottom edge of the sixth course, removing all the siding below the window sills. Feeling like a surgeon probing a malignant cancer, I removed the sheathing boards. What remained of the timber sill would have made an excellent medium for growing mushrooms. The decay had progressed into the ends and bottom edges of floor joists that rested on the sill and continued up into the bottom of the wall studs (photo above).

The irony of all this is that the damage and subsequent repair work could have been avoided if a drip cap or simple flashing had been installed when the buttress wall was poured. Why this was not done eludes me. Perhaps it was ignorance or laziness, but I have seen many such walls over the years, and except for a desiccated bead of caulk between clapboard and concrete, nothing protected this problem zone.

The buttress wall had been poured directly against the siding, forming an exquisite water trap. The old building paper soaked up moisture like a paper towel and held it against the sheathing. Ventilation was discouraged by the painted siding, which was relatively rot-resistant red cedar. A more ideal environment for decay-producing fungi would be hard to build. Thus the rot grew inward, first through the sheathing boards, then into the framing. The sills were hardest hit because they rested on masonry, which tends to draw water.
