Understanding Common Moisture Problems

Three case studies illustrate the importance of controlling humidity and air leakage

by Marc Rosenbaum

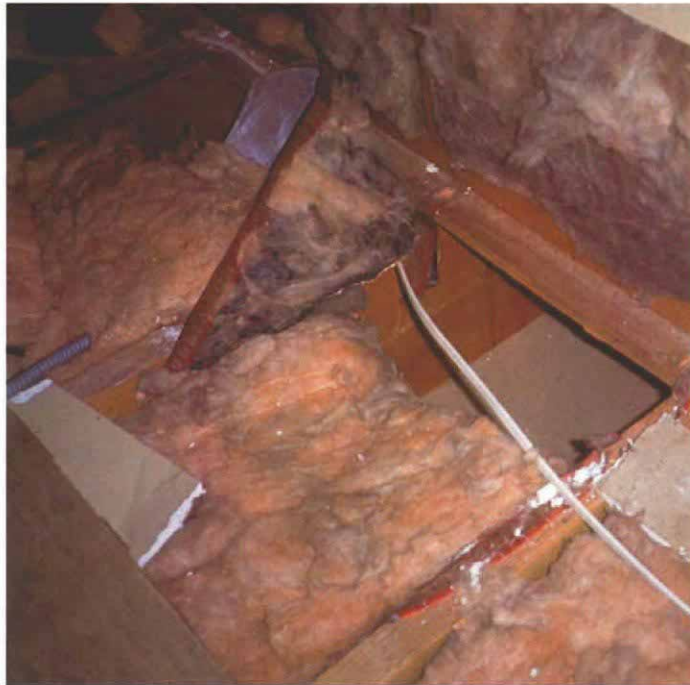
Insulation is no good if it's not continuous. Cold air from this crawlspace has a clear path to the floor of the adjacent bedroom through this and other uninsulated joist bays. Dirt in the insulation could mean that air is escaping from the living space.

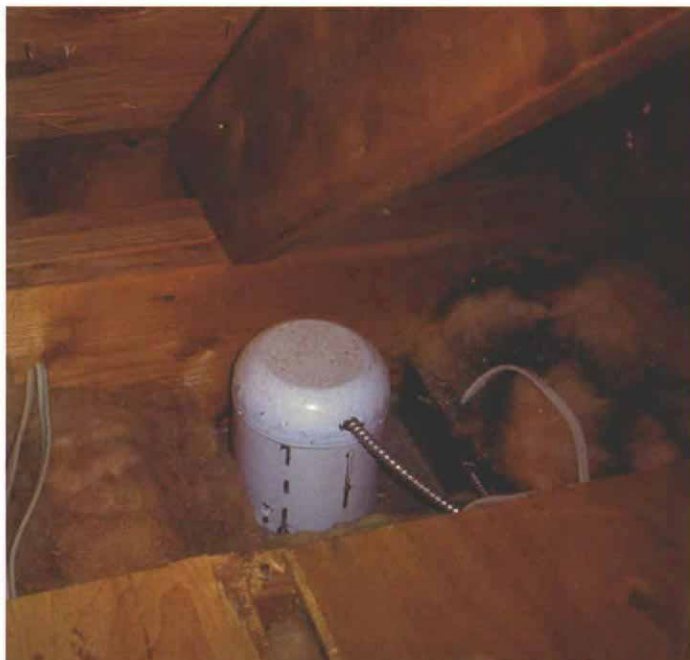
Ceiling fixture provides light below and heat above. This recessed ceiling light, installed during a remodeling job, provides a conduit for warm, humid air to flow from the living space into the attic. The preferred alternative in cases such as this one is to install the type of light fixture that can be covered with insulation completely, without causing a fire hazard.
