Top 10 Deck-

Avoid these common problems, and build a longer-lasting, safer deck

BY GLENN MATHEWSON

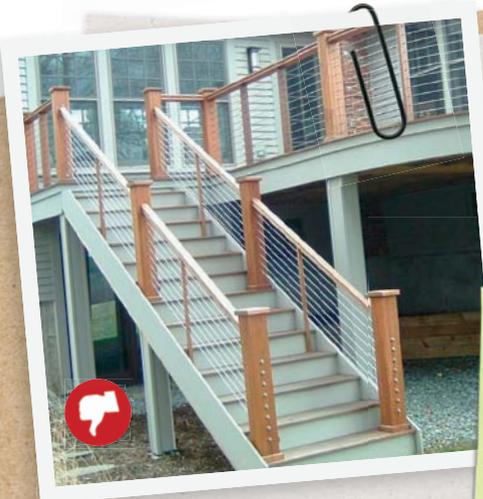
The post in the middle of this flight of stairs interrupts the top of the railing, which was designed to serve as the handrail. A new continuous handrail, albeit an unsightly one, had to be added.

The error: For construction or aesthetic purposes, builders regularly install handrails interrupted with newel posts. It's also common to see a guardrail used as a handrail.

The solution: Code provision R311.7.8.2 requires that a continuous handrail be installed on any set of stairs that has four or more steps. A continuous guardrail free of midspan posts extending through the top can be used as a handrail, but only if it meets specific geometric requirements. To be considered a handrail, the guardrail must be graspable by those walking up and down the stairs.

If a post interrupts a guardrail, a true handrail must be added to the guardrail running along the stairs.

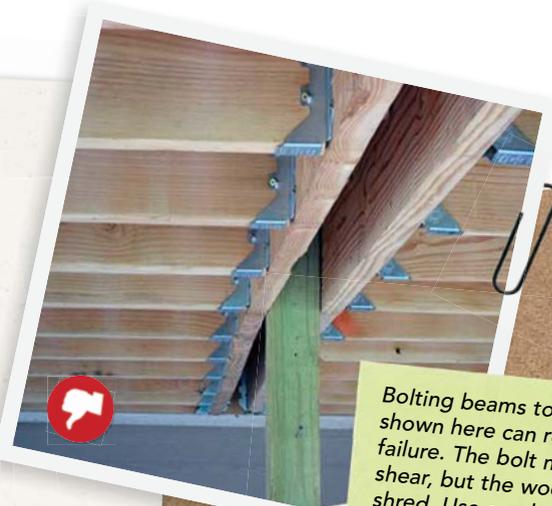
The error: A tragedy brought to us from the aisles of big-box stores: directions to deck builders to bolt deck beams to the sides of support posts. The average backyard deck has relatively few posts. Fewer posts result in greater loads at beam connections. It would take a huge load to shear a 1/2-in.-dia. machine bolt, but long before that occurs, the wood around the bolt would be crushed and distorted, resulting in a failed connection.

Bolting beams to posts as shown here can result in failure. The bolt may not shear, but the wood can shred. Use a galvanized-steel post cap, and keep the beam firmly seated atop its support post.

The solution: A beam should be bolted to the side of a post only for low-level decks that have short-spanning joists and beams and many support posts. Of course, that means lots and lots of foundation piers, which are not the best choice in a region with a significant frost depth. With all the hardware available to handle various direct-bearing applications of different-size beams and posts, there is little reason not to place deck posts directly beneath beams.

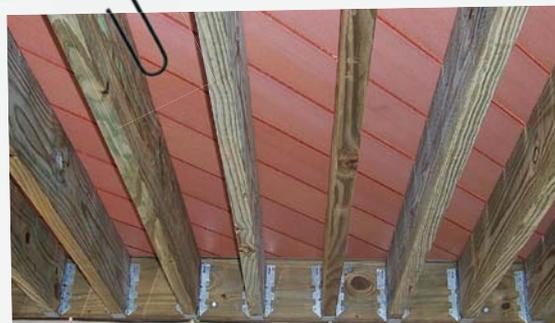
The error: The maximum span of wood-and-plastic composite decking generally depends on the type of plastic used in the product. It's important to follow the span limits of a specific product as outlined in the manufacturer's installation instructions, which some builders fail to review. Overspanning composite decking is most commonly a problem when deck boards are run diagonally over joists or when they're used as stair treads.

To meet the span tolerance of this diagonally installed composite decking properly, additional joists and hangers had to be added to the existing deck framing.

The solution: Floor joists for a deck are typically installed at 16 in. on center, which won't properly support some composite-decking products when installed on an angle. In new construction, be sure floor joists are installed at the correct spacing. In existing decks, adding more floor joists is the only remedy. Similarly, additional stair stringers might have to be added to stairs where composite decking serves as the treads. Stair treads must be able to resist a concentrated load of 300 lb. over an area of 4 sq. in.

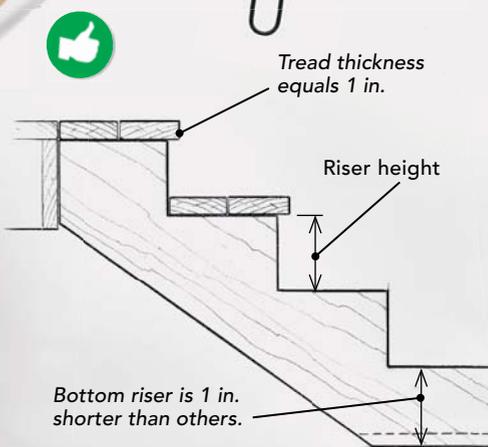
The error: Often, the bottom step on a set of deck stairs is roughly 1 in. taller than the rest. Code allows a maximum variation of only $\frac{3}{8}$ in. between riser heights. This guideline often confuses inexperienced carpenters, who insist that they cut every notch in the stringer the same.

Once you have determined the rise and run of your stairs, stringer layout is straightforward. One detail, however, is easy to overlook. The bottom riser needs to be one tread thickness shorter than the rest.

The solution: Every notch cut into a stringer has an identical riser height except for the bottom one. The steps notched out of the stringer in the middle of the flight have treads placed above and below each step, effectively adding the same tread thickness to each riser height so that they remain constant. The bottom step doesn't have a tread below it, though, so you must subtract the thickness of the tread from the height of the bottom riser, which is the bottom of the stringer.

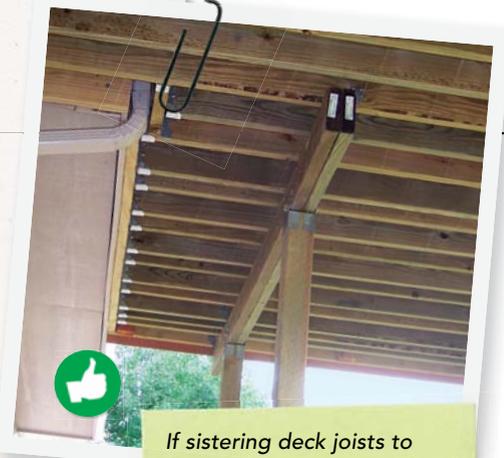
One of the more egregious ledger mistakes is connecting the ledger to a rim joist nailed to the end grain of cantilevered floor joists—those that support a kitchen bump-out, for example.

If sistering deck joists to floor joists isn't an option, adding a beam, posts, and footings can help to relieve some of the stress placed on the fasteners connecting the ledger to the end grain of the cantilevered floor joists.

The solution: Detailing a ledger properly depends on the building type, the cladding material, and the site conditions. Of all the parts of a deck, the ledger can rarely be treated the same from job to job. Long before construction begins, considerations must be made as to, for example, whether stucco needs to be cut back with new weep screed installed or whether a few courses of lap siding need to be removed to bolt and flash the new ledger properly. A ledger connection to a cantilevered floor requires specific considerations. Instead of attaching a ledger to the ends of the cantilevered floor joists, it's often stronger to sister the deck joists to the existing floor joists.

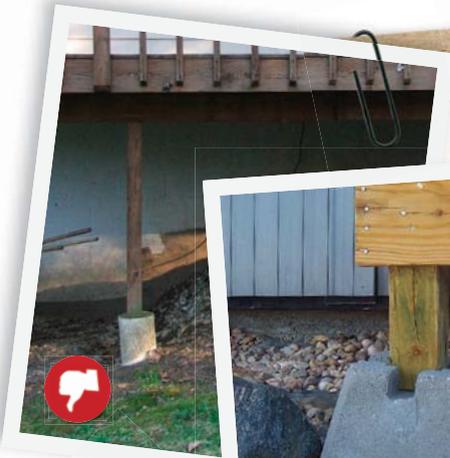
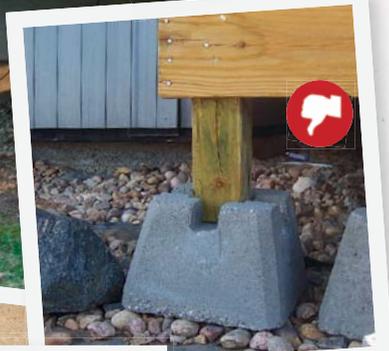
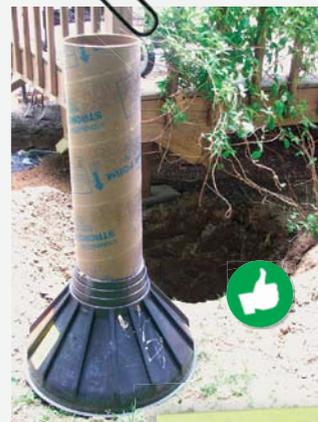
The error: When it comes to digging footings for their deck piers, some builders are lazy. Usually, a deck's foundation piers are not set below the region's frost line. To avoid deck-ledger failures, freestanding decks are becoming popular, but the piers nearest the home's foundation are often set atop backfill.

In areas where the frost depth is not an issue and precast foundation blocks are commonplace, they're often set on top of the exposed grade.

When set above an area's frost line, footings can heave (top photo). Piers set below the frost line with bell-shaped bases (bottom photo) stay in place and distribute the deck's weight. Even where the ground doesn't freeze, footings must be set 12 in. into undisturbed soil and not directly on grade (middle photo).

The solution: Just about every deck is built on an isolated-pier foundation system. Foundation systems are required to extend a minimum of 12 in. into undisturbed soil (R403.1.4). In cold climates, where the earth is subject to freezing, a pier foundation must extend to a depth below that which is likely to freeze—anywhere from 36 in. to 48 in. This prevents the soil below the pier from freezing and heaving the pier upward.

To install deck piers properly, the piers must bear on undisturbed soil and, depending on the region, be set below the frost line. This could mean the need for 3-ft.-deep footings in some areas. However, if the piers are in a backfill region, as is the case with piers nearest the house on a freestanding deck, the footing depth may have to be as deep as 10 ft. to reach undisturbed soil and to comply with code.

Precast foundation blocks must be set at least 12 in. into the ground. However, even in the middle of a lot, the topsoil is tilled roughly 6 in. prior to seeding, so it's likely that the footing needs to be at least 18 in. deep to comply with code. Assume that all deck piers and foundation blocks require some digging.

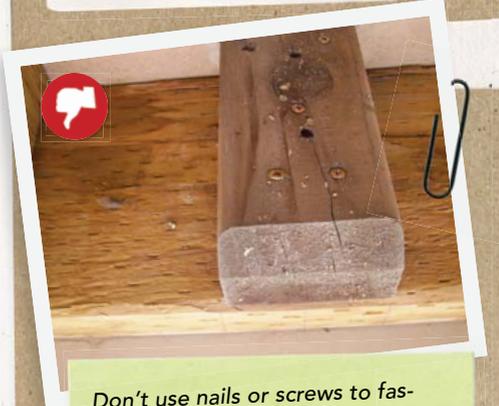
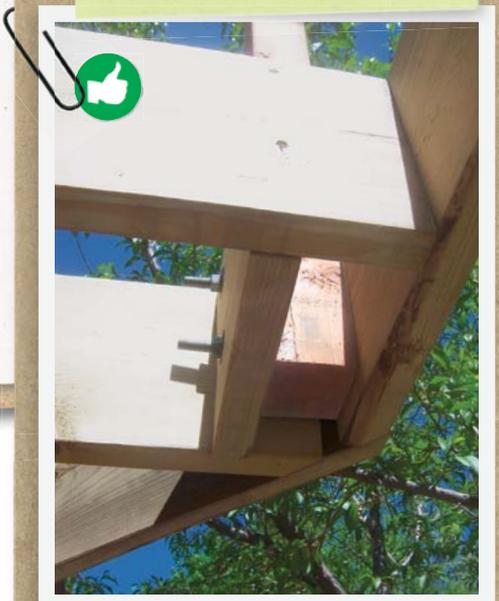
Don't use nails or screws to fasten railing posts to deck framing, as shown above. Use bolts. More specifically, use blocking and bolts, as shown below, to create a stronger railing than one with posts connected to rim joists that are nailed only to the end grain of the joists.

The error: Insufficiently connecting a guardrail post to a deck is among the most dangerous deck-building errors. Fastening guardrails to deck rim joists or floor joists with wood screws is not acceptable. While some builders get the guardrail-to-rim-joist connection correct, they don't always ensure that the rim joist is attached to the deck framing properly.

The solution: The code (table R301.5) requires a guardrail to be capable of resisting a concentrated load of 200 lb. in any direction along its top. Depending on the design of the guard assembly, a stout guardrail-post-to-deck connection can be accomplished with blocking and through-bolts or with horizontally oriented hold-down hardware. In some rail designs, most of the load resistance is handled by the post connection to the deck. In those instances, the post should be attached to the joists, not the rim, because the rim is not usually fastened to the joists in a manner capable of transferring the load. Rims are typically nailed into the end grain of the joist, the weakest possible connection for withdrawal resistance.

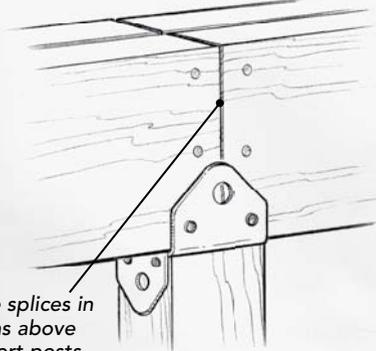
The error: When a long built-up beam spans multiple posts, many builders run one ply long and extend it beyond the support posts. Many builders believe this practice is good because splices of opposing beam plies are greatly separated as opposed to being only inches apart on top of a post. Unfortunately in these cases, an engineer's evaluation or a rebuild of the beam is required.

Make splices in beams above support posts.

Beams suffer the greatest amount of deflection at the center of their post-to-post span. Therefore, strong beams are spliced atop posts. If you can't stagger splices over different posts, then placing them over a single post is permissible.

Beam splices that miss the bearing point by a small amount don't greatly affect bending or deflection, and the shear strength of one fewer ply is likely still sufficient. In these cases, the cost of an engineer's review might just get you the OK to build. If a design calls for a splice in the center of a span, it will be smarter and cheaper to build the beam so that splices land atop posts.
