Replacing a Mudsill

Careful bracing inside and out holds a house steady as rot is removed

BY BILL PHILLIPS

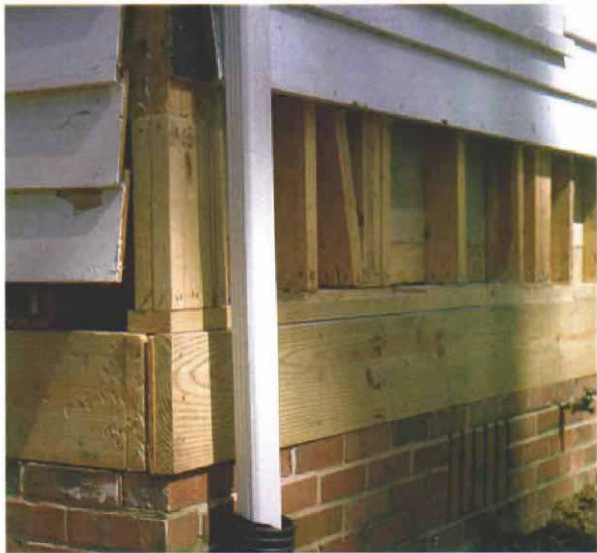
had been badly damaged over the years from a combination of termites and a damp location near a stream. About 80% of the existing mudsill would have to come out and be replaced with new material (photo above left).

Built entirely of southern yellow pine in the 1940s or '50s, the house otherwise seemed sturdy. With relatively simple equipment, we tackled the job methodically, removing and replacing the sill one piece at a time. We raised the house with jacks and suspended it with stout braces. The house never budged as we completed repairs.

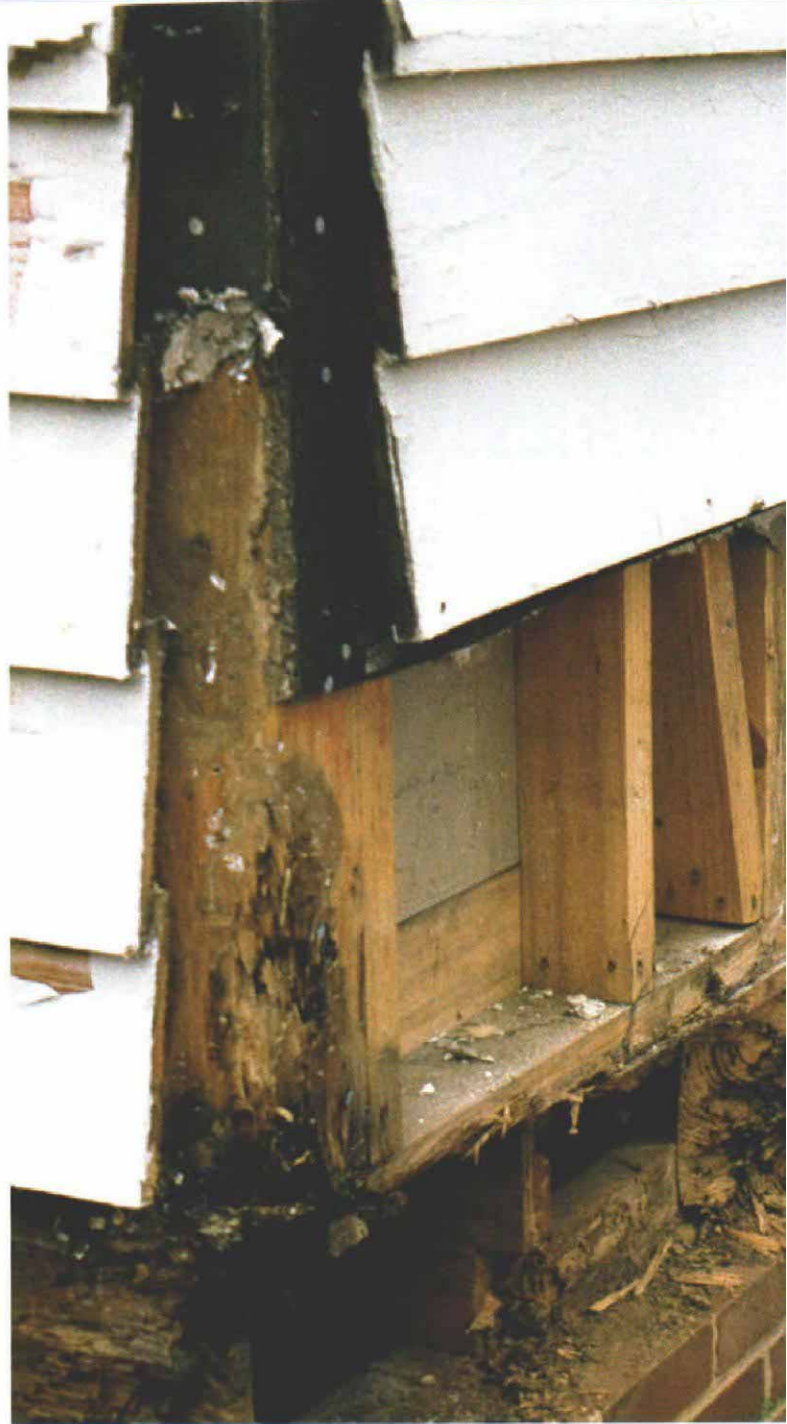
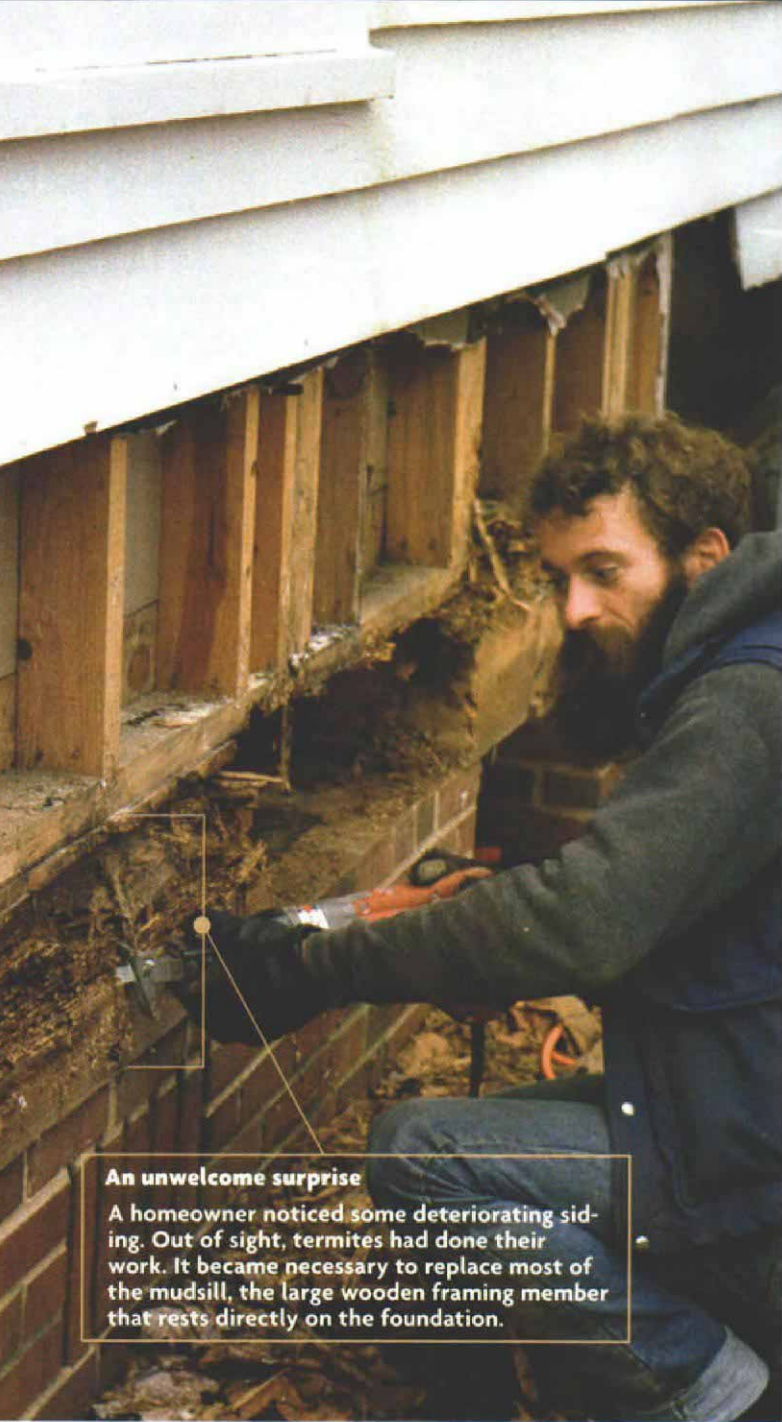
An unwelcome surprise

Our clients were people like the young woman, a first-time homeowner, who called a home inspector when she noticed a piece of deteriorating siding. She had bought the house assuming that it was solid, and from the outside, that's just the way it looked. But the inspector found that extensive rot lay beneath the siding (photo above right). The one-piece 4x10 mudsill, which also served as a rim joist,

A homeowner noticed some deteriorating siding. Out of sight, termites had done their work. It became necessary to replace most of the mudsill, the large wooden framing member that rests directly on the foundation.

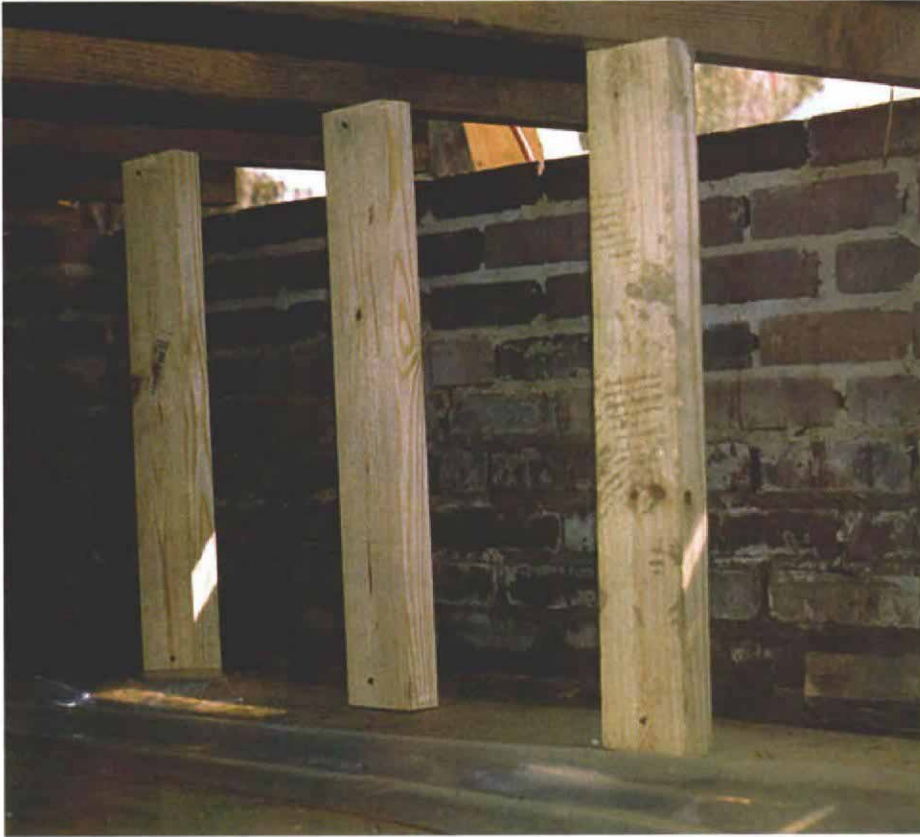
TAKING THE WEIGHT OFF INSIDE

Because the original sill supported the joists, they needed to be propped before the sill was removed.

These 2x4 braces support the floor joists.

Once jacks were holding the weight of the house from the outside, we moved operations to the crawlspace and supported each joist with a 2x4 brace (photo left). The 2x4 posts are toenailed to a 2x10 that is lying flat on the crawlspace floor near the foundation wall. We tapped the 2x4s into place and secured them before removing the section of sill nearby.

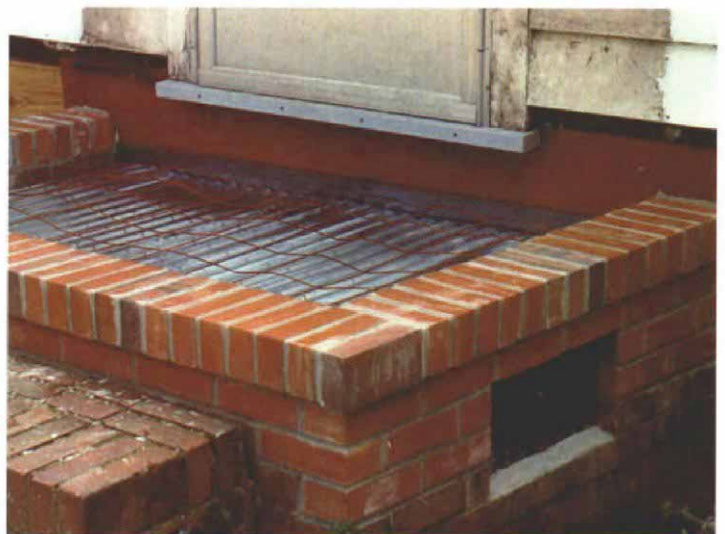
VENTILATION FOR A NEW SET OF STEPS

A new front stoop includes vents to evacuate unwanted moisture and a concrete slab cast on corrugated steel. Galvanized-steel flashing protects the house. Repaired, painted and adequately drained, the house is as structurally sound as the day it was built, this time with preventive measures that should keep it that way.

A further complication was the brick stoop at the front of the house. It was clear we had to demolish what was there and rebuild. Not only was the rubble-filled brick construction weak, but the stoop also had been built tight against the sill and provided a path for termites to enter the structure. To reduce moisture, we built a new set of ventilated steps with a suspended slab supported by a corrugated-steel form (photo right). Galvanized flashing primed with red oxide paint was placed between the stoop and the house to prevent water damage.
