Installation mistakes are often to blame for leaky roofs

10 Roof Goofs and How to Fix Them

BY STEPHEN HAZLETT

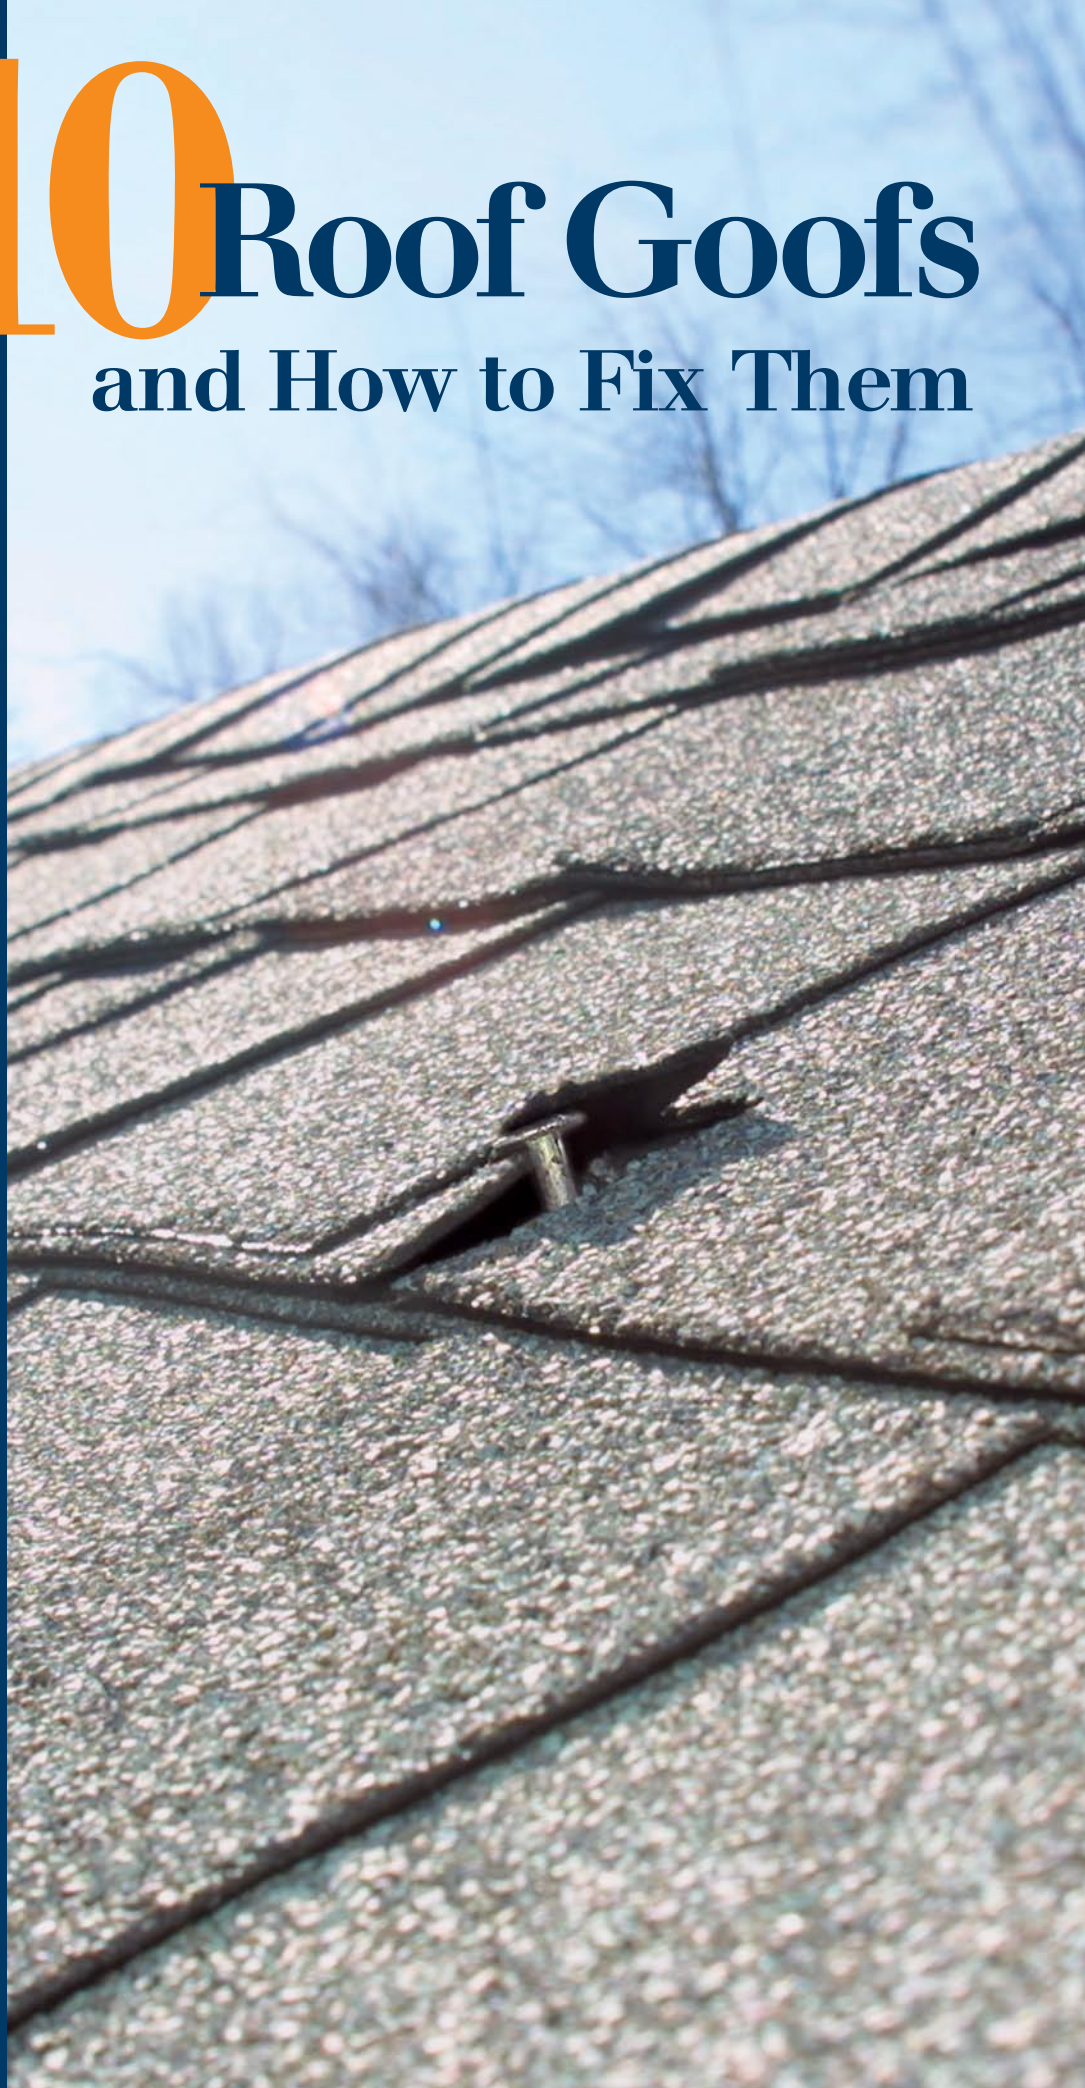
ONE

POORLY FASTENED SHEATHING

Sloppy deck installation on new roofs and poorly prepared decks on reroof jobs are among the most common problems I investigate. Poorly fastened sheathing curls along the edges, absorbs water, and swells. This movement causes the nails to pop out. Loose nails puncture the shingles and cause leaks. Tracking down the offending nail is often harder than the repair itself. Once I find and remove the loose nail, I replace the damaged shingle (sidebar p. 87). Nail pops are to be expected over time. On an older roof, they are not a big concern. On a new roof, however, nail pops are a sign of a sloppy installation and frequently are followed by more problems.

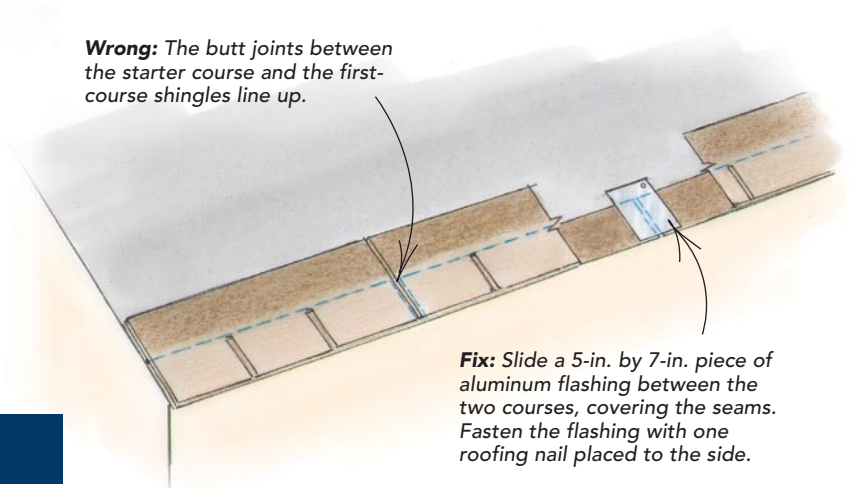
Wrong: The butt joints between the starter course and the first-course shingles line up.

Fix: Slide a 5-in. by 7-in. piece of aluminum flashing between the two courses, covering the seams. Fasten the flashing with one roofing nail placed to the side.

It's surprising how often I see leaks because the butt joints between starter-course shingles line up perfectly with the joints between first-course shingles. This layout translates into a leak every 3 ft. along the bottom edge of a roof and will cause the rafter tails, wall sheathing, top plates, and drywall to get wet and rot. If the sheathing is not damaged, the repair is simple: Pull out a few nails, and slip a 5-in. by 7-in. piece of aluminum flashing between the starter course and the first course to cover the exposed joints. You can fasten the flashing with a single nail or with a bead of caulk between the flashing and the starter course and another bead between the flashing and the first course. If the sheathing is damaged, I remove several courses of shingles, replace the damaged wood, and install waterproof membrane with a properly aligned starter course.

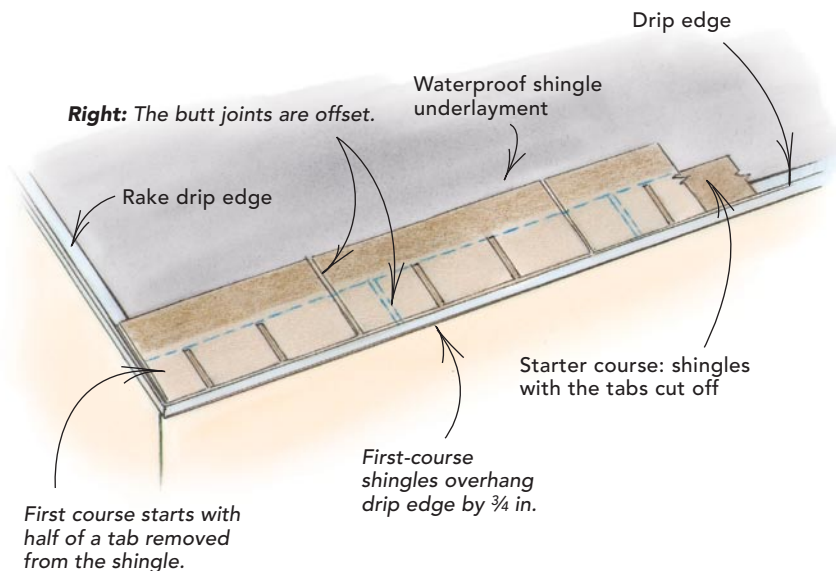
Right: The butt joints are offset.

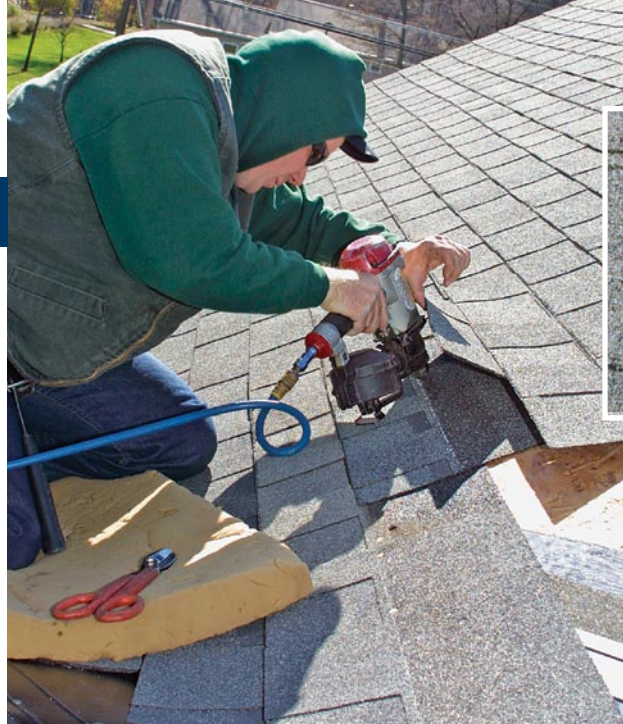
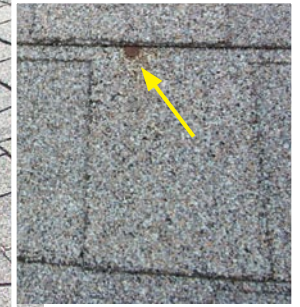
Nail placement is important. Nails should be driven through the nailing strip, just below the seal-down strip, where they'll be covered by the tabs of the next course of shingles. Exposed nails give water a way into the roof.

If shingles are not fastened properly, the wind can get under them, lift up the edges, and give water an easy path into the roof. Examples of lazy nailing include too few fasteners; fasteners placed too high or too low on the shingle; staples shot in vertically instead of horizontally; and not storm-nailing (six nails per shingle in high-wind areas). Always follow the nailing guidelines on the shingle wrappers, and storm-nail shingles on all roofs in high-wind areas or on roofs steeper than 10-in-12 pitch.

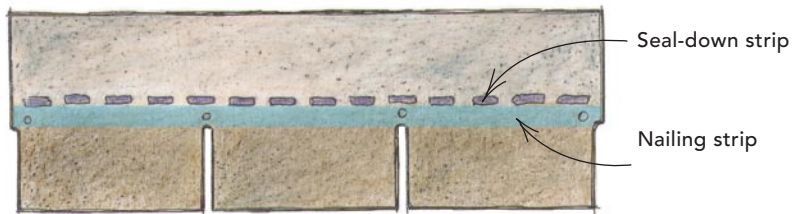
Typical nailing pattern: four nails per shingle

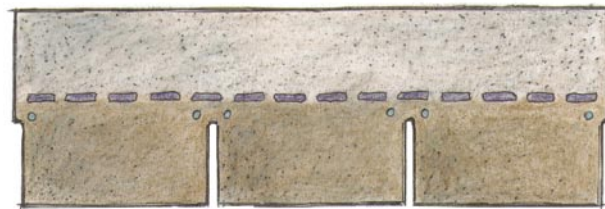
Storm nailing pattern: six nails per shingle

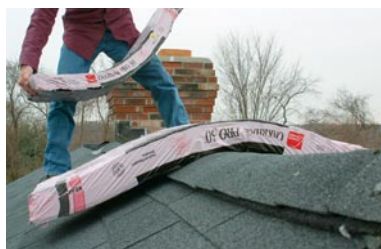
Don't bend the shingles over the ridge. Folding bundles of shingles over the ridge can damage the shingles and diminish their life span. Lay the bundles flat on the roof, and use a board to prevent them from sliding down the roof.

Some roofers make a big mistake when they load shingles onto the roof by folding the bundles over the ridge. Ironically, delivery crews call this "breaking the bundles," and that's exactly what happens. Breaking the bundles can create stress fractures and separates shingle laminations, reducing the life span of a new roof. Always store shingles flat on the roof. Because cold shingles are more prone to breaking, limit cold-weather roofing to emergency repairs.

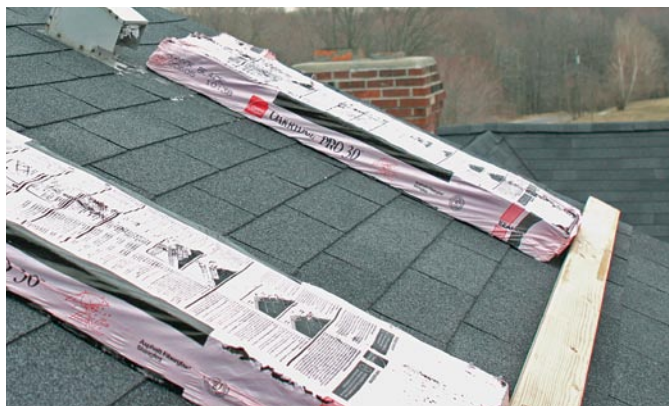
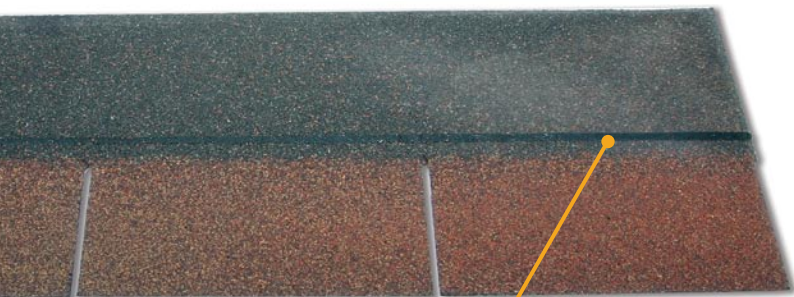
Avoid continuous seal-down strips. They may seem like a good idea, but water that gets under the shingle can't escape. Shingles with segmented seal-down strips (top drawing, facing page) give water an exit every few inches.

Here's one that may surprise you: Shingles with continuous seal-down strips can cause leaks themselves. Water that gets under the side edge of a shingle with a continuous adhesive strip won't be able to escape and will migrate sideways until it finds an exit point, usually a joint between two shingles. This joint is where the leak begins. Valleys, chimneys, waste stacks, and roof vents are the most likely places for water to get under shingles. These leaks are difficult to track down and repair. The solution is to use shingles with breaks in the adhesive strip. And don't use pieces of shingle smaller than the sections between breaks. If you must use continuous-strip shingles, make sure the valley and chimney flashing doesn't dump water where it easily can find its way under the shingles.

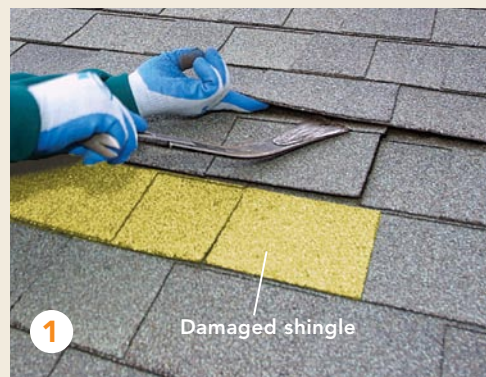
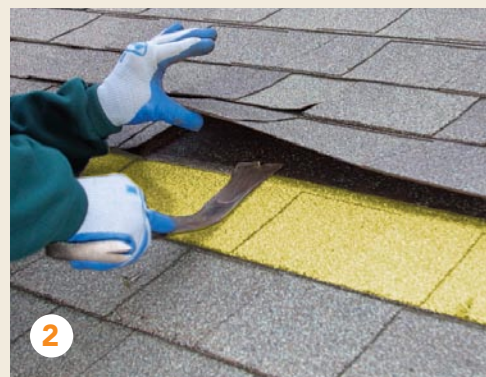
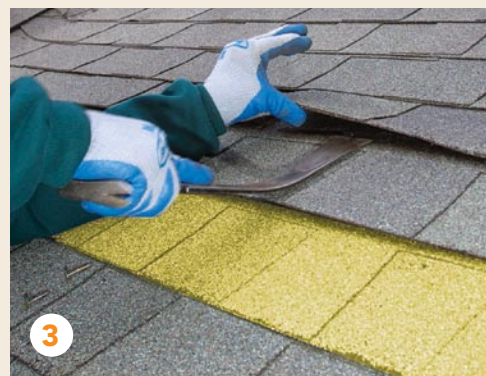
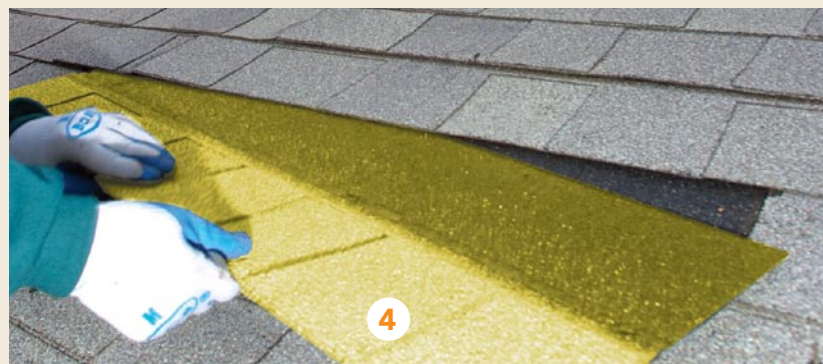
Removing a damaged shingle

1 The first step is to break the bond created by the seal-down strips below and on the two courses above the shingle you want to remove. Breaking this bond may be difficult with some newer laminated shingles. A 50-year shingle with a 110-mph wind warranty has an aggressive adhesive bond. In these cases, I cut the adhesive strip with a pry bar.

2 With the bonds broken, I can remove the four nails holding the damaged shingle. **3** Before I remove the shingle, though, I have to remove four more nails driven through the course above.

4 Now I can pull out the damaged shingle, slip in a new shingle, and renail all the loosened shingles.

When refastening shingles, don't put new nails in the old nail holes; they'll pop right out. Instead, nail next to the holes and put a dab of sealant over the old holes. While your caulk gun is handy, seal down all the loosened shingle tabs with a dab of sealant.

Some roof repairs—nail pops, for example—require replacing single shingles. Removing the damaged shingle without damaging the surrounding shingles is the tricky part. This process is best done while shingles are cool enough not to melt underfoot and warm enough not to crack. In the summer, I handle this part of the repair before 8 a.m. In the winter, I do only emergency repairs.

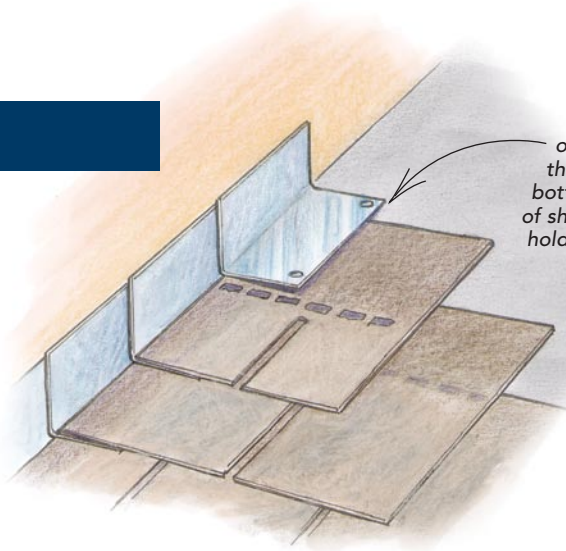
Step flashing no-no.

Nailing above the top of the shingle will cause the flashing to lift up the bottom of the next course of shingles. An extra nail to hold down the flashing is a potential leak spot.

Another common problem is improperly sized step flashing. Step flashing should be in line with the top of the shingle course being flashed and should extend down to the top of the shingle tab, about 7 in. on standard shingles or about 8 in. on metric shingles. Even properly sized step flashing can cause a problem if it is out of position. Because correctly placed step flashing covers the adhesive strip on a shingle, it won't let the next shingle seal down in that area. Some people try to solve this minor problem by moving the step flashing up an inch or so, extending the top edge of the flashing above the top of the shingle. When the top of the flashing is nailed, it transforms the top edge of the shingle into a fulcrum, and the flashing lifts up the bottom edge of the next course, causing a gap that water can enter. The installer then tries to fix the problem by nailing at the bottom edge of the flashing. This nail won't be covered by the next piece of step flashing and can cause a leak. Improperly installed step flashing should be stripped and replaced.

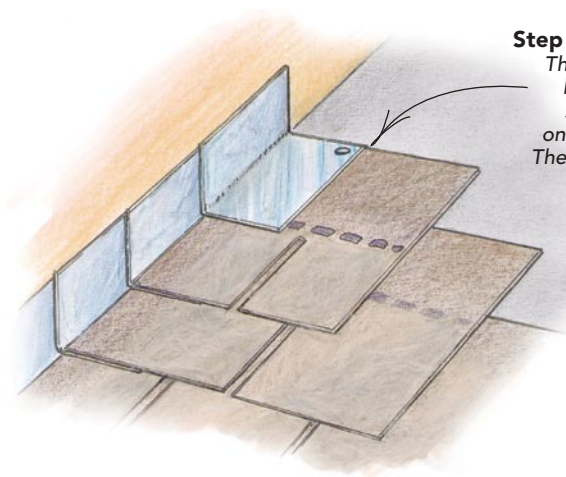
Step flashing done right.

The flashing should be in line with the top of the shingle and nailed only once in the upper corner. The flashing pieces should overlap 2 in.

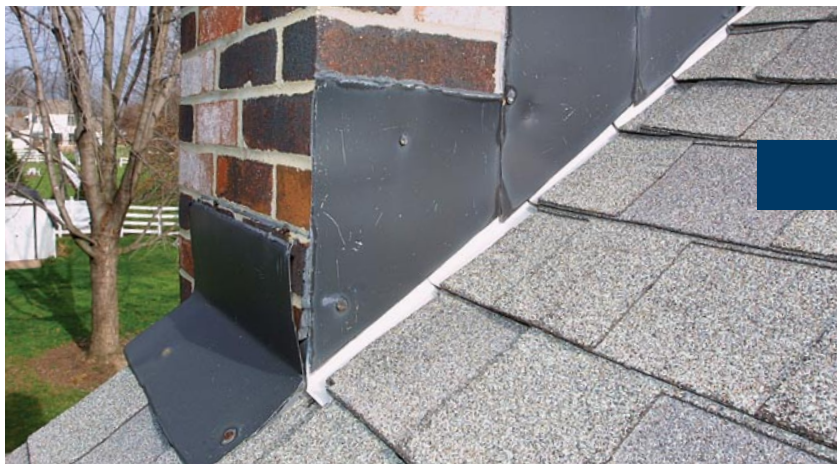
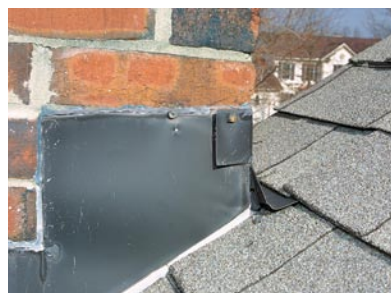
Chimney flashing is best left to the experts. Chimneys have great potential for leaks. If masons don't set counterflashing into the mortar or if the flashing fails, nails and caulk are not a solution. The mortar must be cut with a grinder so that carefully bent new flashing can be inserted between brick courses.

A lot of roof leaks are blamed on chimney flashing, and for good reason. Before replacing the chimney flashing, though, spend a little time to rule out other possibilities such as a cracked mortar cap or missing chimney bricks. The most common chimney-flashing error is when roofers don't take the time to insert counterflashing into the mortar. Properly installed counterflashing is bent on a sheet-metal brake, producing sharp, straight, L-shaped bends that seat cleanly in the mortar between brick courses. Chimney flashing bent without a brake is a red flag to me; it signifies sloppy detailing. When I find a roof with poor chimney flashing, I look closely for additional problems.

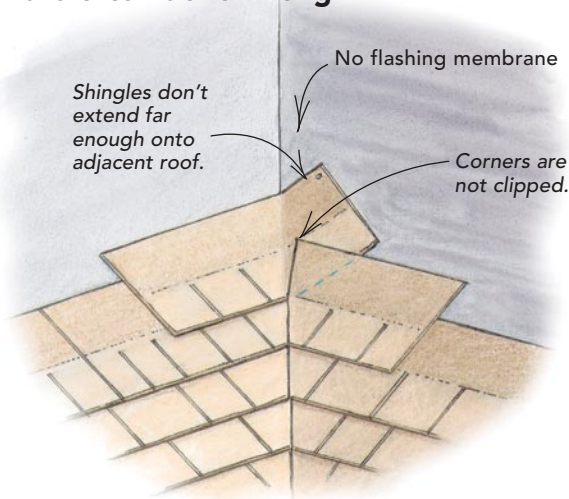
Closed-cut valleys are often done wrong

I'm surprised by how many valleys have no flashing. An alarming new practice is using peel-and-stick waterproof membranes as valley flashing. Some less expensive waterproof membranes are warranted for only five years. Fifty-year shingles over a five-year membrane isn't a good investment in a valley where lots of things can go wrong. The only sure way to fix a leaky valley is to reroof the entire valley. I install a waterproof membrane and W-type valley flashing on almost all valley repairs. (For a complete discussion of shingling valleys, go to www.finehomebuilding.com).
