Why Decks

Build a safer deck with the right hardware, codes, and methods

BY DAVID GRANDPRÉ

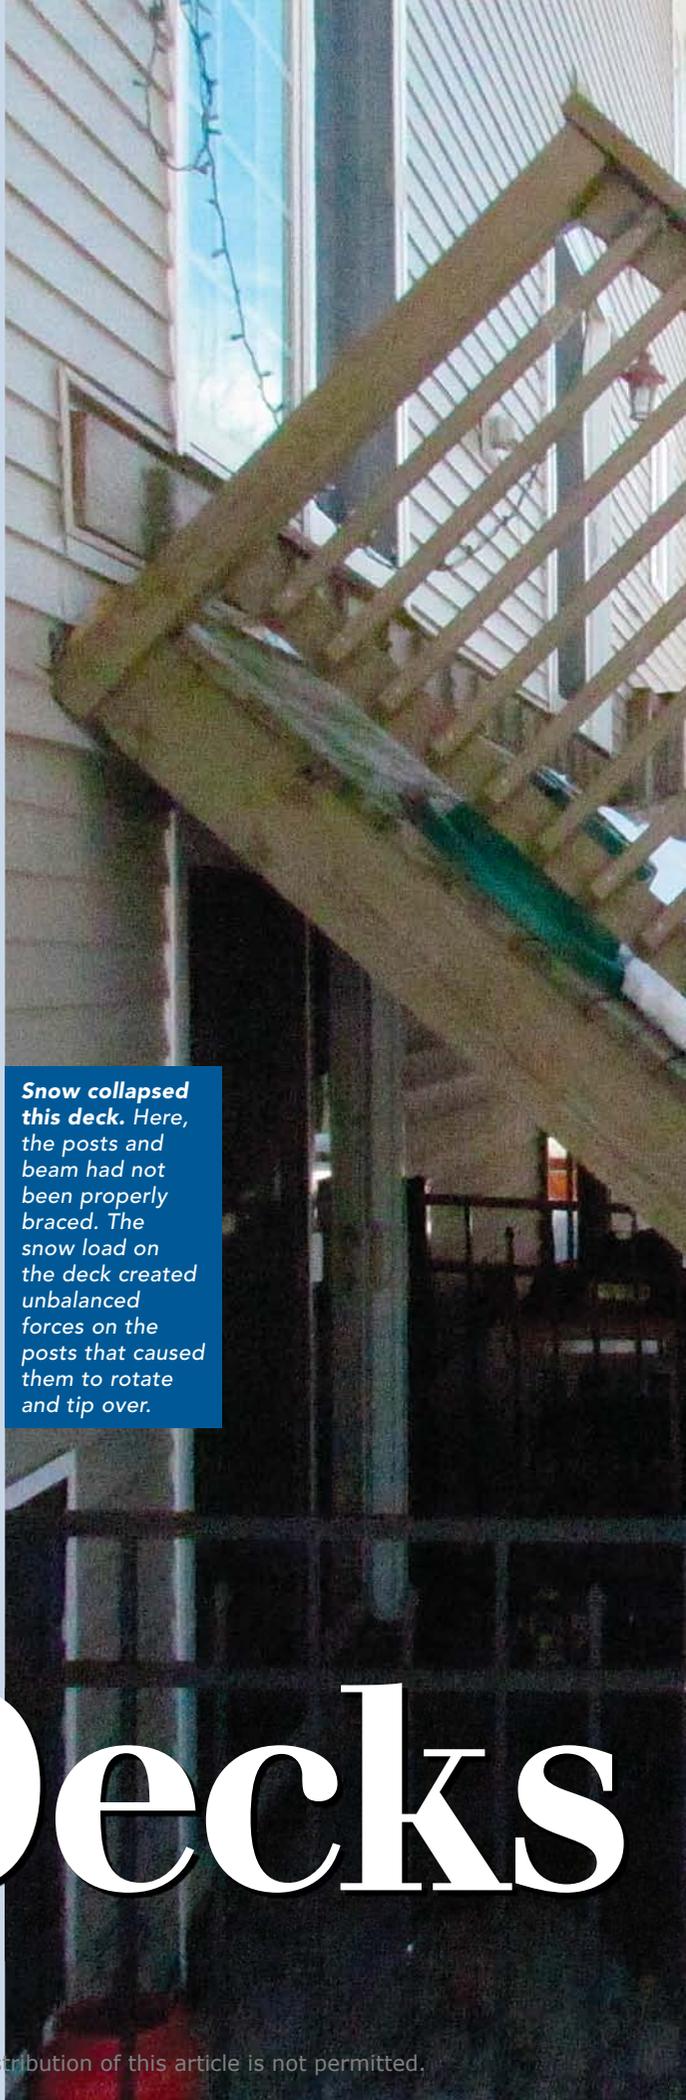
Snow collapsed this deck. Here, the posts and beam had not been properly braced. The snow load on the deck created unbalanced forces on the posts that caused them to rotate and tip over.

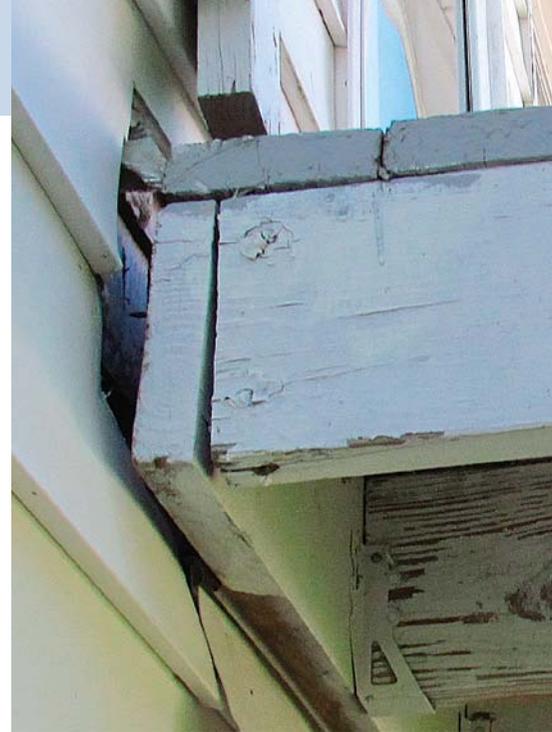
Detaching ledger. In this case, the homeowner noticed the failure of the nailed connection before the deck gave way. In other cases, decks have given way suddenly, often when they've been loaded with people.

Improper installation of the ledger to the house is probably the most common reason for deck failure. Since the 1980s, codes have required that the deck ledger be bolted to the house, but it's still common to see nailed connections in older decks and in decks built without permits. In some cases, sudden failure at the ledger has resulted in injury and even death. This is a widely discussed topic, and recent editions of the building codes have done a good job of providing prescriptive requirements for fastening deck ledgers.

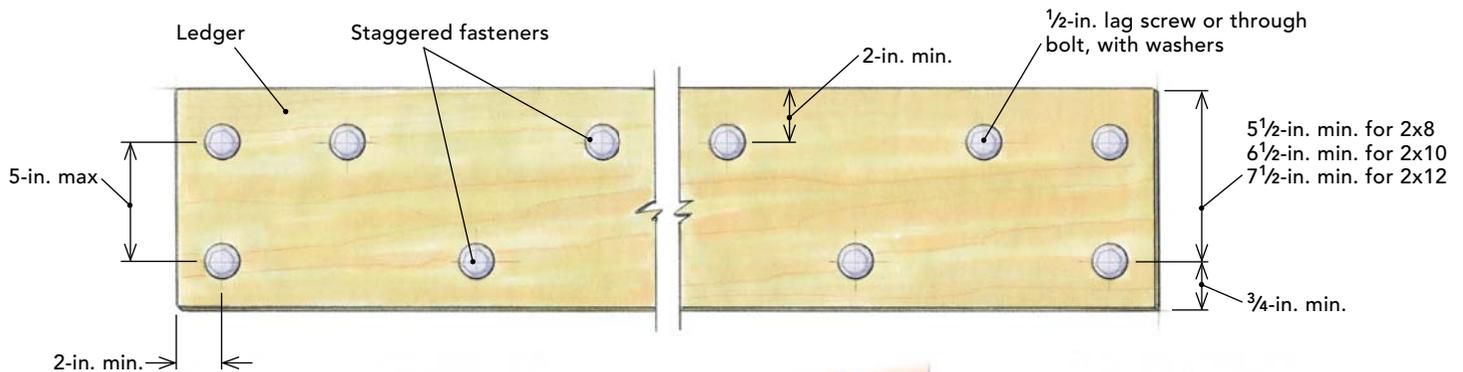
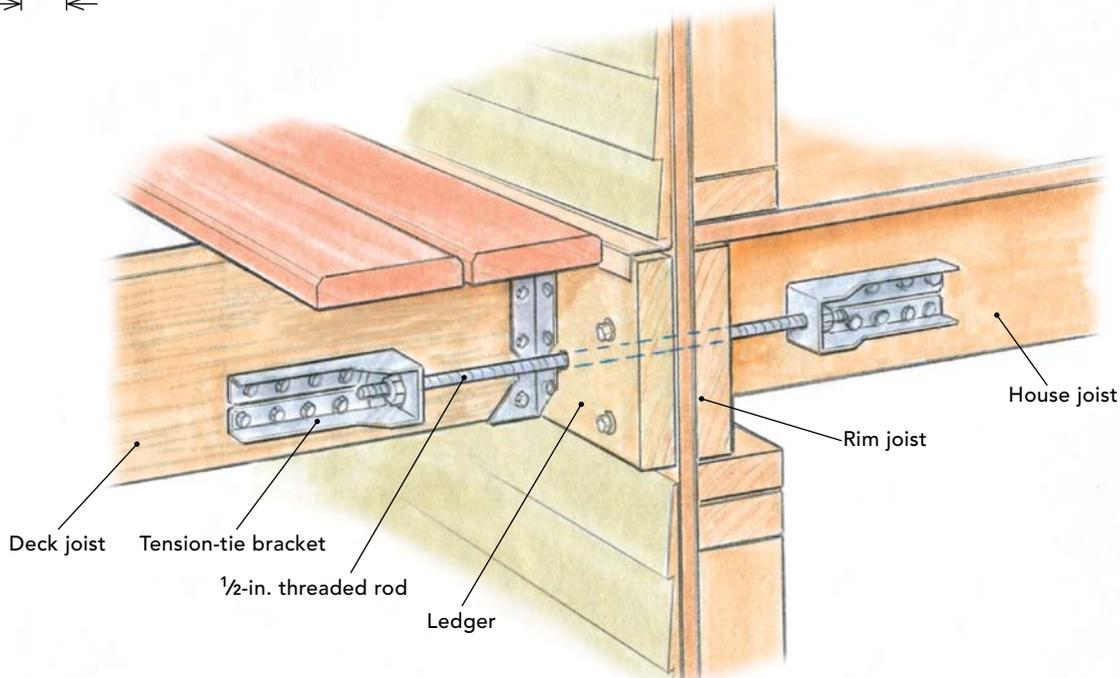
Bolt the ledger and the house together

Code now requires decks to be attached to the rim joist of a house with a minimum of either 1/2-in. machine bolts or 1/2-in. lag screws; in both cases, the fasteners must be made of hot-dipped-galvanized or stainless steel. Bolt location and spacing is spelled out in both the IRC and the DCA 6-12 and depends on the span of the joists. Additionally, code now requires a lateral-load anchor capable of resisting a 1500-lb. outward pull in two places on each deck. One common method uses threaded rods and tension-tie brackets screwed to the joists in the house and the deck. The details here are for houses with solid-lumber joists. A house with engineered joists or floor trusses requires different details acceptable to the manufacturer.

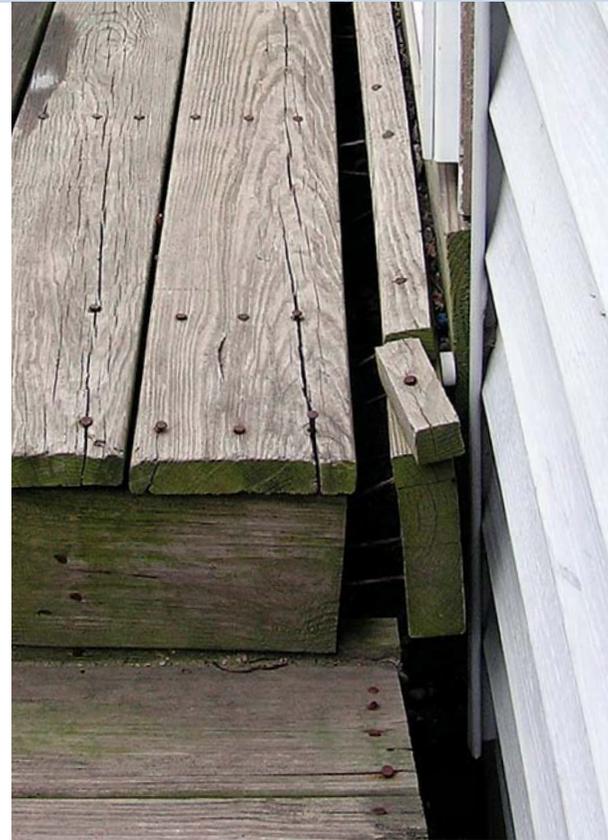
Nails alone don't do the job. This small deck was assembled by driving nails through the back of the ledger into the joists' end grain prior to installation. Toenailed joist-to-ledger connections are more common but also likely to fail.

The use of metal joist hangers in joist-to-ledger connections has become an industry standard. Previously, joists were usually toenailed to the ledger. Alternatively, nails were driven through the ledger into the end grain of the joists, with the entire assembly then put in place and the ledger secured. Nails used in these ways don't provide either the shear connection or the withdrawal resistance needed. Any hardware or structural fasteners used on a deck must be stainless steel or galvanized to the G180 standard (which is stamped on the hardware).

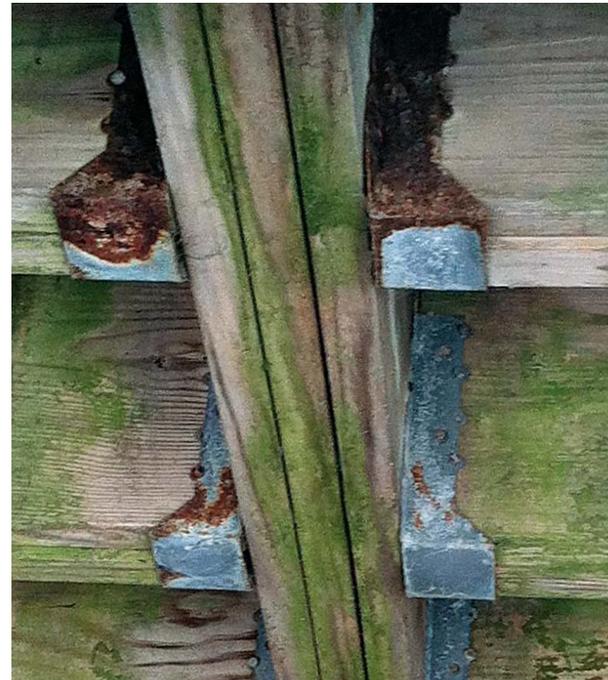
Use the right joist hangers. Although galvanized, the hangers on this seaside deck are rusty and nearing failure. Regular inspection of hardware is a good idea.

Properly sized joist hangers support vertical loads and help to prevent joists from pulling away from the ledger. Joist hangers with concealed or inverted flanges should be used for joists at the ends of a ledger. They are nailed to the ledger first, and then the joist is placed in the hanger and nailed home. Stainless-steel hardware should be used near the ocean.

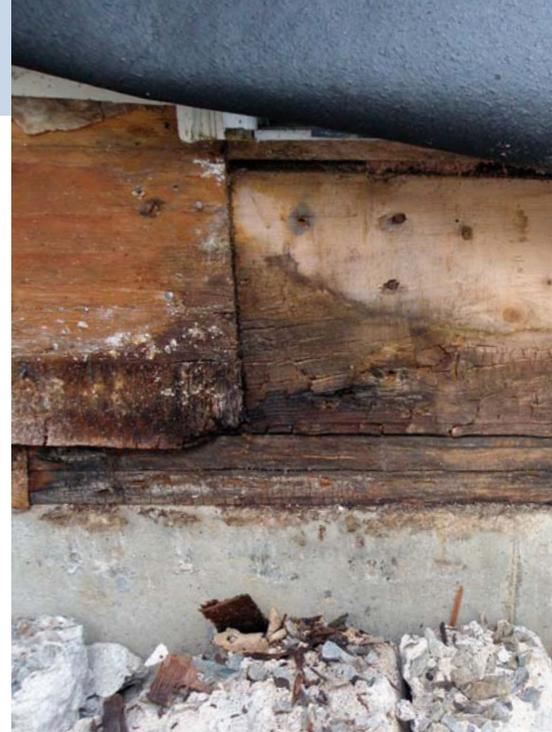
Poor flashing leads to a rotted house. Although this deck ledger had flashing, it was not properly integrated with the housewrap or building paper behind the siding. Water found its way to the house framing, rotting the rim joist and mudsill.

Deterioration of components due to water exposure is a leading cause of deck failures. Decayed deck boards and joists often can be seen and repaired before a deck has a disastrous failure. However, the decay of wood or of fasteners that are not easily observable leads to some of the most dramatic deck failures. The most likely place for hidden decay is at the interface with the house. Not only can ledgers and ends of joists decay, but missing or poor flashing can lead to severe decay of the house's sheathing, rim joist, and mudsill, leaving little for the ledger fasteners to grab.

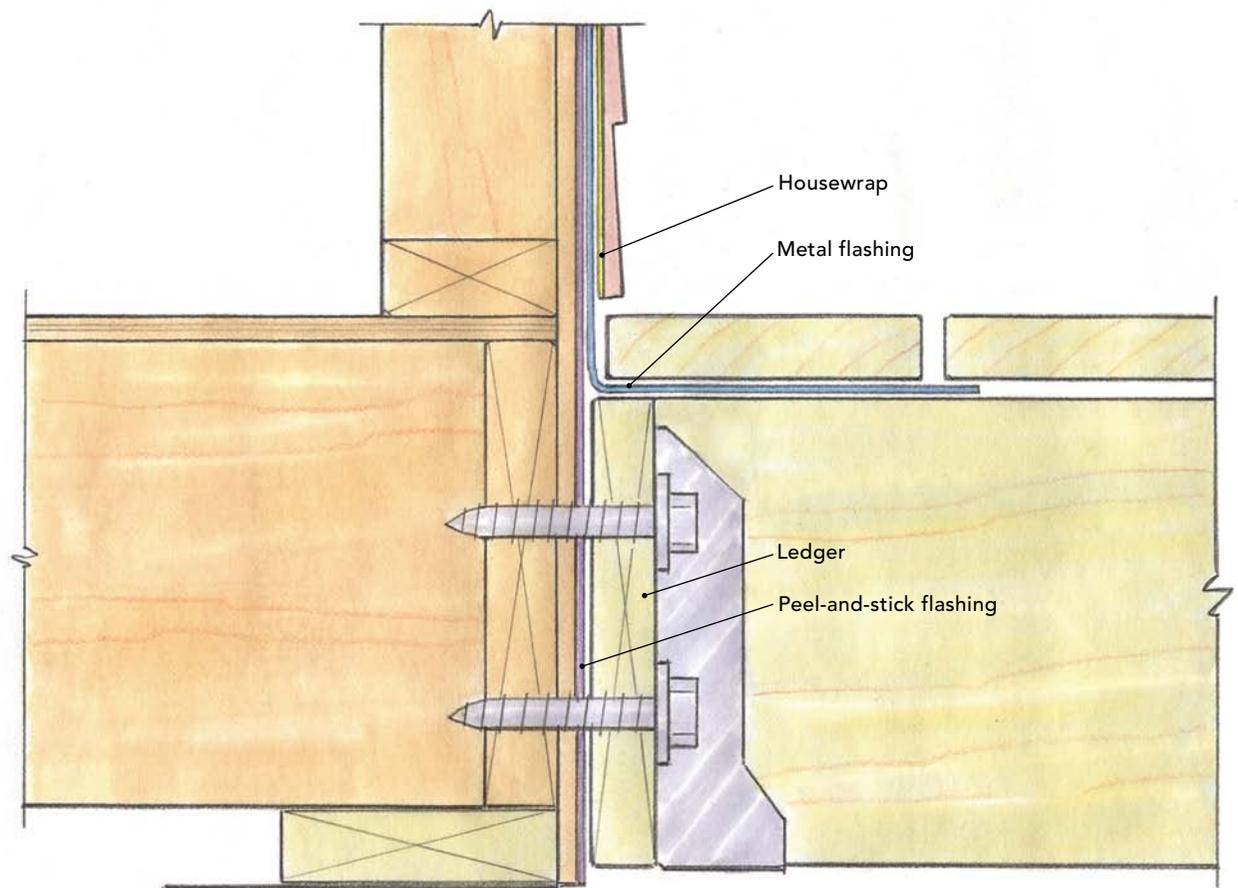
Integrate ledger flashing with housewrap

Keeping water out of the joint between the deck and the house calls for multiple layers of flashing. Self-sealing flashing (peel-and-stick) should be applied to the wall sheathing before installing the ledger. The flashing should run below the ledger and at least 6 in. higher up the wall than the top of the ledger. L-shaped metal flashing goes over the top of the ledger and up the wall as high as the peel-and-stick. A narrow band of peel-and-stick over the top of the metal prevents water that gets behind the housewrap from getting behind the ledger. At the least, the housewrap must extend several inches down the face of the metal flashing.

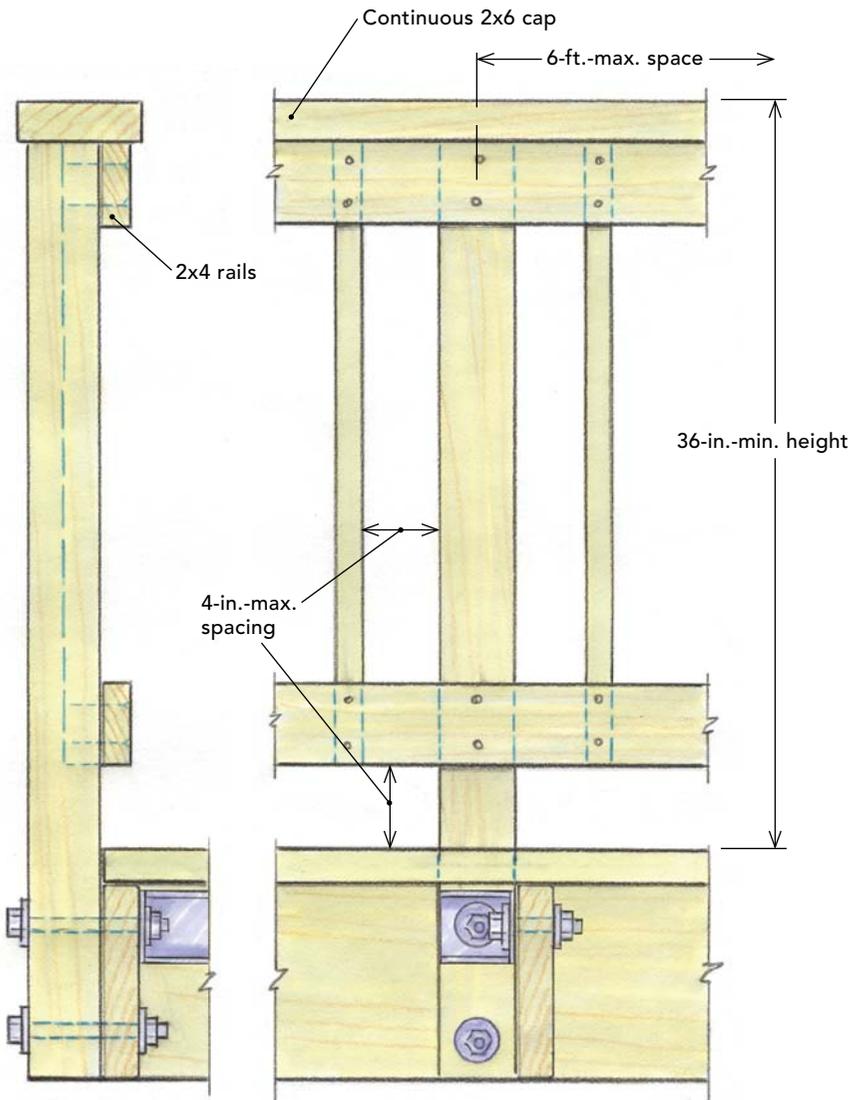
Screw rails to the inside of posts

A robust and code-compliant wood railing can be built if you rely on corrosion-resistant screws and place the railing inside the posts. Capping the posts and railing sections with a continuous 2x6 makes the assembly more rigid.

In my experience, very few residential wood railing systems are built to endure code-designated loads. A rail is supposed to be able to withstand a 200-lb. force pushing out on the top. It is a challenge to accomplish this with wood, and in my opinion, the ideal railing is made from welded, hot-dipped galvanized steel. The DCA 6-12 shows details (below) for a wood railing, but I would be more comfortable with 6x6 posts, 2x8 top rails, and 2x6 rails.

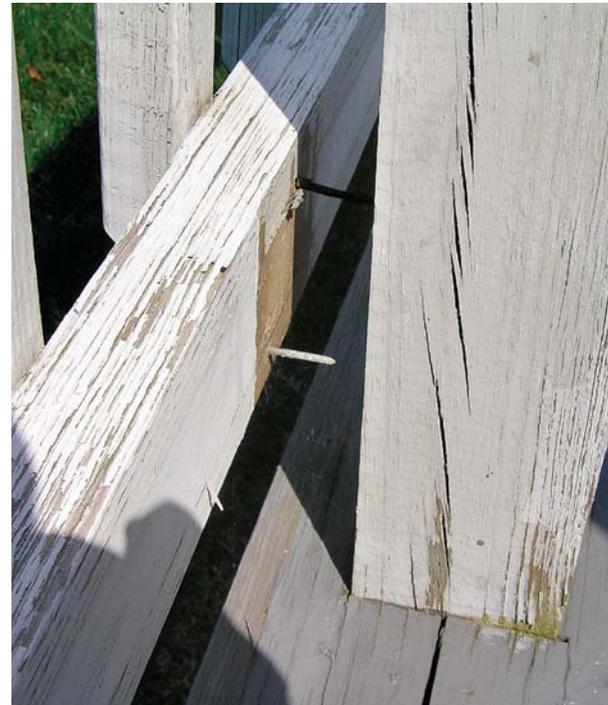
Don't rely on nails. This railing was just nailed to the outside of the posts. The nails eventually withdrew, and the railing pulled away.

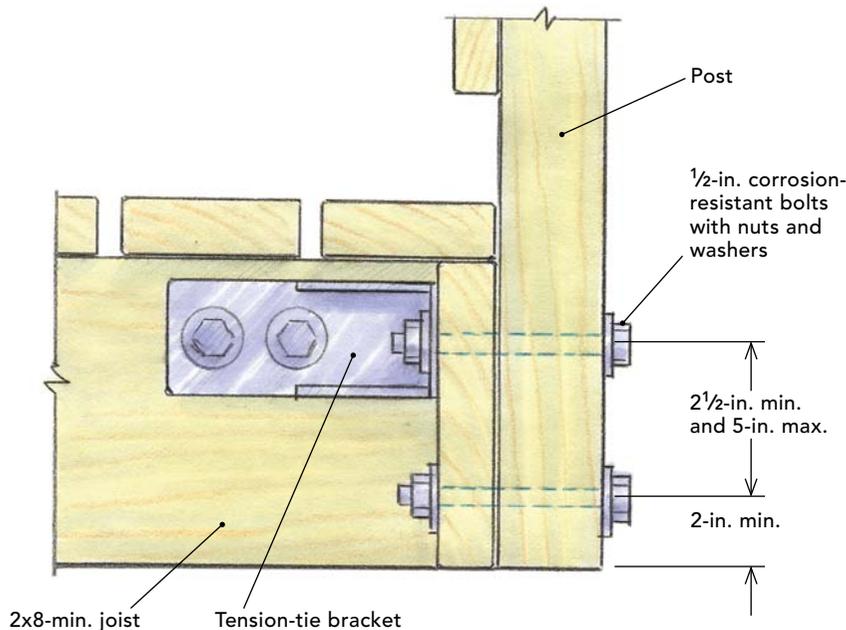
Scabbed-on bracing points to trouble. The post is notched around the joists and nailed into place, but this joint won't meet the code's load requirement. The untreated wood bracing is a poor attempt to address the problem.

No matter how well a railing is attached to a post, it is bound to fail if the post isn't firmly anchored to the deck framing. This connection hadn't been studied or addressed in the code until recently, so it's common to find loose and shaky railing posts. Although the DCA 6-12 allows 4x4 posts, I prefer 6x6s.

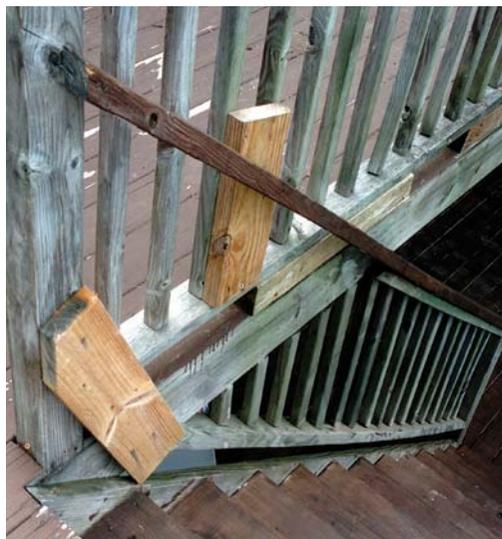
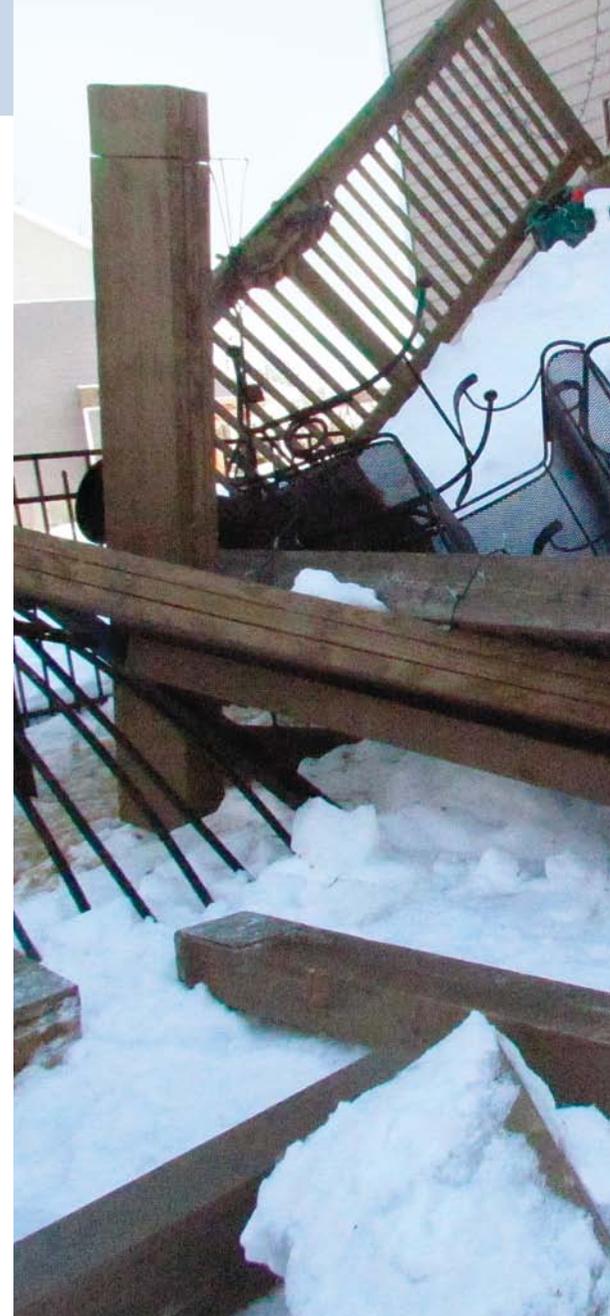
Fasten wood posts with metal hardware

One way to achieve the code-required load capabilities is with a combination of bolts and metal tension-tie brackets, although this can only work with joists that are 2x8 or larger. That's because the top of the joist acts as a fulcrum for the post, and 2x6 joists don't provide enough depth for the fasteners to resist the leverage. Shallower, 2x6 joists would require a manufactured surface-mount railing system.

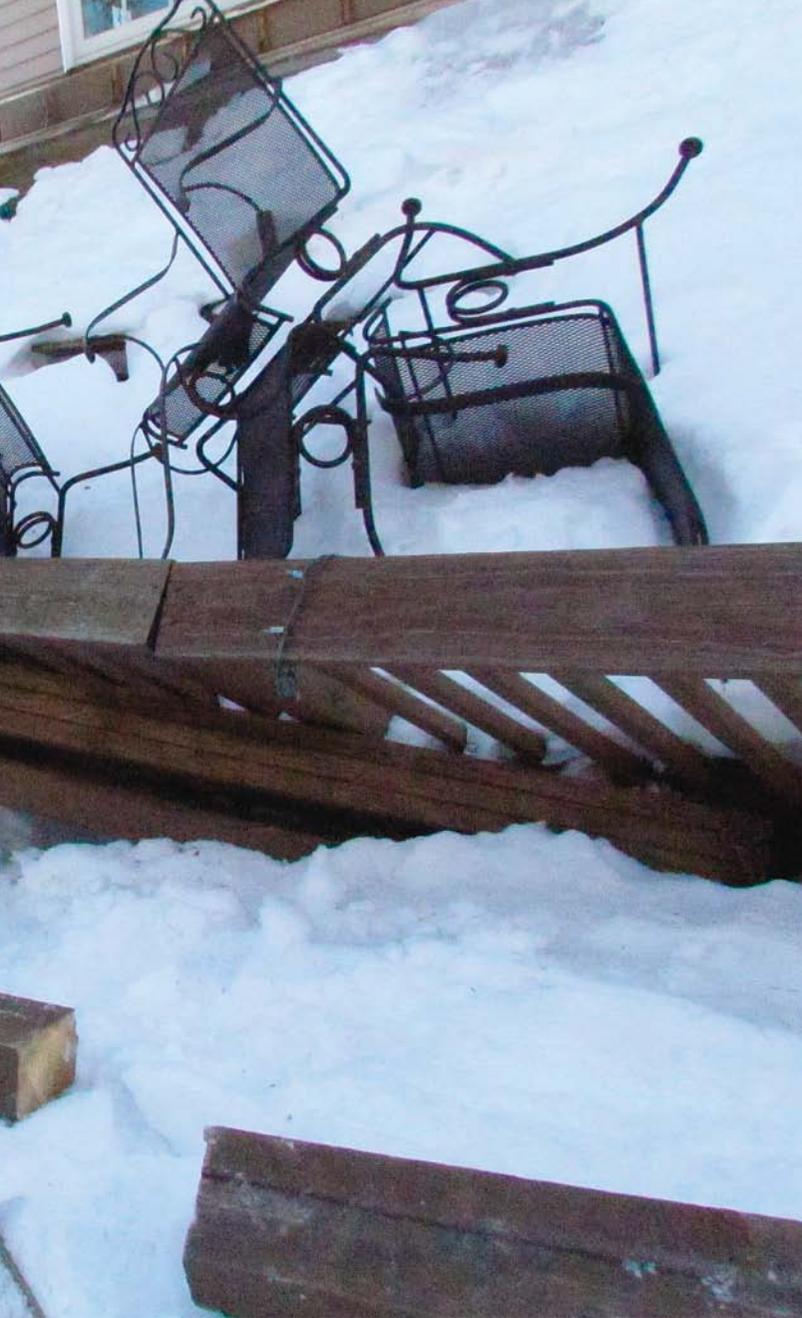
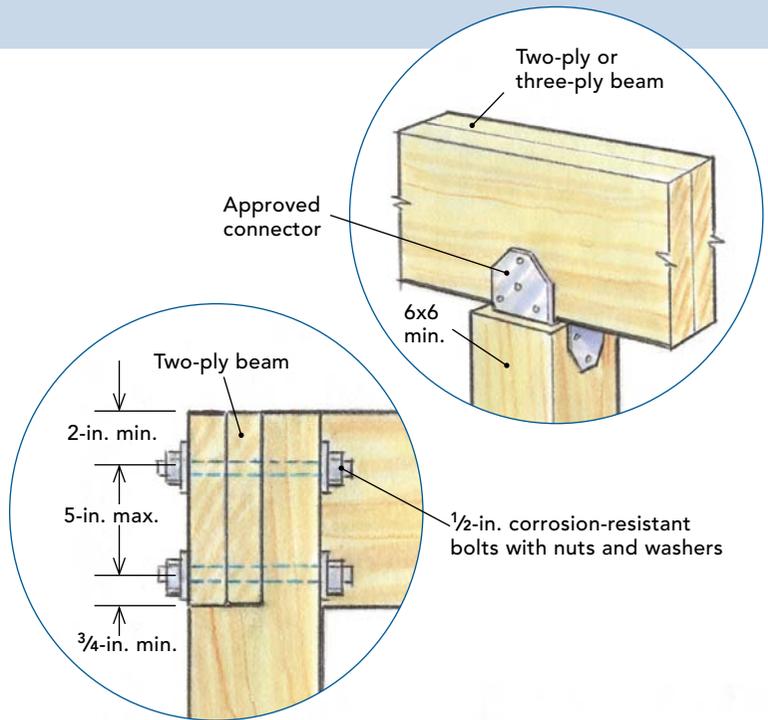
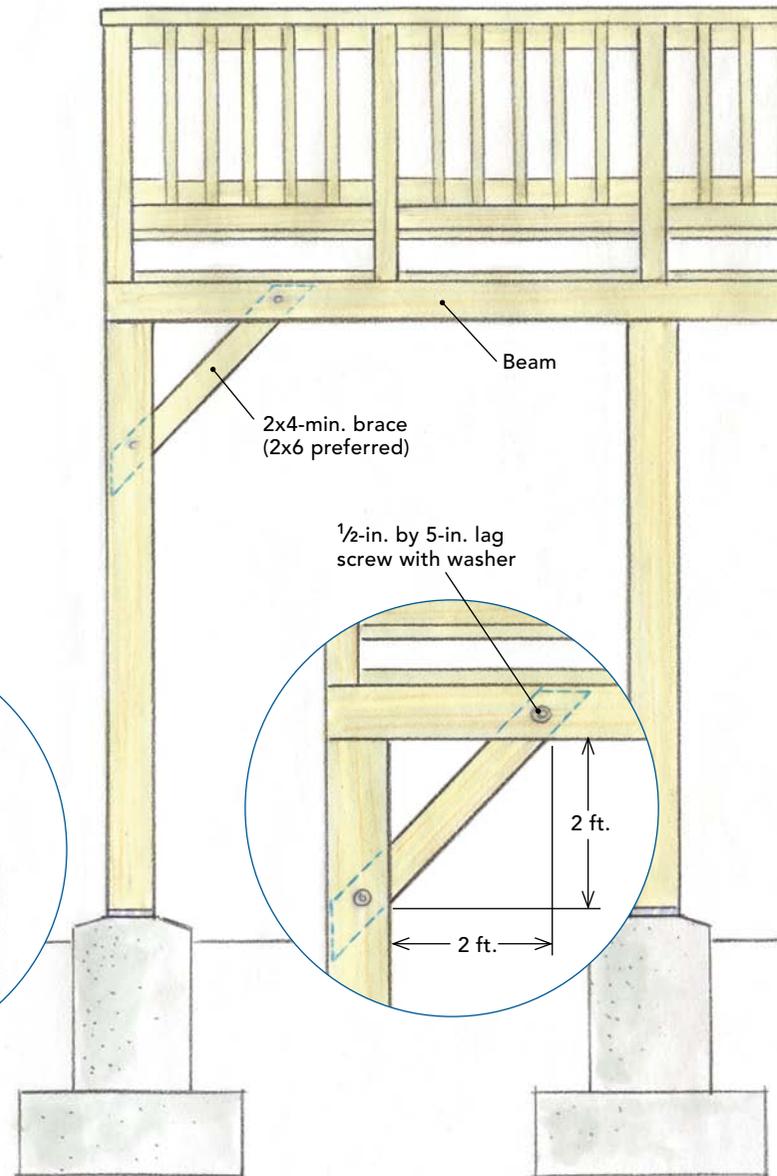
THE FIX **Brace and fasten the posts**

Posts should be at least 6x6 and should join to the beam either by being notched and bolted to two-ply beams, or with an approved metal connector to either two-ply or three-ply beams. Posts must fasten to footings with approved post bases. When the outer posts of a deck are taller than 2 ft., they require diagonal bracing between them and the beam.

While the bolts and tension ties at the ledger keep a deck from pulling away from the house, they do little to prevent lateral motion at the outer beam. If the beam moves far enough laterally, the posts can topple over sideways, causing the deck to collapse. Bracing between the posts and the outer beam is crucial whenever the posts exceed 2 ft. in height, and the taller the posts supporting the outer beam of a deck, the more important bracing becomes.
