Strengthening Plate-to-Rafter Connections

It may be time to abandon the time-honored toenail

by Stanley H. Niu

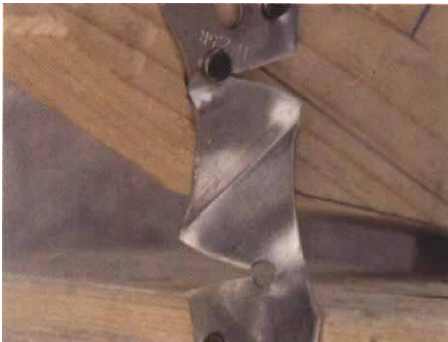
Overloaded rafter-tie connection.

The results of these tests are shown in the chart on the facing page. Ties fell into three groups ranked according to their average load capacity: below 650 lb.; 900 lb. to 1,300 lb.; and above 2,700 lb. (the last group represents the high-performance end of the spectrum, with a load capacity that is double or triple most of the midrange connections). As it turns out, the weakest sample tested was the 8d toenail connection, with an average load capacity of only 208 lb. In contrast, the lowest-capacity rafter tie tested had an average load capacity of 497 lb. When the toenailed connection failed, the nails pulled out of the top plate (top photo, p. 36). In some cases, when the connection failed, the bottom of the rafter split first. When a metal tie fails, it usually tears in half, but the nails stay put (bottom left

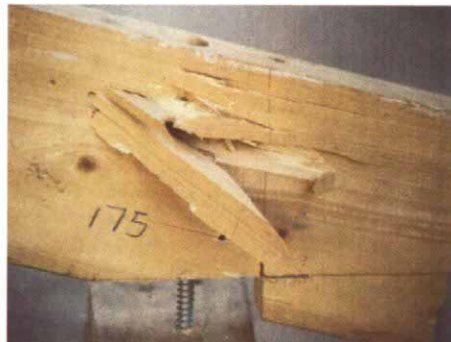
Overloaded lag-screw connection.

photo, p. 36). The lag-screw connections failed when the lag pulled free of the top plate (bottom right photo, p. 36). Unfortunately, toenailed rafters are probably the most common rafter/plate connection found in wood-frame houses. In fact, this connection is in compliance with the Uniform Building Code (UBC) and the Building Officials and Code Administrators (BOCA).
