# Building an Ornate Cornice

Cabinet-grade trim meets detective work when a carpenter restores a Victorian facade

by Terry Murphy

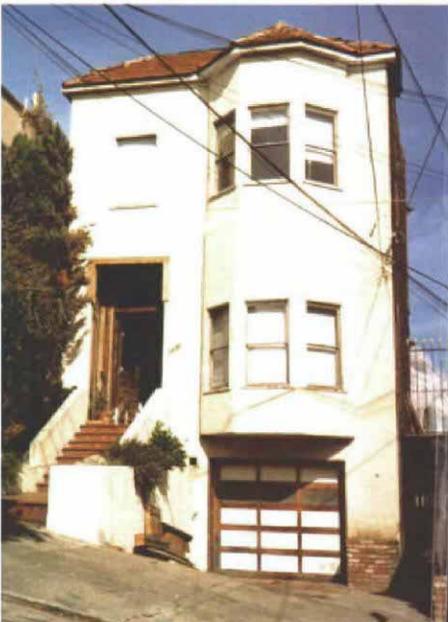
**Tiled and defiled.** By the 1950s, many San Franciscans had stripped their houses and stuccoed them. This Italianate Victorian had been further disfigured with a barrel-tile roof.

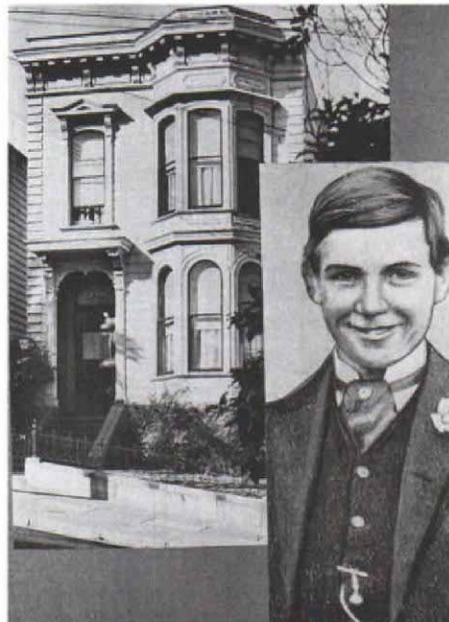
**Sunny Jim's house.** While researching its history, the owner of this house hit paydirt when she found its photo in a book about one of its inhabitants: California Gov. James Rolf.

We were lucky. Pam had learned that her house was the boyhood home of one of California's governors—"Sunny" Jim Rolf (Rolf had also presided over the city's rebuilding as mayor after the 1906 quake, along with some less-lofty activities). In a biography of Rolf, Pam found a small photo of his boyhood home (bottom middle photo, facing page). It showed that what had become a squat, flesh-colored mass of stucco with aluminum windows was once a restrained Victorian house of the Italianate style. When new, its octagonal bay had arched first-floor windows topped by what's called a belt cornice and a generous main cornice with a mansard roof.

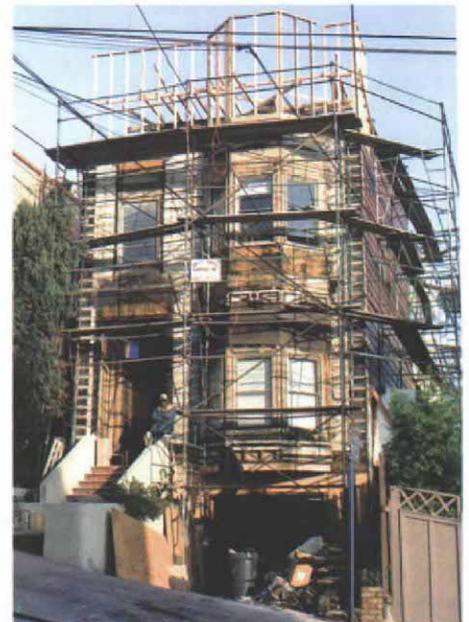
**Putting it back.** Guided by an old photo of the house, the author extended the parapet and the bay window to their original heights, then began work on the restored cornice (top).

**Raising the bay**—Before we could finish the siding, we had to add several feet to the height of the building (bottom right photo, facing page). But we weren't sure exactly how tall the building had to be. We decided to frame it higher than we thought necessary, then cut it back based on the Sunny Jim photo.

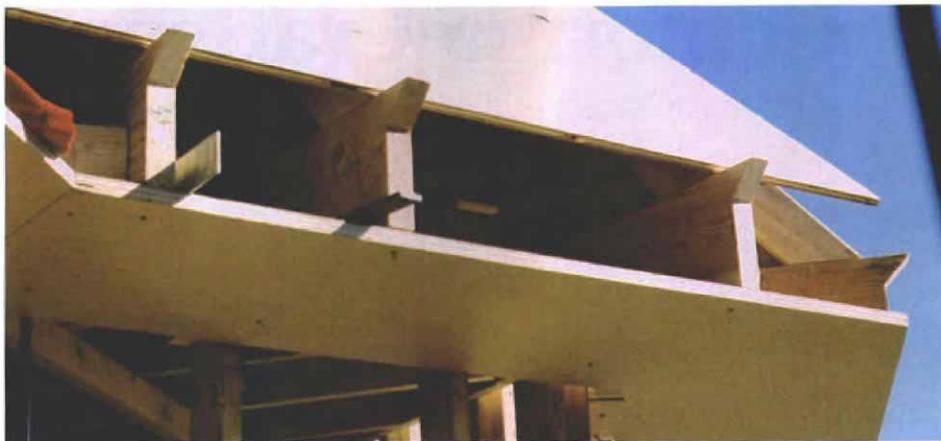
**Supporting the main cornice.** Triangular trusses made of Douglas-fir 2x4s fan out from the wall framing to serve as backing for the cornice roof and soffit. The trusses are held in the same plane by plywood gussets. The beaks on the bottom cords of the trusses anchor the crown molding.

My design uses a series of small triangular trusses to support the structure of the main cornice. The trusses are made of Douglas fir 2xs held in the same plane by plywood gussets. The profile of the trusses defines the soffit, the fascia and the

mansard roof over the cornice while the beaks on the ends of the lower cords are backing for the crown molding (top photo, facing page). John and I nailed the trusses to the new stud wall and then locked them together with a soffit of medium-density overlay (MDO) plywood, a redwood fascia and a roof of  $\frac{5}{8}$ in. CDX plywood.

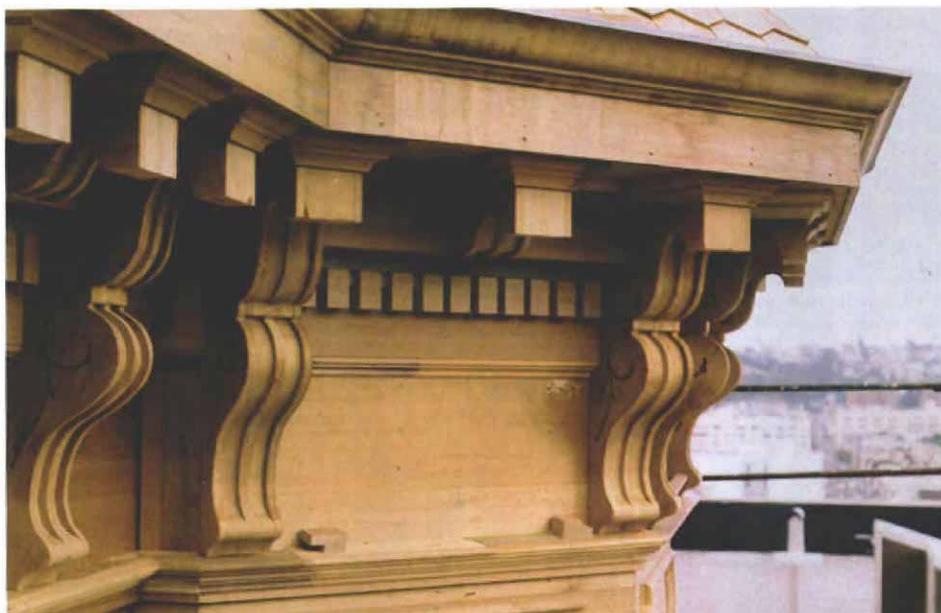
**Cabinet-grade trim at 30 ft.** Curvy brackets and modillions (smaller brackets), which are laminated from alternating layers of 1x and 2x redwood, detail the cornice's soffit and frieze. The dentils provide a secondary level of texture. On top of the architrave, two dentils await installation.

**Making the brackets**—A dozen big brackets and seven small ones, called modillions, march across the main cornice, appearing as if they hold up the mansard roof (middle photo, facing page). These brackets have five layers—three 1xs sandwiching two 2xs—for a total thickness of  $5\frac{1}{4}$  in. The 2xs are recessed along most of their exposed edges, creating a shadow that emphasizes their curves. I built the brackets and modillions, including the fretwork incisions in the outer layers, on site with templates and a router.

First we assembled the architrave—the lowest part of the cornice—from a bullnose sill, a 1x6 apron and a bed molding. The tails of the brackets bear on the top of the architrave (middle photo, right). We fastened the brackets plumb and square under the soffit, using a pneumatic nailer to position them and angled screws to anchor them. A box made of 1x6s tucks under the soffit, running between the brackets and bracing their sides. The box appears to run continuously across the front of the house, filling out the cornice and providing anchorage for the modillions.

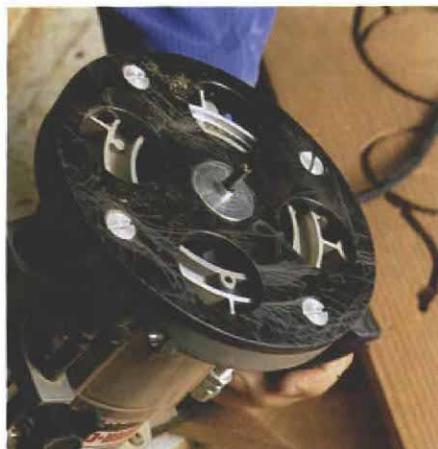
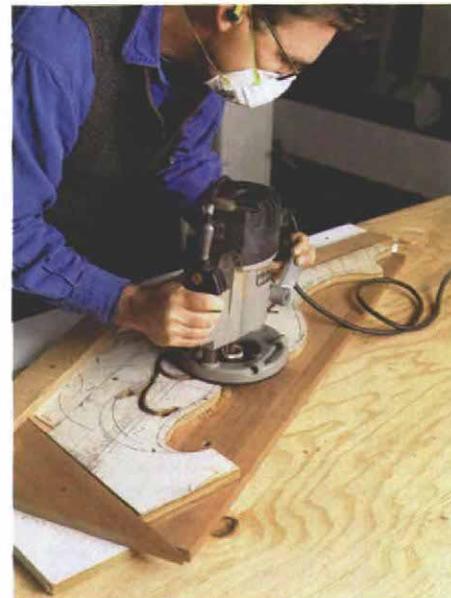
**Making the brackets.** Over a hundred pieces went into the brackets and modillions, making their fabrication perfect for template routing. In the photo to die right, the author routs the profile of an outer lamination. The next pass, with a  $\frac{1}{4}$ -in. bit and collet (above) will mill the fretwork pattern in its face.

I began by spray-gluing a full-size drawing of the bracket to a piece of  $\frac{1}{2}$ in. plywood. Cut out with a jigsaw, this pattern became the template

that I used to guide my router as I cut out the bracket pieces (right photo, below). I have a long-shanked  $\frac{1}{2}$ -in. bit that plowed through redwood in a hurry, so I used it to cut out the bracket profiles. Then I switched to a  $\frac{1}{4}$ -in. bit and collar (left photo, below) to rout the fretwork pattern in the exposed side of the brackets.
