Synthetic Stucco

Exterior insulation and finish systems provide an attractive, energy-efficient, low-maintenance siding; but should you trust them on your house given their recent failures?

by Steve Culpepper

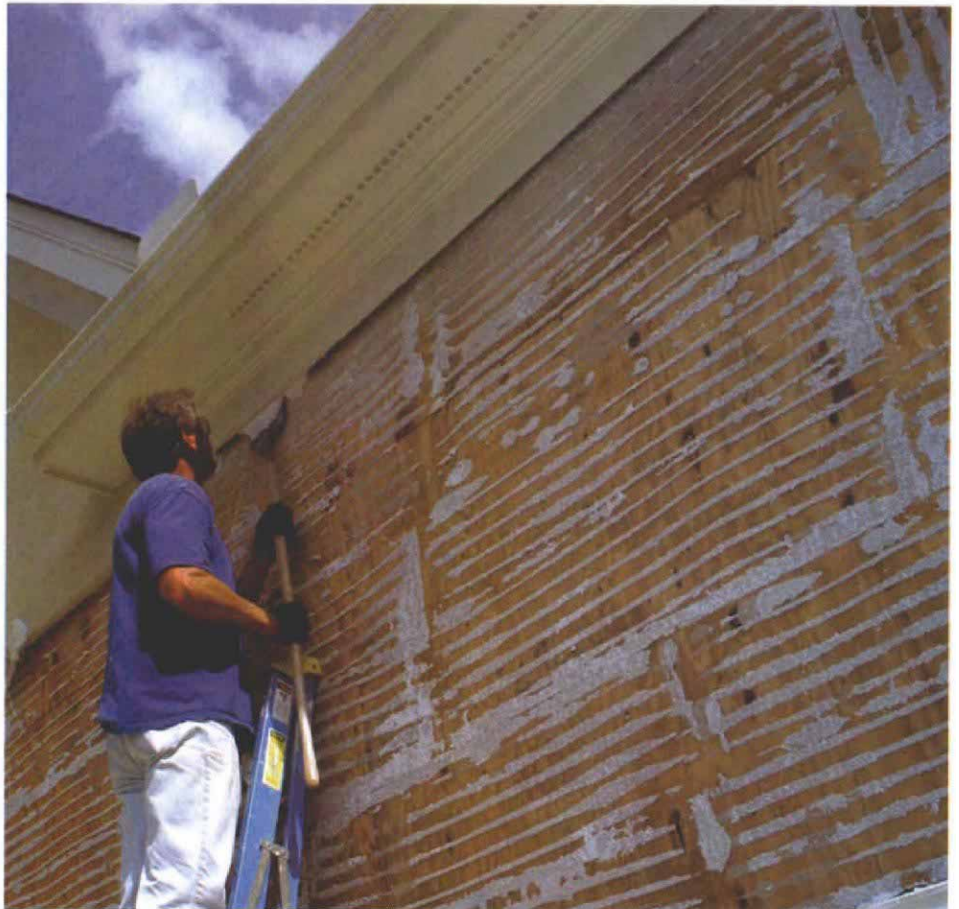
What went up must come down.

Although this EIFS-sided home in Wilmington, North Carolina, suffered only minor damage from water intrusion, the synthetic-stucco skin is being ripped off anyway—to make way for more traditional siding.

Synthetic stucco, or EIFS (exterior insulation and finish systems; the acronym is pronounced *eefs*), is being ripped from houses in almost every neighborhood in Wilmington, North Carolina (top photo). In its place: clapboards, shingles, hardboard siding, real stucco or brick. Rarely is EIFS going back up. The siding is being replaced because water got behind the synthetic stucco and damaged the sheathing. In some cases, even the framing suffered damage.

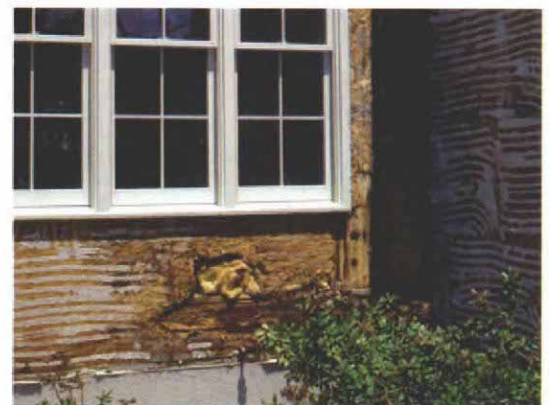
When water gets in, rot happens.

This Cary, North Carolina, house was about a year old when moisture-testing showed that water had gotten behind the synthetic stucco. The main culprit for the leaking was the windows, where water dribbled past the caulking or through the jamb-and-sill connection to the OSB substrate.

Ironically, the greatest strength of EIFS is also its greatest weakness. Because it is a water-barrier system, water can't get in—theoretically. When water does get in, it cannot easily get out. And when water gets trapped between sheathing and an otherwise impermeable covering, rot can occur (bottom photo, facing page).

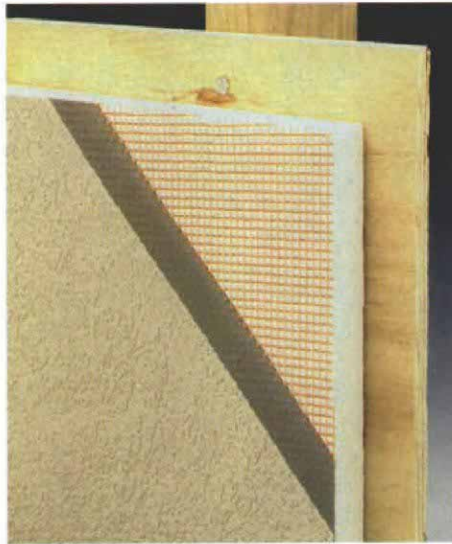
These layers should add up to a protective barrier against the elements. Glued to the sheathing is the expanded polystyrene insulation board. Over that is a base coat embedded with protective fiberglass mesh. Topping off the system is a textured acrylic finish.

Why does water cause so much damage when it gets behind EIFS?—Traditionally, residential EIFS refers to a surface-sealed, water-barrier siding system made up of a layer of foam-insulation board, fiberglass mesh and one or two base coats and a finish coat of synthetic stucco (top photo).

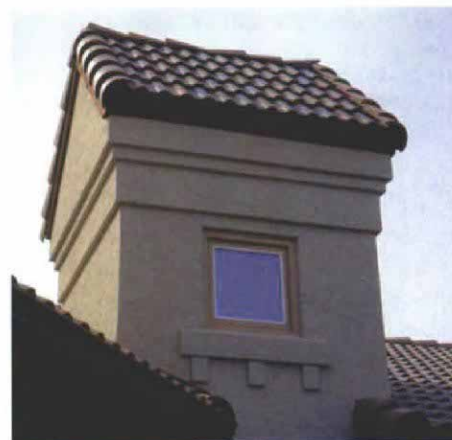
It looks like real stucco. Architectural elements such as this EIFS-clad tower can be made to look like real cement stucco.

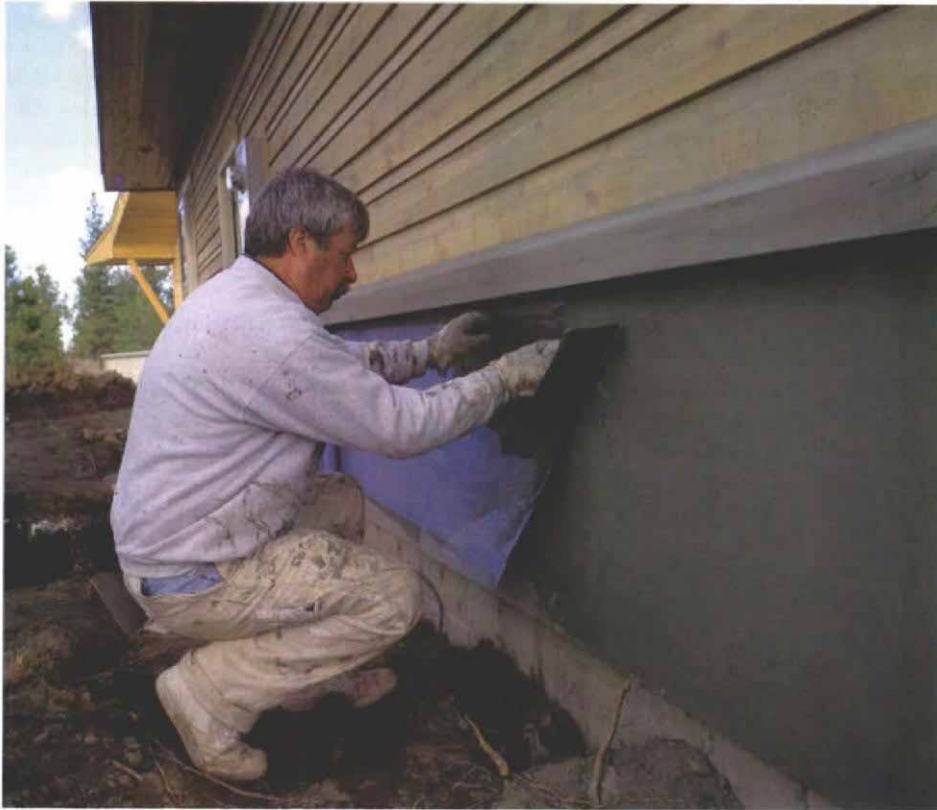
Mesh reinforcing is embedded in the base coat. A thin layer of base coat is applied to the insulation before the fiberglass-reinforcing mesh is rolled onto the wall surface. More base coat is applied over the mesh.

Embed fiberglass mesh fully in the base coat—The EIMA recommends that fiberglass-reinforcing mesh be embedded in the base coat until no mesh color is visible (top photo). Some researchers say that after you wait at least 24 hours, a second base coat should be applied until no mesh pattern can be seen.

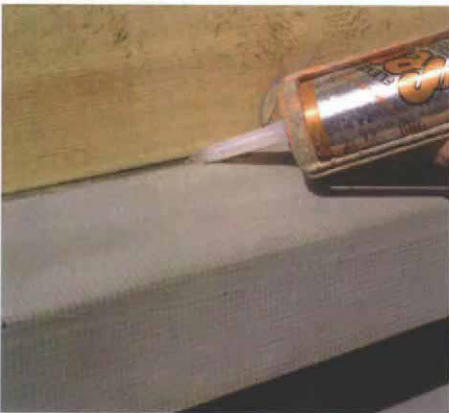
Caulk the base coat, not the finish. Sealant recommended by the manufacturer is applied wherever the EIFS intersects other materials, such as at this strip of molding separating the EIFS from the clapboard siding.

In most cases, caulking means the difference between a successful EIF system and one that lets in water. It used to be recommended that caulk be applied to the finish coat at all terminations. But the finish coat proved to be an inadequate surface for caulking adhesion. Now it's recommended that caulk be applied to the base coat (photo bottom left, facing page).

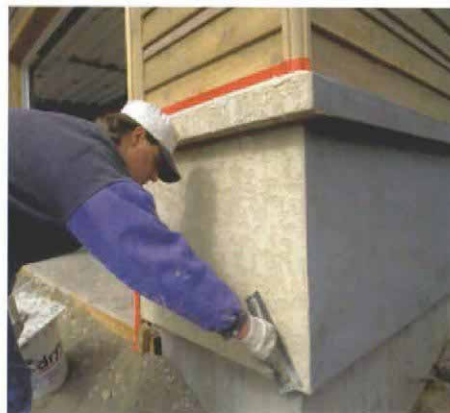
One worker should trowel the finish coat. To ensure a uniform appearance, the same person should trowel the final coat of stucco. On big jobs one worker can apply the finish while a second worker textures it.

Finally, a finish coat is troweled on—On a small job such as the one shown here, Bogart usually assigns one person to apply and texture the finish coat (photo bottom right, facing page). That way, the texture that's troweled into the mix will be consistent throughout. On a larger job, one person applies the finish-coat mix and another trowels in the texture.

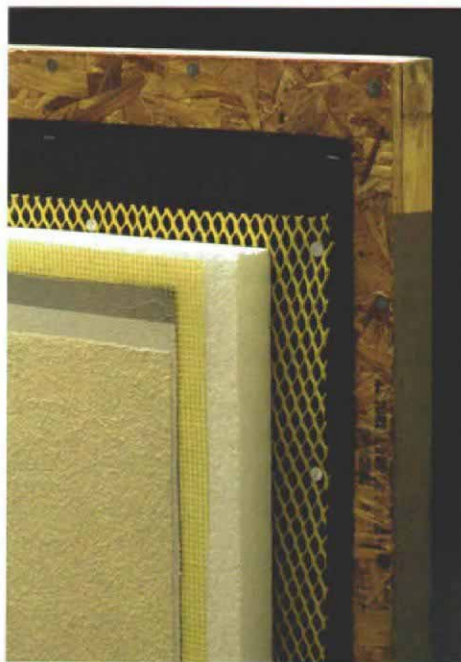
A watershed EIFS design. Sto now offers this design in North Carolina: a layer of building paper, plastic lath for drainage and the standard built-up insulation, mesh and top coat. The wall terminates at the bottom into a plastic molding that contains weep holes.

Parex (800-226-2424) is another manufacturer that has developed a drainage system for North Carolina. The Parex system is nearly identical to the Sto system shown in the photograph on p. 69.

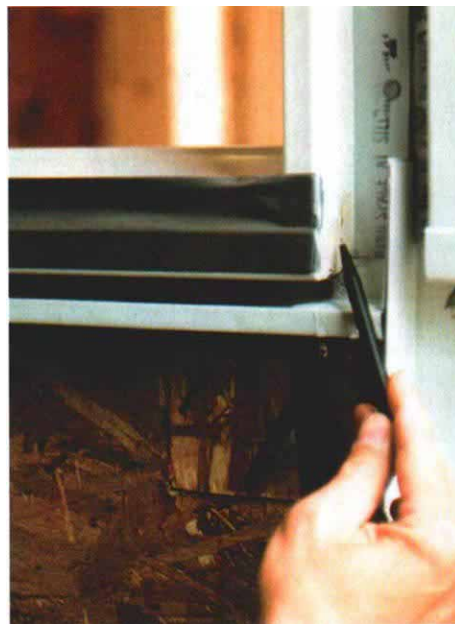
Water got through even this brand-name window. In an experiment, the sill was dammed with duct tape and water poured in. After less than a minute, water began leaking through the sill-frame joint in this window.

As part of his research, Williams mocked up an EIFS-sided house at his office in Maple Glen, Pennsylvania. On one window (I won't name the brand, but it's a major window company, and the window wasn't a cheap one), Williams dammed up the sill using duct tape. Then he poured in a cup of water. After less than a minute, the water started dribbling through the joint where the sill is attached to the jambs (photo left). Builders can't be blamed for code-approved windows that leaked water into an EIF system, according to Williams.
