Singular Details

Rebuilding the cornice of the Octagon house

by Scott McBride

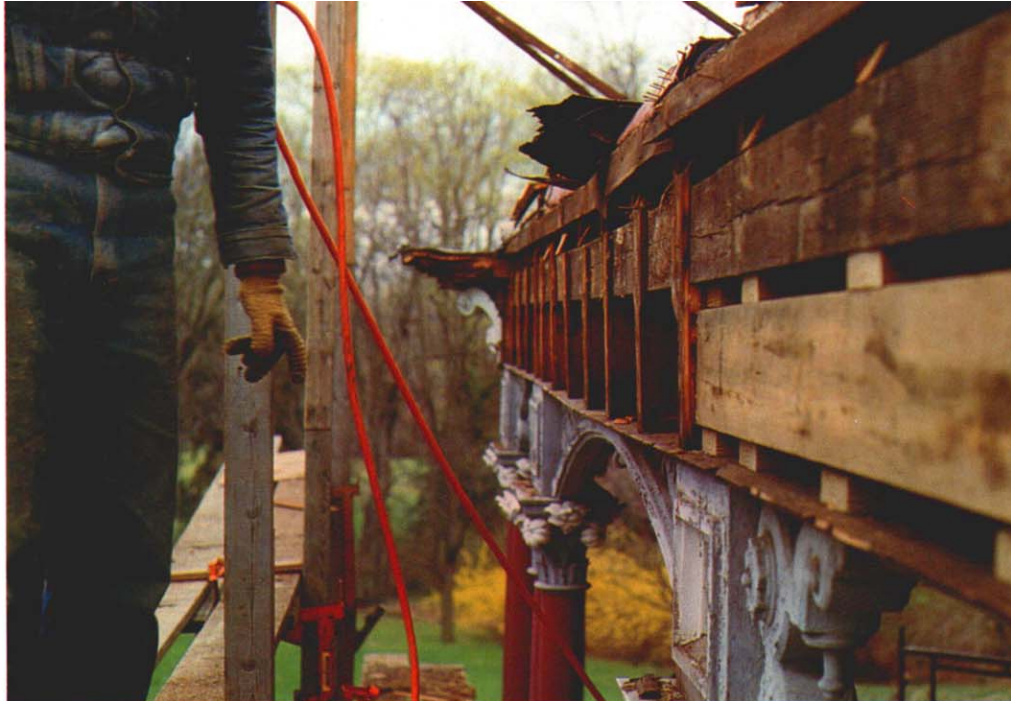
To make the lintels look beefier than they are, the original builders dropped the lintel soffit nearly a foot below the lintel and framed in the space between the lintel and the soffit with 2x6 cripple studs. The author replaced the studs beneath each damaged section of the lintel with a 6x8 beam (at right in photo), adding blocks to transfer the load.

Our worst fear was that we'd find the lintels and the rafter ends bearing upon them to be thoroughly rotten. That would require a complete rebuild of the elaborate coffered ceiling of the porch. Fortunately, damage to these elements turned out to be minimal and—thanks to the design of the lintel—relatively easy to fix. In order to give the finished lintel an appearance of greater depth, the original builders had dropped the lintel soffit nearly a foot below the 6x8 lintel itself and framed in the resulting dead space with 2x6 cripple studs. That allowed us to yank out the cripple studs beneath damaged sections and to replace them with 6x8 beams, positioning the beams to bear on two adjacent porch columns (photo above right).

Also, instead of splicing the lintels over the intermediate columns, the original builders had used one continuous lintel for each side of the house, each a whopping 32 ft. long. That made it possible for us to prop up each damaged lintel section with temporary posts which were offset from the porch columns and out of our way while we slipped the new 6x8s into place. Once the beams were home, we added blocking to transfer loads from the old lintels to the new beams.

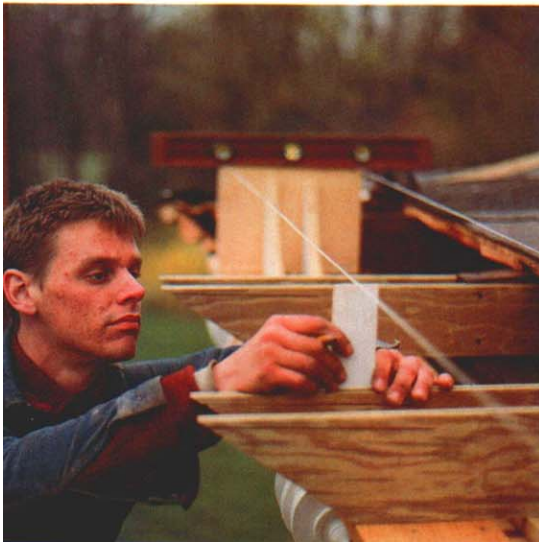
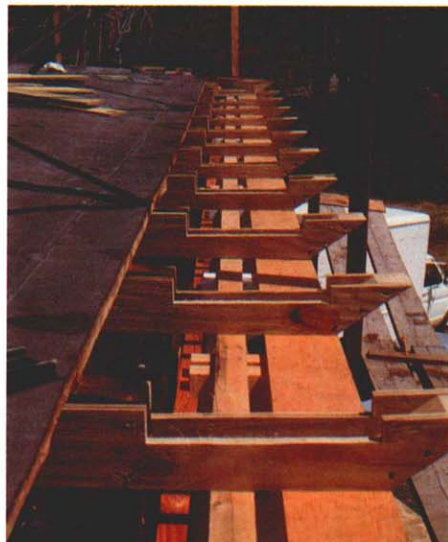
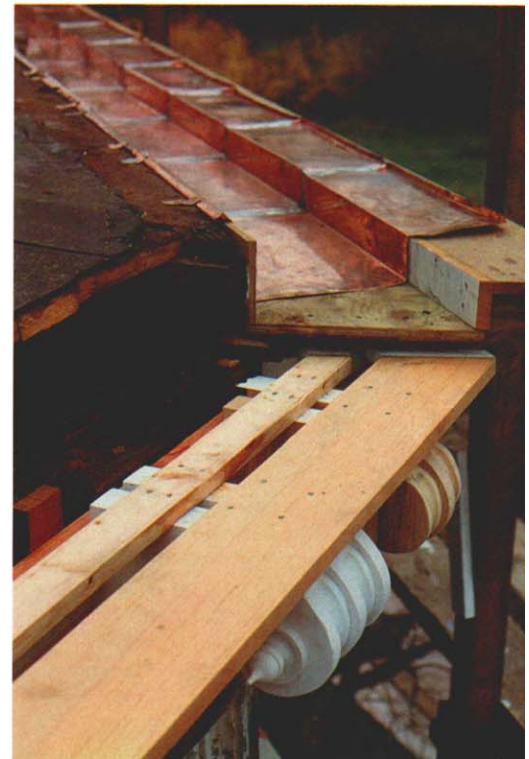
To lay out the lookouts for the gutters, workers stretched a pair of strings between temporary supports on opposite ends of the cornice so that the strings paralleled the desired slope of the gutter. The depths of the cutouts were then established by touching a measuring stick against the string and marking the lookouts at the bottom of the stick (photo below left). Cut lines for the sides were squared down from chalklines snapped across the tops of the lookouts. Once the lookouts were removed, cut out with a bandsaw and reinstalled, they formed a perfectly straight inclined trough to house the gutter (photo below center). The brackets support a split soffit (photo below right), which serves as a level foundation for the built-in gutter on top. The new copper lining for the gutter was cut into small square sheets and soldered at the seams, typical of the 19th century.

Next, we nailed down two pieces of the cornice soffit to the tops of the brackets. Duplicating the original design, we used clear pine for the exposed outboard-half of the split soffit and common spruce for the hidden inboard half (photo next page, bottom right). A split soffit was less likely to cup than a solid soffit and it saved on material.

support at each end of the cornice so that the strings were on an incline parallel to the desired incline of the gutter (photo facing page, bottom left). The incline was calculated so that the lookout at the high end of the gutter would be cut only slightly and the lookout at the low end would be cut to within an inch of its bottom.

Next, I made a measuring stick equal in length to the desired distance from the strings to the bottom of the cutouts. The stick was beveled at one end and left square at the other. By just touching the strings with the beveled top of the stick and marking the lookouts across the bottom of the stick, we were quickly able to establish the elevation of the bottom of each cutout. The sides of the cutouts were simply squared down from parallel chalklines snapped across the top edges of the lookouts. Once the lookouts were removed, cut out with a bandsaw and reinstalled, they formed a perfectly straight inclined trough ready for plywood (middle photo, facing page). The cutouts for the splayed lookouts at the corners of the house were extrapolated from the common lookouts with a straightedge after the commons were installed.

A copper lining—When Dupin wasn't busy making trim, he was up on the roof forming and soldering the copper lining for the new gutter. Although Dupin could have handled 8-ft. lengths of copper in his portable brake, the Lombardis insisted that he cut the copper into the small square sheets used by roofers in the 19th century. Dupin used traditional soldering irons for the job as well, although he heated his irons with a roaring propane brazier instead of with the traditional charcoal pot.

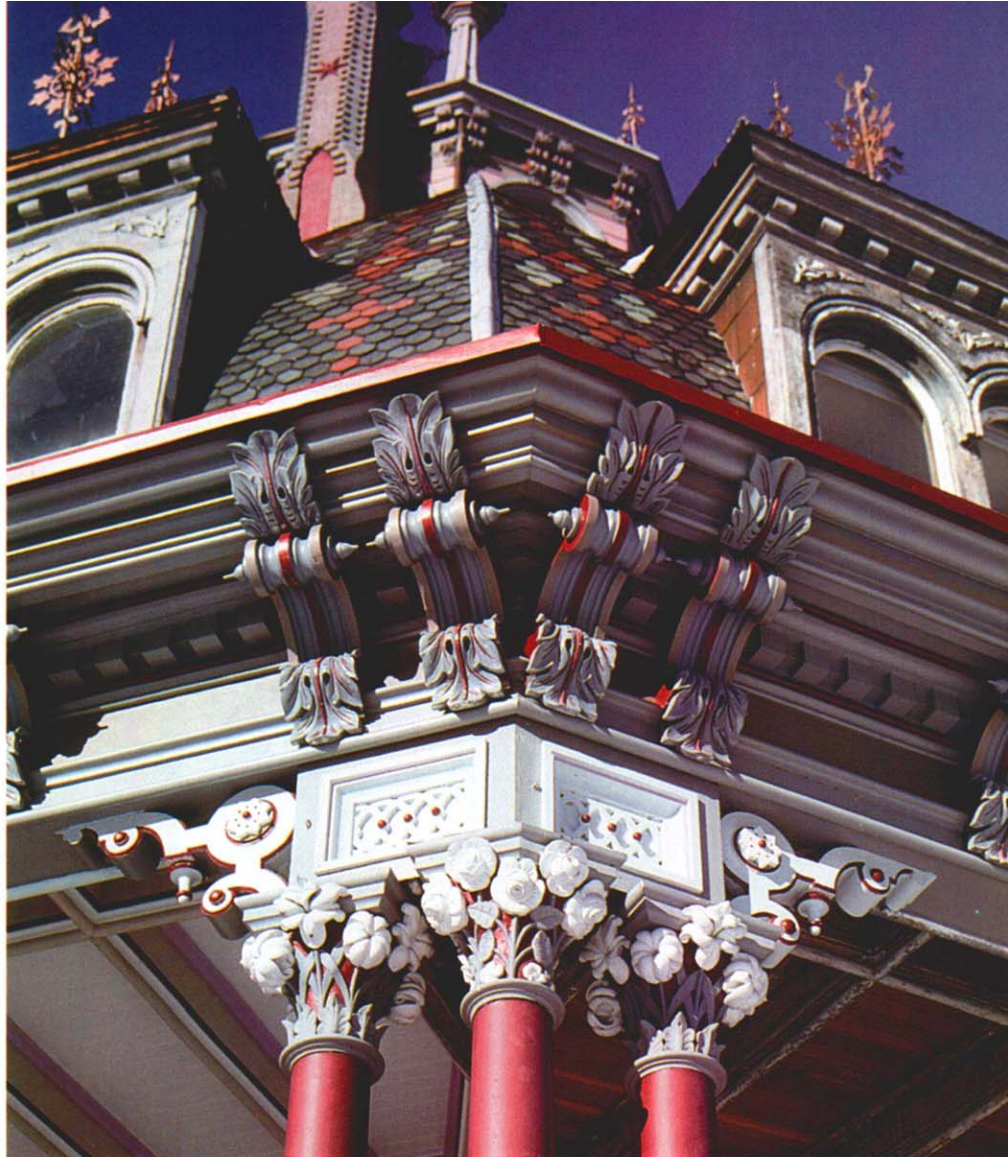
The finished cornice reflects the Victorian passion for ornament and vibrant color schemes.

Analyzing the paint—As a prominent preservation architect himself, Joe Lombardi had access to state-of-the-art techniques in the restoration of his own home. To determine the colors used at the time of the 1870s remodeling, paint chips were sliced on the bias so that successive layers of paint were exposed. The sample was then placed under a microscope to make its history clear. Results indicated that the Octagon house was a stunning example of the Victorian passion for vibrant color schemes (photo above).
