Revamping a 60-Year-Old Bath

The decision-making process
behind a six-week gut job

BY JOHN KELSEY

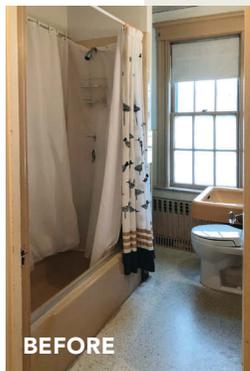
PROBLEM The room measured just 7 ft. 6 in. by 6 ft.—it was both small and oddly laid out. The vestibule connecting the hallway to the bath was wasted space.

SOLUTION We made the bathroom larger and more efficient by relocating the door between the vestibule and bedroom. With that door eliminated and the vestibule better integrated into the bathroom, the tub/shower, vanity, and toilet could be located on one wall, providing 40 in. of circulation in front of all plumbing fixtures.

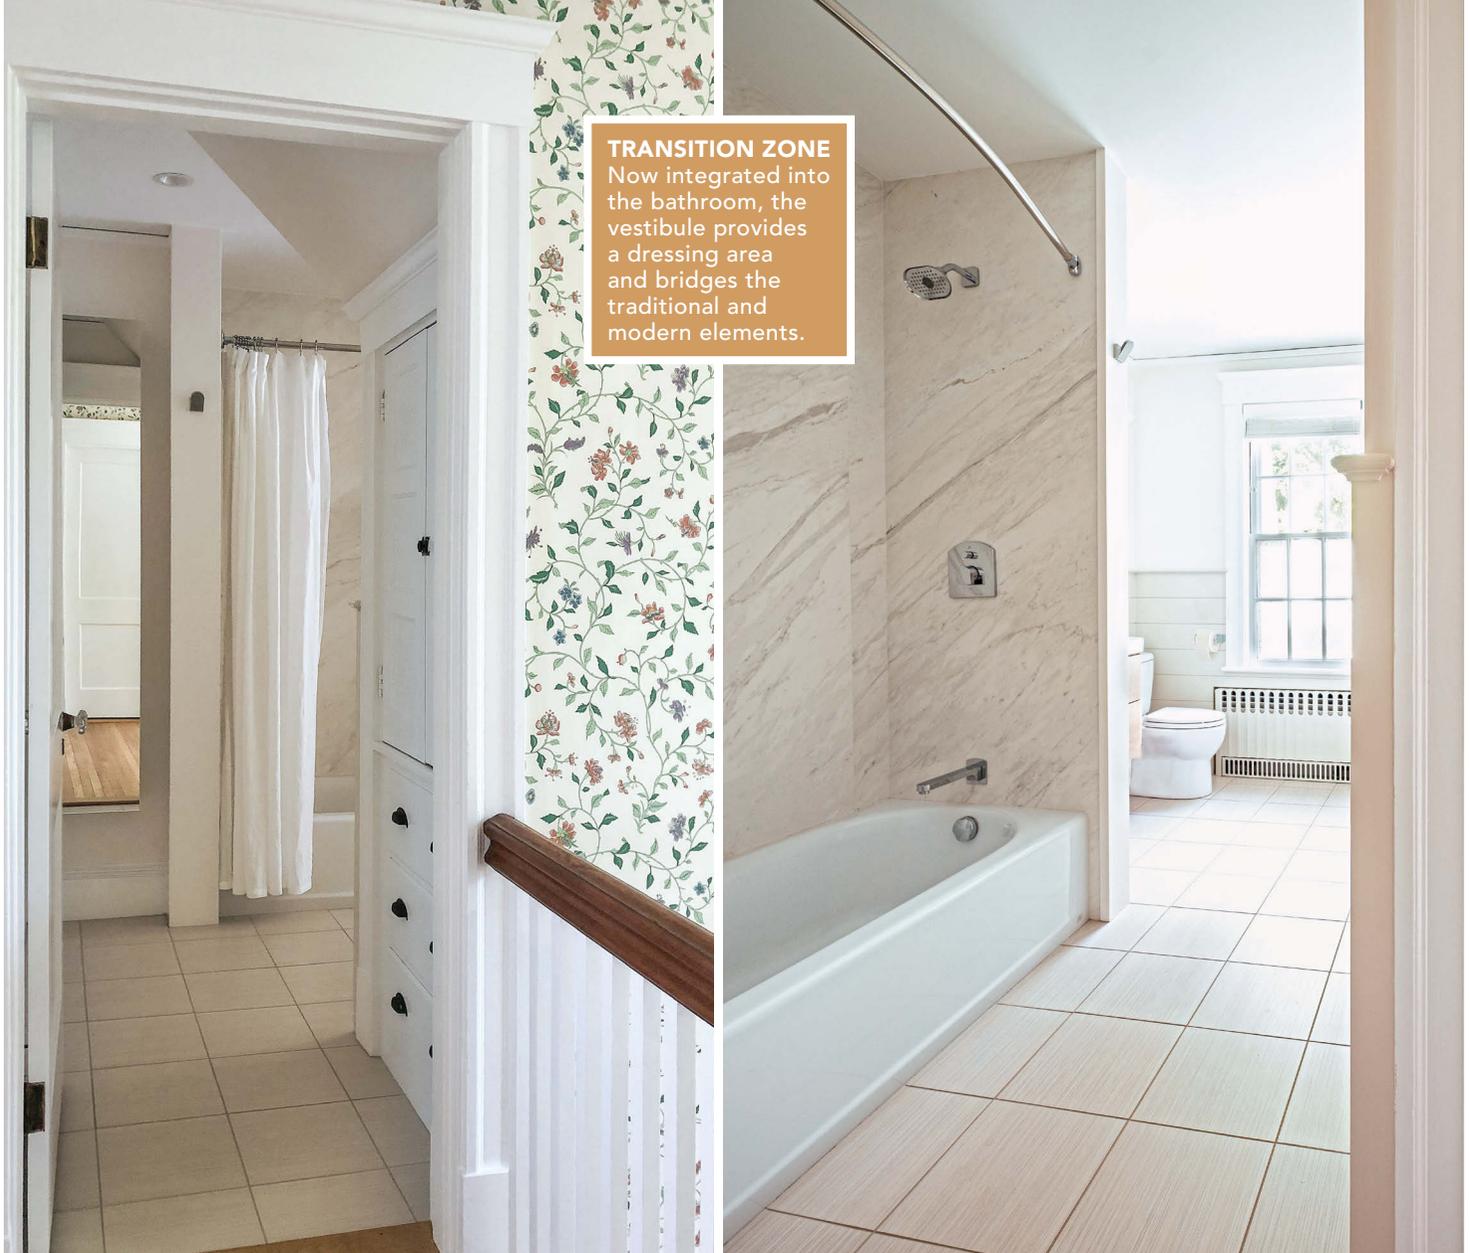
TRANSITION ZONE
 Now integrated into the bathroom, the vestibule provides a dressing area and bridges the traditional and modern elements.

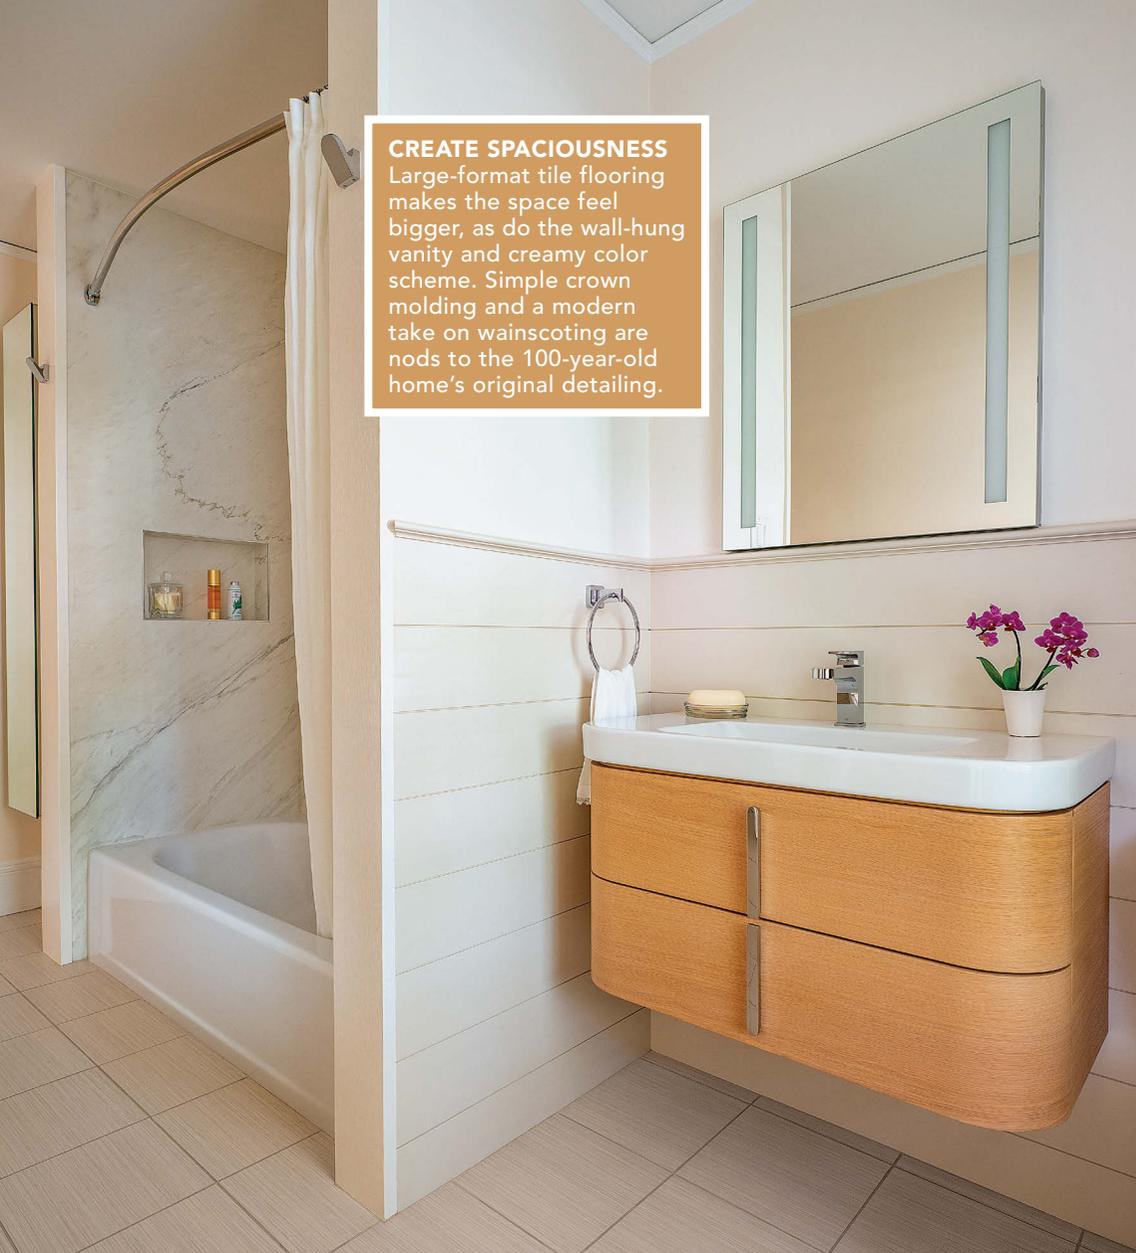
Large-format tile flooring makes the space feel bigger, as do the wall-hung vanity and creamy color scheme. Simple crown molding and a modern take on wainscoting are nods to the 100-year-old home's original detailing.
