# Classical Details in a Harsh Environment

Craftsmen build a coastal house to withstand hurricane winds, meticulous architects and exacting clients

by Robert Weinstein

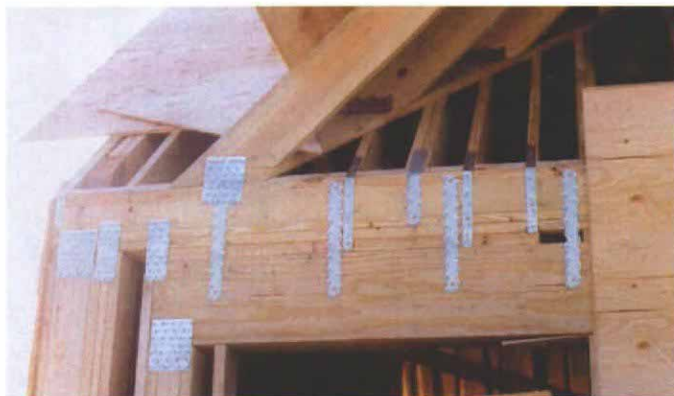
**Hurricane straps.** Typical of the detailing throughout the house, every rafter was fastened to the walls with galvanized metal straps.

The studs in the shear walls were tied to the plates with steel stud-plate ties. At the top of the walls, the rafters were held to the plates with steel hurricane anchors. The tops of all the rafters were held to the ridge with sloped or sloped-and-skewed hangers as the location required.

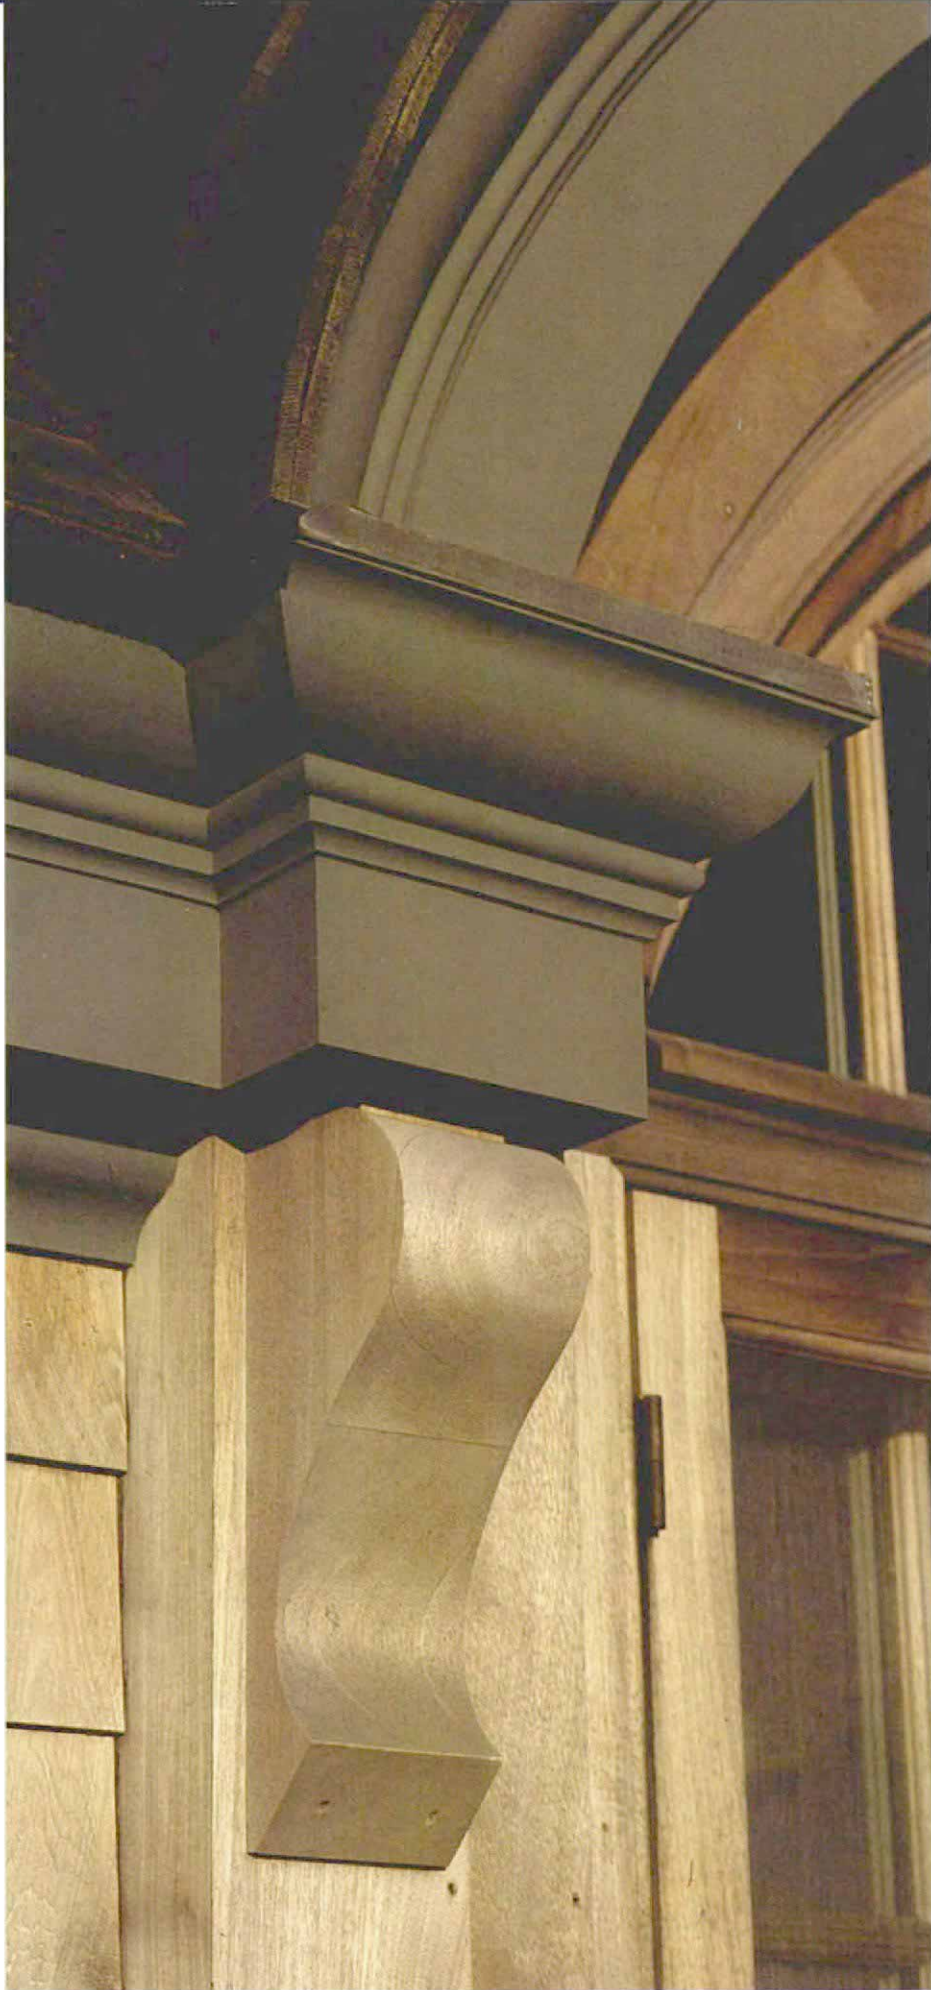
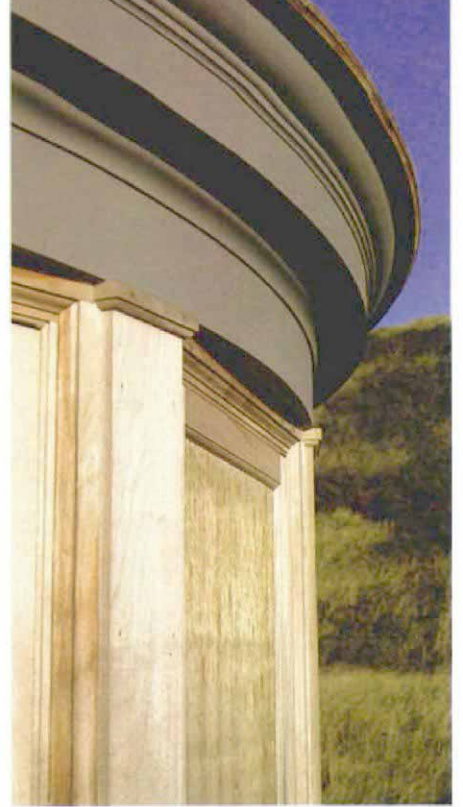
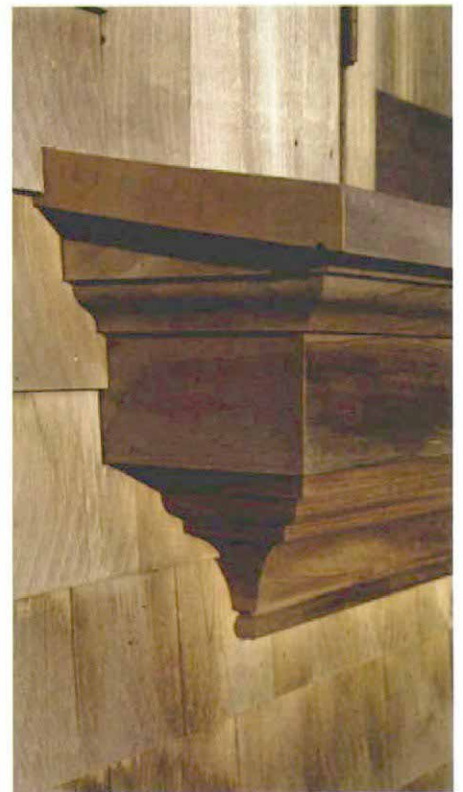
***Two miles of trim.*** Over 11,000 lin. ft. of wood, including teak, mahogany and redwood, was used for the running trim outside the house. The trim includes cornices that were radiused, curved and mitered. All of the trim was biscuited, glued with epoxy and fastened with square-drive stainless-steel screws.

All of the running trim was installed with stainless-steel screws. Screws have superior holding power over nails, but there was another reason we used them for the trim. Using screws enabled us to dry-fit the myriad pieces of cornice, columns, water tables and scotia. Because we were working to the highest standards and the smallest tolerances, we had to be able to dismantle easily any of the hundreds of trim components and adjust a particular cope or miter until the joints were perfect. All of our end-to-end joints are scarfed and biscuited and glued with a two-part West System epoxy glue (Gougeon Brothers, Inc., P. O. Box 908, Bay City, Mich. 48707; 517-684-7286). When we were working in the cold, we added a hardener that accelerates the curing process of the glue. More than two years after the completion of the construction, all joints remain perfectly tight.

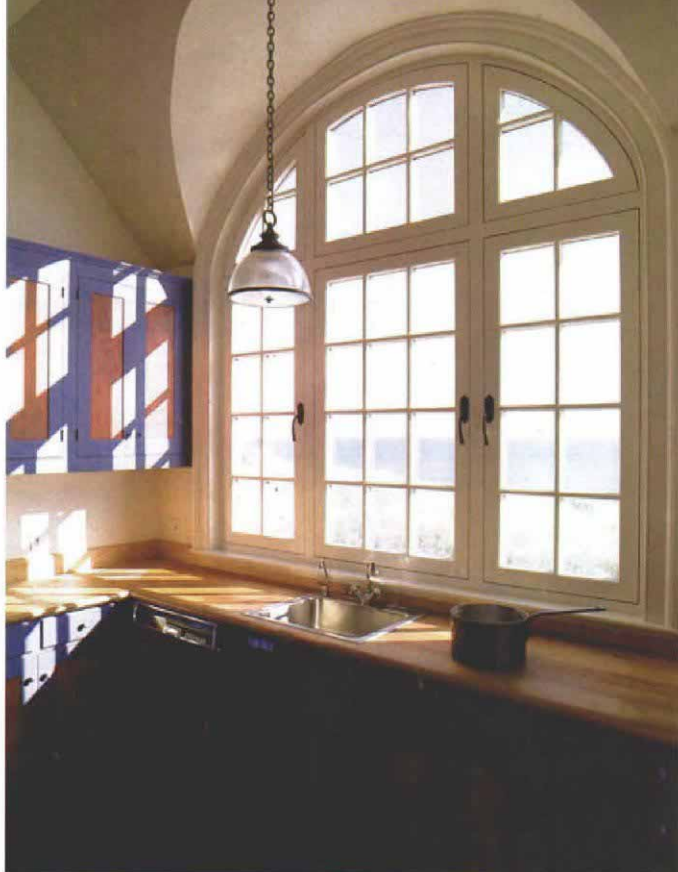
**Curved cornice in an eyebrow dormer.** The focal point of the house's ocean-side facade is the large, 40-lite kitchen window seen here from the interior (left) and the exterior (right). The curved five-piece exterior cornice terminates in bracketed water tables.

Perhaps one of the most striking features of the house is the arched kitchen window (top photos, p. 84). The construction of the rough opening and the assembly of the window unit as it came to us from the millwork shop presented quite a challenge. The unit itself is made of three rectangular, tilt-turn sash and three curved, fixed sash above. The five-piece cornice at the head

of this massive window is curved; the two ends of the curve terminate in bracketed water tables.

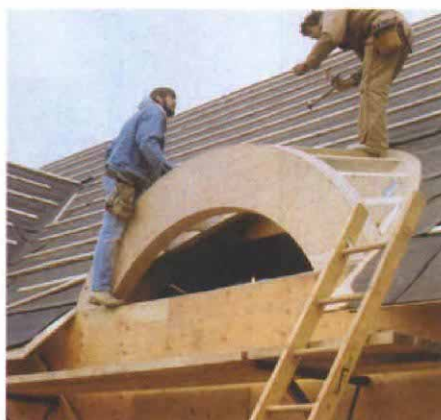
**Plywood header.** The header for the arch top kitchen window is made of seven layers of  $\frac{3}{4}$ -in. plywood cut to fit the window's curves.

If the window was installed in a flat wall, the installation would have been fairly straightforward. The rough opening complicated things because it incorporates a 3-in-12 pitch eyebrow dormer that ends flush with the sidewall. We built the header out of seven layers of  $\frac{3}{4}$ -in. plywood. Each piece was cut to the curve of the window arch as well as to the angle of the dormer pitch (bottom photo, p. 84).

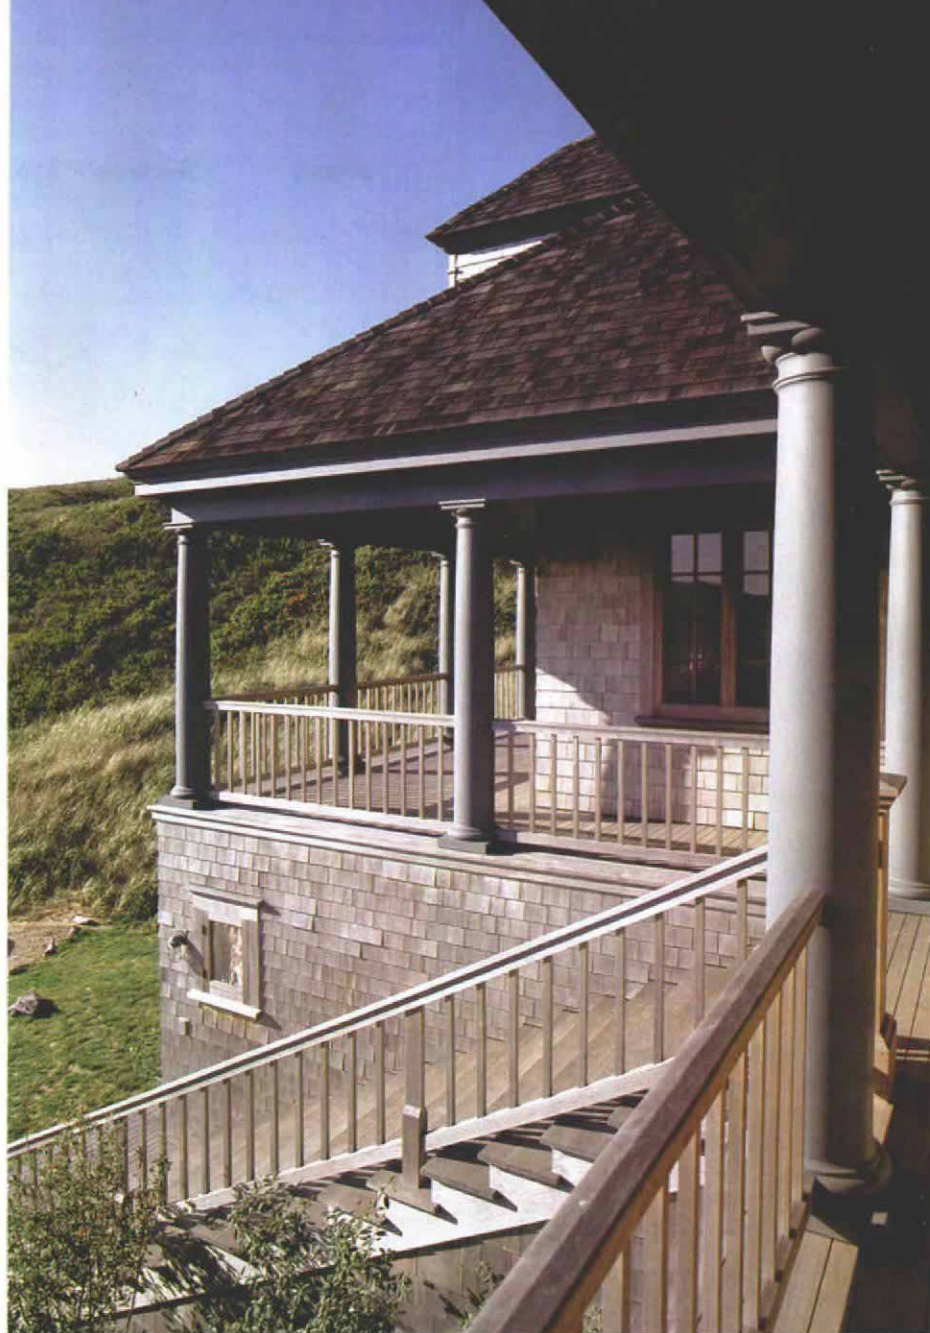
**No surprises with full-scale mock-ups.** In the photo below, a porch cornice is mocked up with the full-scale profile of a tapered column (cut from 1x stock) set in place for final approval from the architect and the client. This ensured that there would be no surprises when the porches were flanked by 24 columns (photo above). Visible along the outside edge of the porch ceiling are the unobtrusive vents for the roof system.

Numerous times during construction we were asked by the owners or the architect to build a full-scale mock-up of a trim detail on the house for inspection (bottom photo, right). Although it was time-consuming work, both the architect and the client were thoroughly satisfied with the final results. There were no surprises.

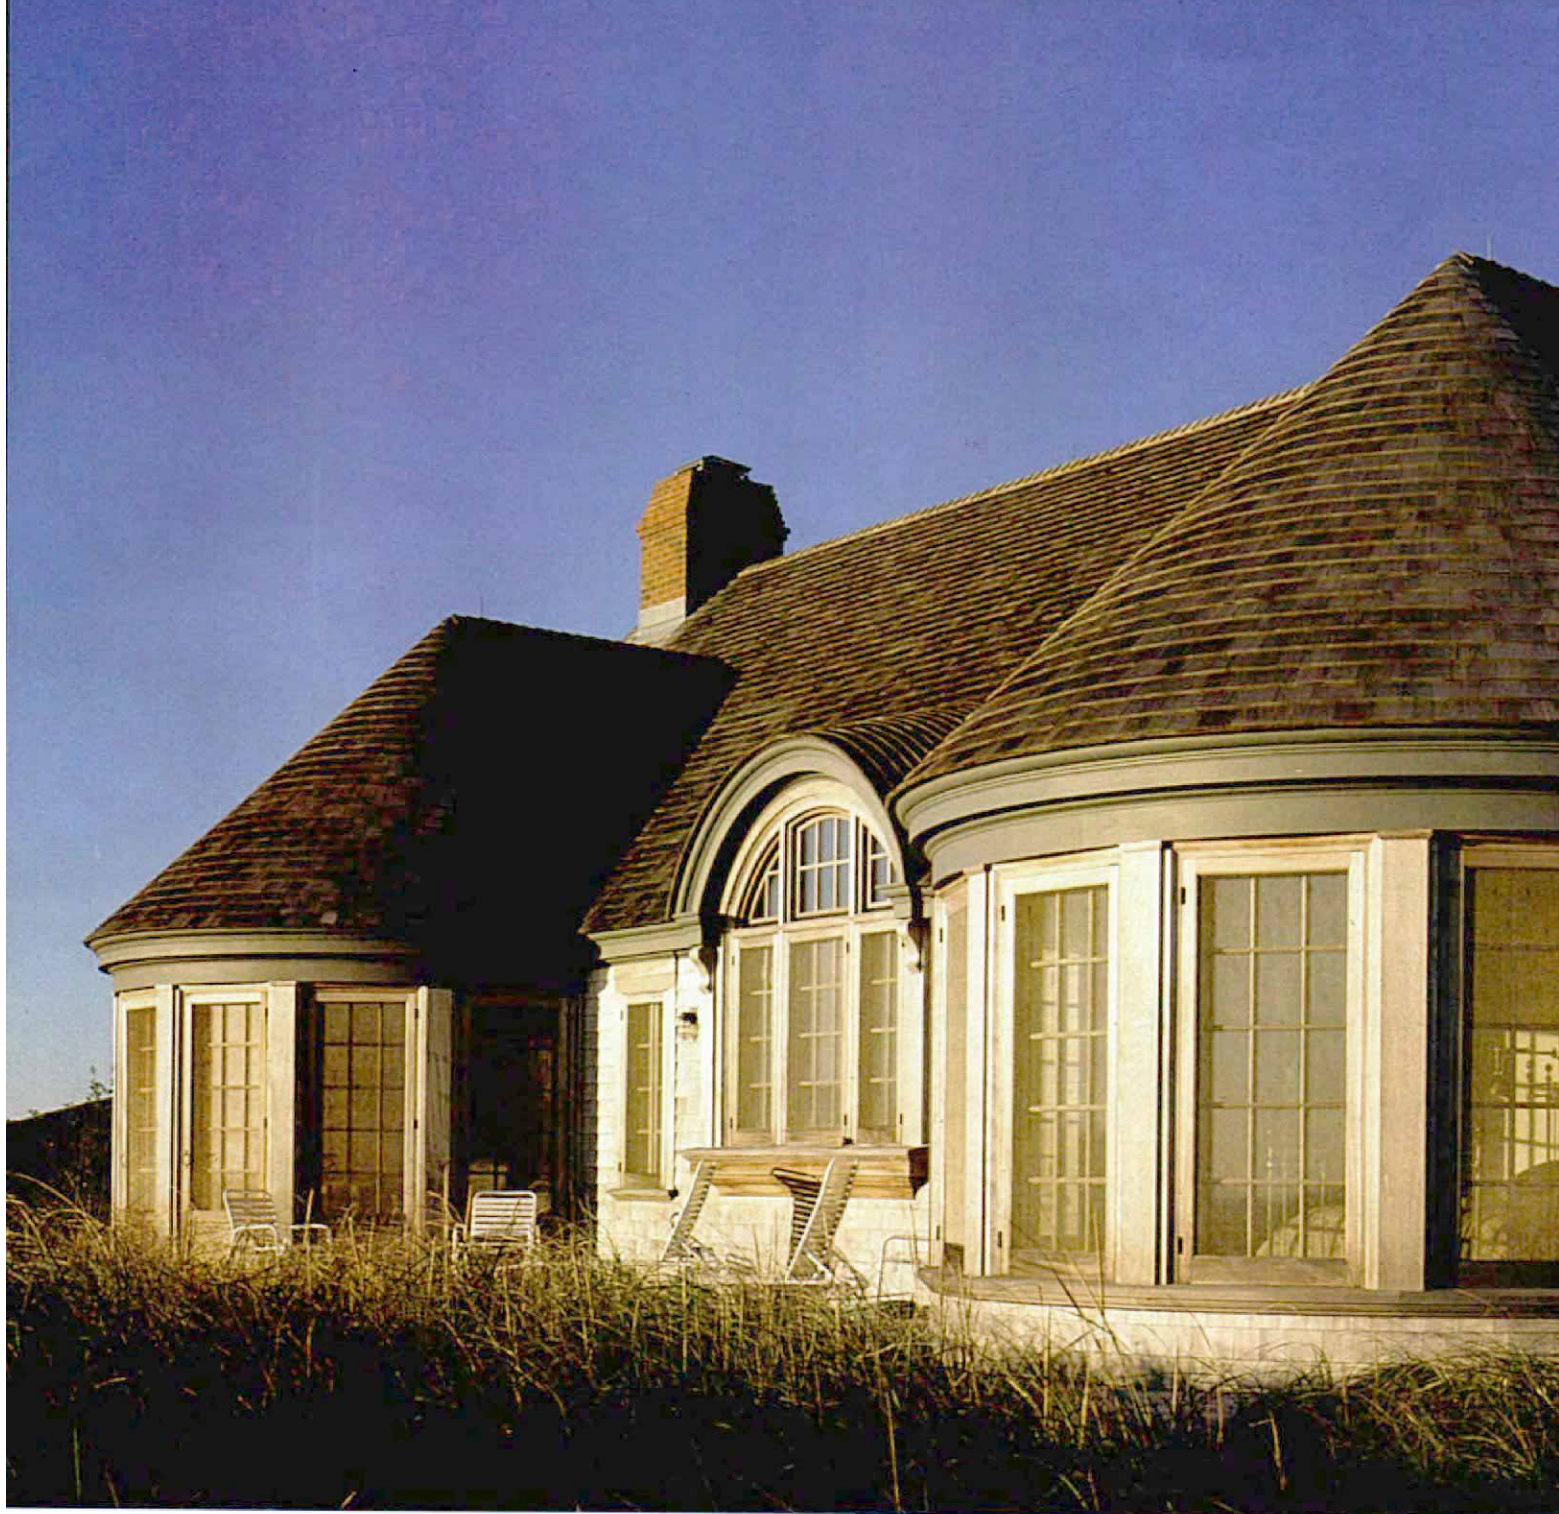
***Tight to the weather.*** Utmost care was taken to waterproof the house. The soldered 20-oz. lead-coated copper shown at right is typical of the house's flashing details. All doors and windows had soldered head flashings. A soldered flashing also protects the bottoms of doors, windows and gable vents.

A soldered head flashing was used over exterior doors, windows and gable vents. A 20-oz. lead-coated copper pan was soldered in place for all the door openings. A soldered flashing also protects the bottoms of windows and gable vents.
