In Seattle, a builder and architect prove that remodeling and energy efficiency can be a winning combination

# ADVANCED FRAMING: LESS IS MORE, EVEN IN A SEISMIC ZONE

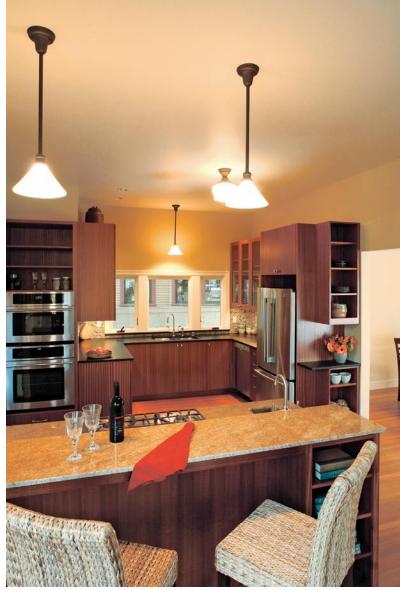
**High ceilings and elbow room.** Moving the bedrooms to the second floor allowed the first-floor space to breathe. Veneer-plywood cabinets, a glass-tile backsplash, counters made of FSC-certified paper, and reclaimed apitong flooring work together to create a durable and sustainable kitchen.
