Top 10 Deck-

Avoid these common problems, and build a longer-lasting, safer deck

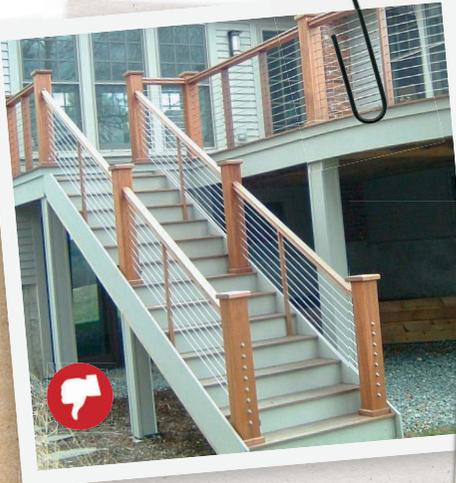
MISTAKE 1

FAILING TO INSTALL A CONTINUOUS HANDRAIL ON STAIRS

The post in the middle of this flight of stairs interrupts the top of the railing, which was designed to serve as the handrail. An unsightly continuous handrail had to be added.

The error: For construction or aesthetic purposes, builders regularly install handrails interrupted with newel posts. It's also common to see a guard's top rail used as a handrail.

The solution: Code provision R311.7.8.4 requires that a continuous handrail be installed on any set of stairs that has four or more steps. A continuous guard free of midspan posts extending through the top can be used as a handrail, but only if it meets specific geometric requirements. To be considered a handrail, the guard's top rail must be graspable by those walking up and down the stairs.

If a post interrupts a guard's top rail, a true handrail must be added to the guard running along the stairs.

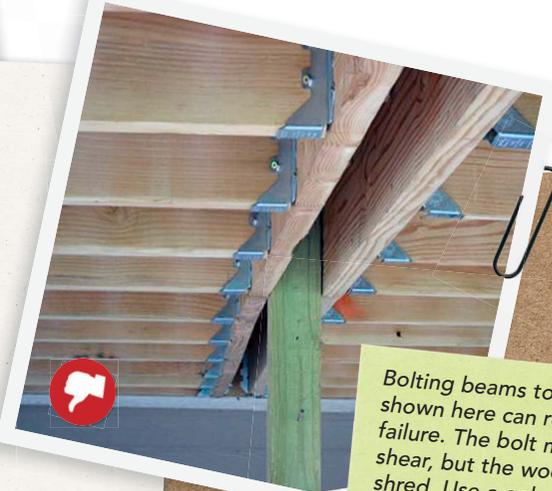
Bolting beams to posts as shown here can result in failure. The bolt may not shear, but the wood can shred. Use a galvanized-steel post cap, and keep the beam firmly seated atop its support post.

BOLTING BEAMS TO THE SIDES OF POSTS

The error: A tragedy brought to us from the aisles of big-box stores: directions to deck builders to bolt deck beams to the sides of support posts. The average backyard deck has relatively few posts. Fewer posts result in greater loads at beam connections. It would take a huge load to shear a 1/2-in.-dia. machine bolt, but long before that occurs, the wood around the bolt would be crushed and distorted, resulting in a failed connection.

The solution: Each ply of a multispans beam, whether single or multi-ply, must have full bearing on intermediate posts. This can be accomplished by notching a 6x6 to accept a 2-ply beam and bolting the beam to it, or by the use of an approved post cap. With all the hardware available to handle various direct-bearing applications of different-size beams and posts, there is no excuse for disregarding this code requirement.

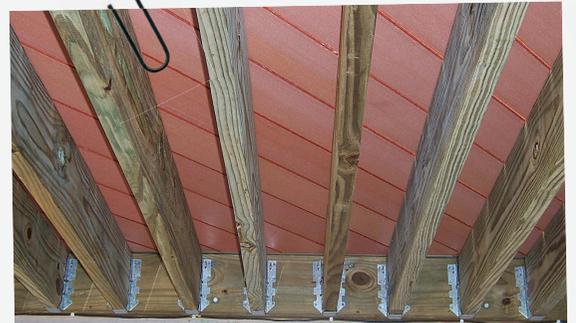
To meet the span tolerance of this diagonally installed composite decking properly, additional joists and hangers had to be added to the existing deck framing.

The error: The maximum span of wood-and-plastic composite decking generally depends on the type of plastic used in the product. It's important to follow the span limits of a specific product as outlined in the manufacturer's installation instructions, which some builders fail to review. Overspanning composite decking is most commonly a problem when deck boards are run diagonally over joists or when they're used as stair treads.

The solution: Floor joists for a deck are typically installed at 16 in. on center, which won't properly support some composite-decking products when installed on an angle. In new construction, be sure floor joists are installed at the correct spacing. In existing decks, adding more floor joists is the only remedy. Similarly, additional stair stringers might have to be added to stairs where composite decking is used for the treads. Stair treads must be able to resist a concentrated load of 300 lb. over an area of 4 sq. in. This requirement puts a lot of pressure on the actual tread material to support concentrated loads. Some composite products are limited to an 8-in. maximum span when used as stair treads, which require the support of six stringers in a 36-in.-wide stairway.

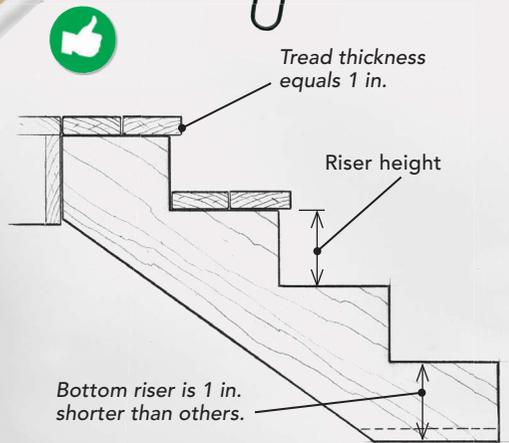
Once you've determined the stairs' rise and run, the stringer layout is straightforward. One detail, however, is easy to overlook. The bottom riser needs to be one tread thickness shorter than the rest.

The error: Often, the bottom step on a set of deck stairs is roughly 1 in. taller than the rest. Code allows a maximum variation of only $\frac{3}{8}$ in. between riser heights. This guideline often confuses inexperienced carpenters, who insist that they cut every notch in the stringer the same.

The solution: Every notch cut into a stringer has an identical riser height except for the bottom one. The steps notched out of the stringer in the middle of the flight have treads placed above and below each step, effectively adding the same tread thickness to each riser height so that they remain constant. The bottom step doesn't have a tread below it, though, so you must subtract the thickness of the tread from the height of the bottom riser, which is the bottom of the stringer.

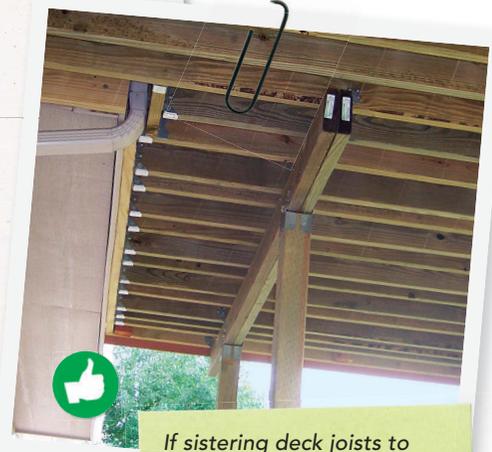
If sistering deck joists to floor joists isn't an option, adding a beam, posts, and footings can help to relieve some of the stress placed on the fasteners connecting the ledger to the end grain of the cantilevered floor joists.

One of the more egregious ledger mistakes is connecting the ledger to a rim joist nailed to the end grain of cantilevered floor joists—those that support a kitchen bump-out, for example.

The solution: Detailing a ledger properly depends on the building type, the cladding material, and the site conditions. Of all the parts of a deck, the ledger can rarely be treated the same from job to job. Long before construction begins, considerations must be made as to, for example, whether stucco needs to be cut back with new weep screed installed or whether a few courses of lap siding need to be removed to bolt and flash the new ledger properly. Code requires that band joists supporting deck ledgers bear fully on the primary structure capable of supporting all required loads—in other words, they can't be part of a cantilevered floor. A better option in that scenario is to build a freestanding deck that doesn't rely on the cantilever to support it.

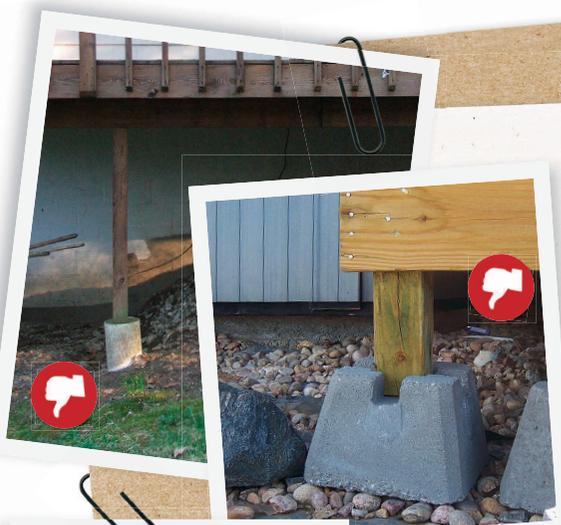
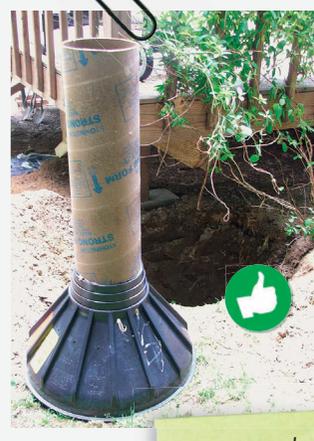
When set above an area's frost line, footings can heave (top photo). Piers set below the frost line with bell-shaped bases (bottom photo) stay in place and distribute the deck's weight. Even where the ground doesn't freeze, footings must be set 12 in. into undisturbed soil and not directly on grade (middle photo).

The solution: Just about every deck is built on an isolated-pier foundation system. Foundation systems are required to extend a minimum of 12 in. into undisturbed soil (R403.1.4). In cold climates where the earth is subject to freezing, pier foundations for non-freestanding decks must extend to a depth below that which is likely to freeze—in some places deeper than 48 in. This prevents the soil below the pier from freezing and heaving the pier upward.

To install deck piers properly, the piers must bear on undisturbed soil and be set below the frost line in cold-climate regions. However, if the piers are in a backfill region, as is the case with piers nearest the house on a freestanding deck, the footing depth may have to be as deep as 10 ft. to reach undisturbed soil and to comply with code.

Precast foundation blocks must be set at least 12 in. into the ground. However, even in the middle of a lot, the topsoil is tilled roughly 6 in. prior to seeding, so it's likely that the footing needs to be at least 18 in. deep to comply with code. Assume that all deck piers and foundation blocks require some digging.

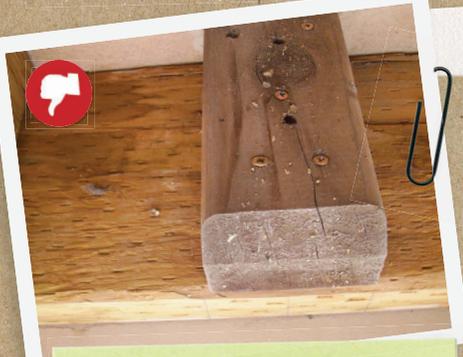
Don't notch posts or use nails or screws to fasten them to deck framing, as shown above. Use bolts. More specifically, use blocking and bolts, as shown below, to create a stronger guard system than one with posts connected to rim joists that are nailed only to the end grain of the joists.

The error: Insufficiently connecting a guard post to a deck is among the most dangerous deck-building errors. Fastening guard posts to deck rim joists or floor joists with wood screws is not acceptable. While some builders get the guard-post-to-rim-joist connection correct, they don't always ensure that the rim joist is attached to the deck framing properly.

The solution: The code (Table R301.5) requires a guard to be designed and constructed to resist a concentrated load of 200 lb. in the outward and downward directions along its top. Depending on the design of the guard assembly, a stout guard-post-to-deck connection can be accomplished with blocking and through-bolts or with horizontally oriented hold-down hardware. In some rail designs, most of the load resistance is handled by the post connection to the deck. In those instances, the post should be attached to the joists, not the rim, because the rim is not usually fastened to the joists in a manner capable of transferring the load. Rims are typically nailed into the end grain of the joist, the weakest possible connection for withdrawal resistance.

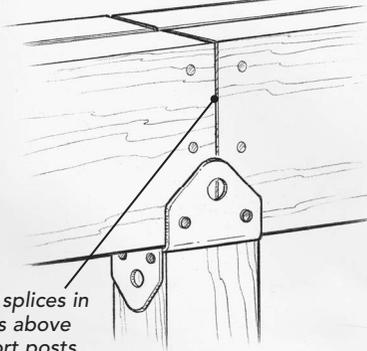
Make splices in beams above support posts.

Beams suffer the greatest amount of deflection at the center of their post-to-post span. Therefore, strong beams are spliced atop posts. If you can't stagger splices over different posts, then placing them over a single post is permissible.

The error: When a long built-up beam spans multiple posts, many builders run one ply long and extend it beyond the support posts. Many builders believe this practice is good because splices of opposing beam plies are greatly separated as opposed to being only inches apart on top of a post. Unfortunately in these cases, an engineer's evaluation or a rebuild of the beam is required.

Beam splices that miss the bearing point by a small amount don't greatly affect bending or deflection, and the shear strength of one fewer ply is likely still sufficient. In these cases, the cost of an engineer's review might just get you the OK to build. If a design calls for a splice in the center of a span, it will be smarter and cheaper to build the beam so that splices land atop posts.
