Resurrection

A Revolutionary War-era stone farmhouse is restored with a preservationist's attention to detail

BY JEFFREY DOLAN

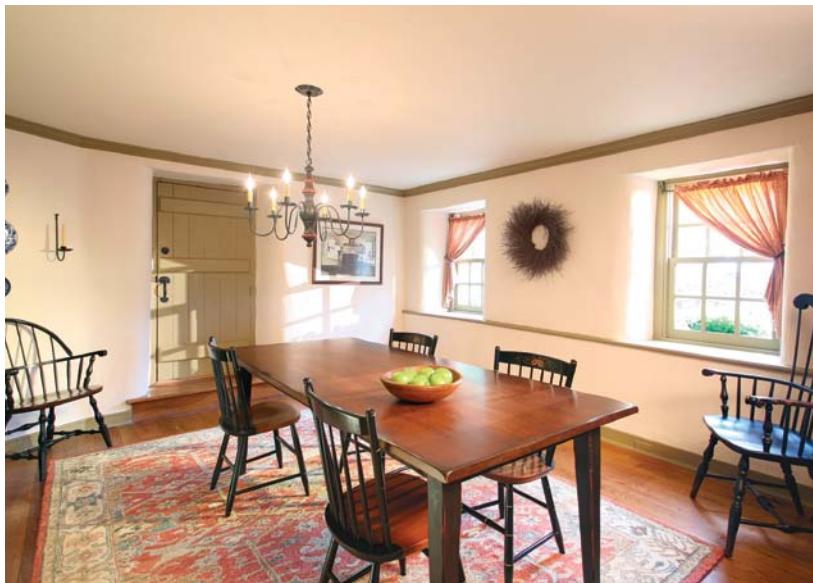
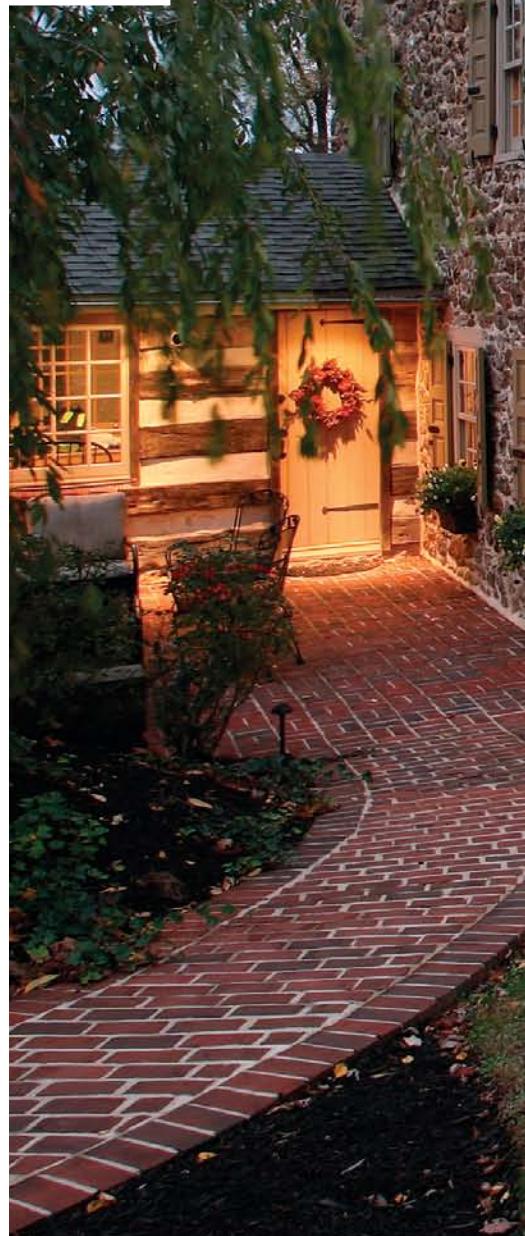
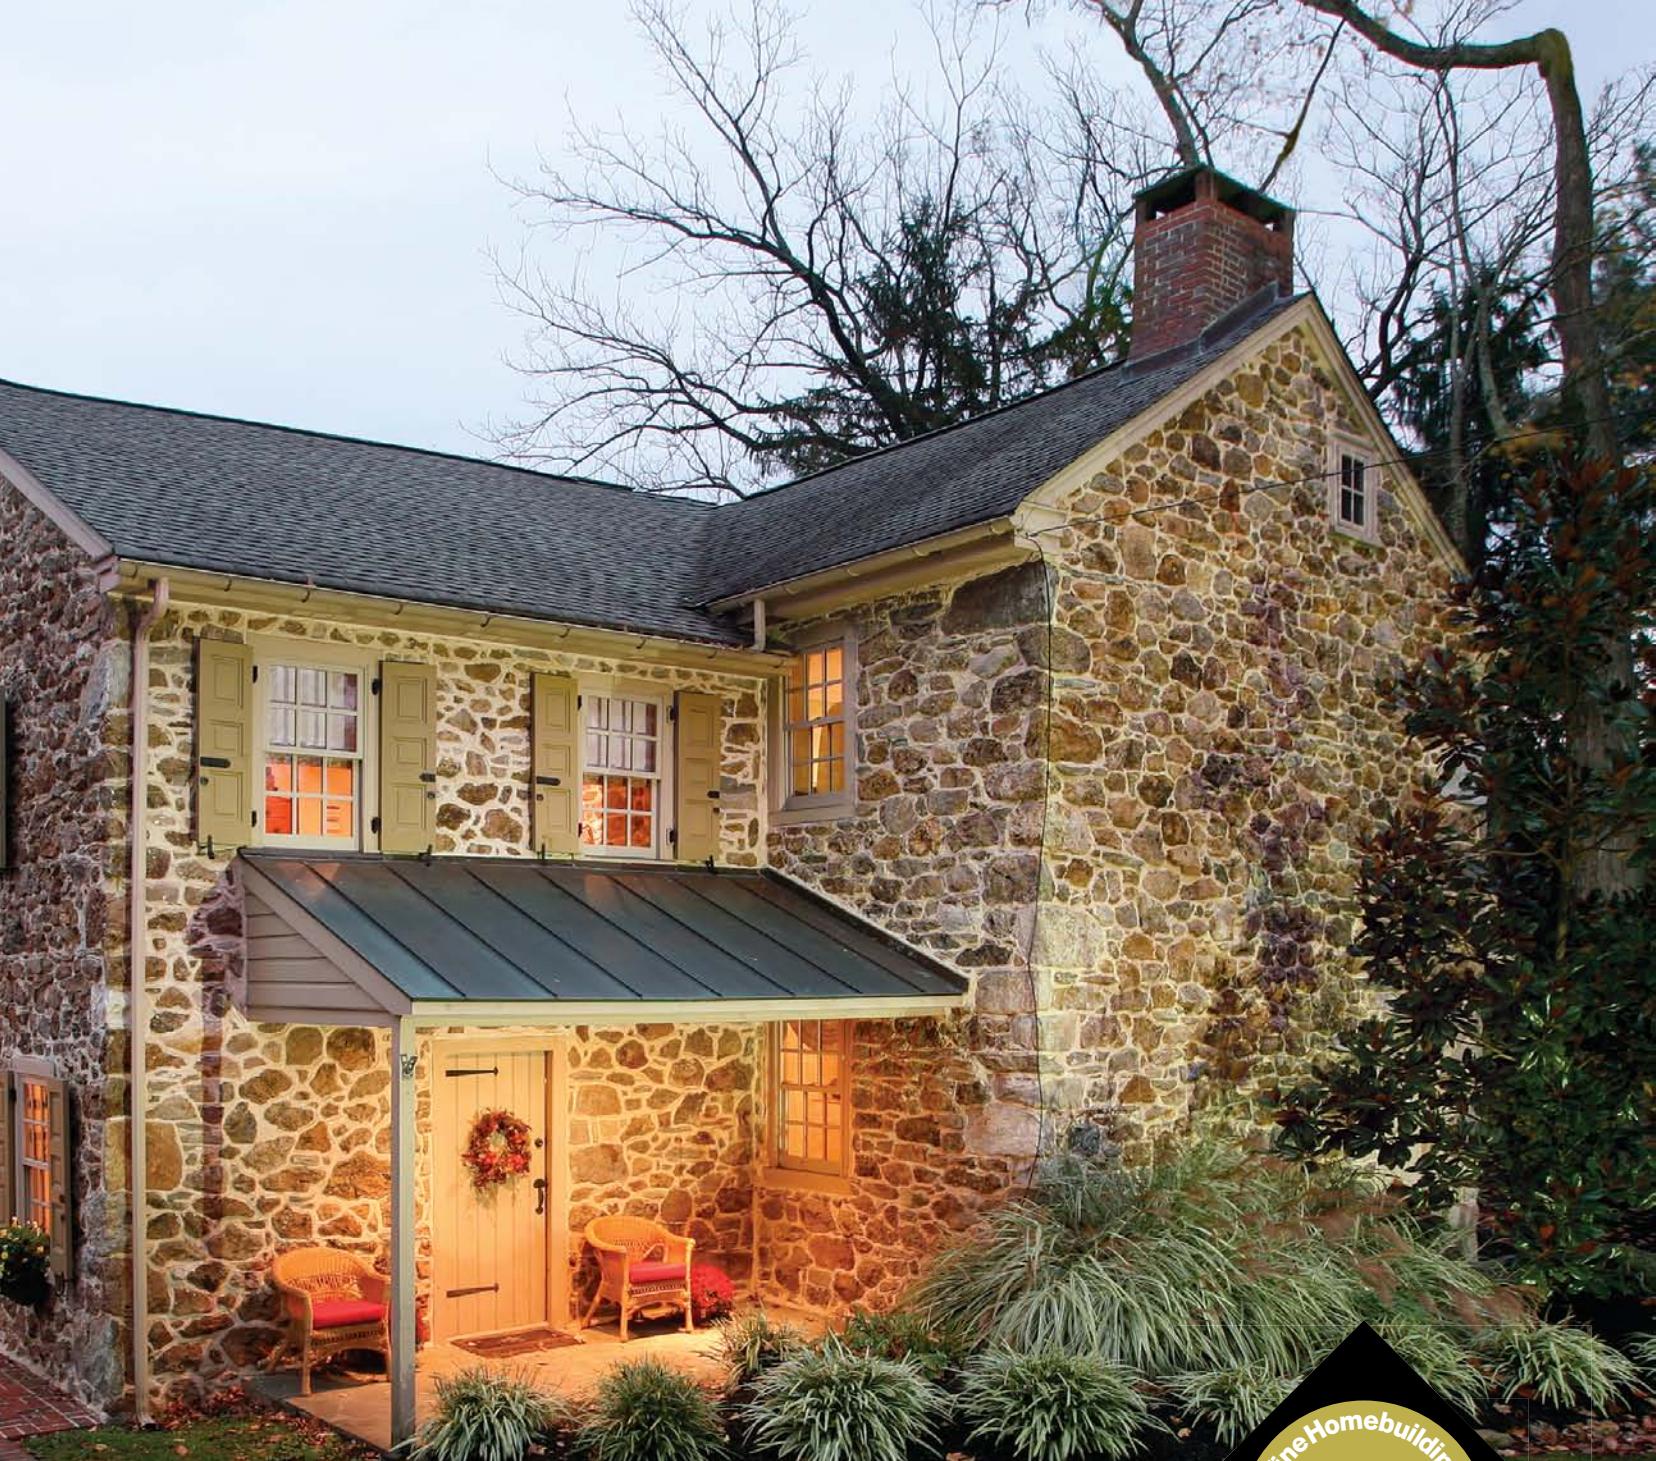
Diamond in the rough. Obscured by stucco for decades (above), the fieldstone shell of John Edwards's 1776 homestead lends an unmistakable character to the house (right). The rehabilitated dining room (left) retains its straightforward colonial charm.

After stripping the stucco from the exterior, mason Cleveland Ambris began the painstaking task of repointing the entire house with a historically correct, hydraulic, lime-based (rather than portland-cement-based) mortar mix. Used for centuries, lime-based mortar is more flexible and won’t crack or spall. The entire process took Ambris about three months to complete.

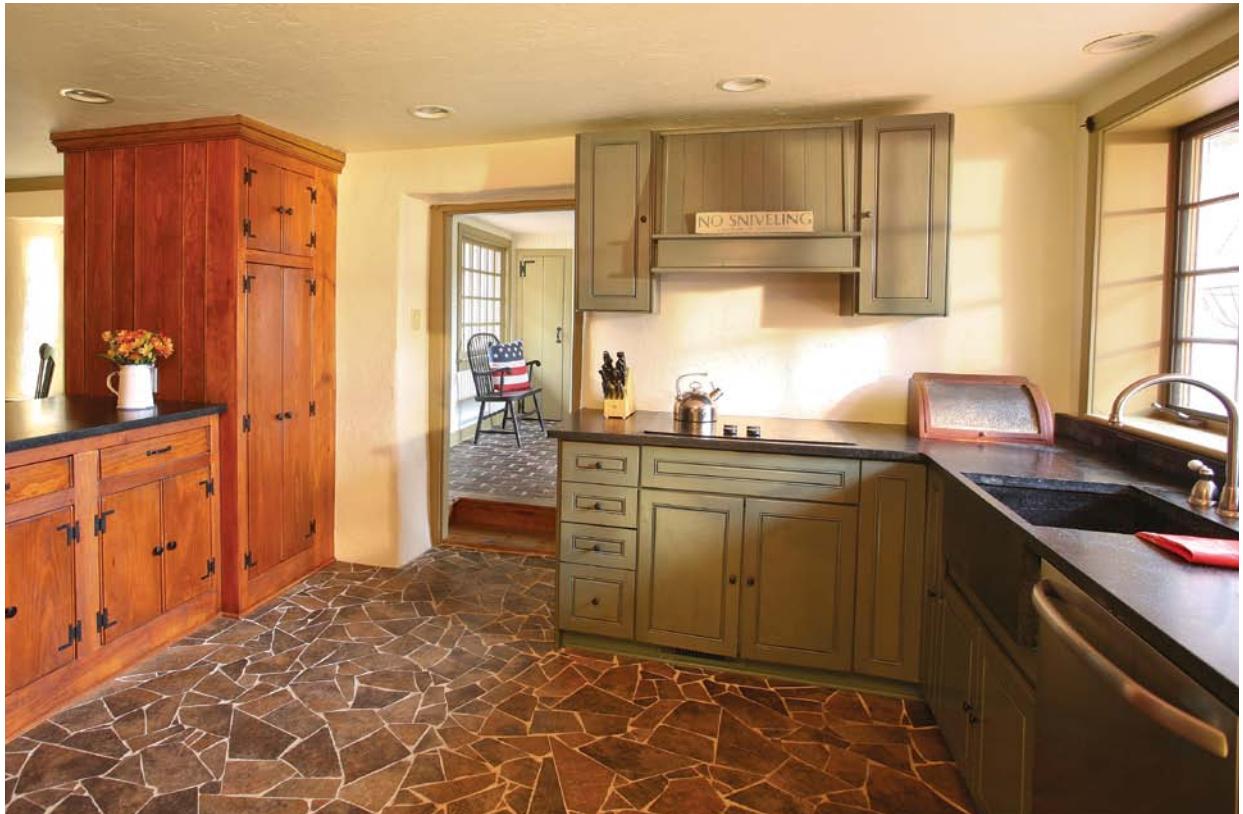
Meeting halfway.

Creating a comfortable home for the 21st century meant designing a roomy, updated kitchen and an equally spacious mudroom.

Details such as reproduction iron hardware keep the newer spaces grounded in the colonial age.

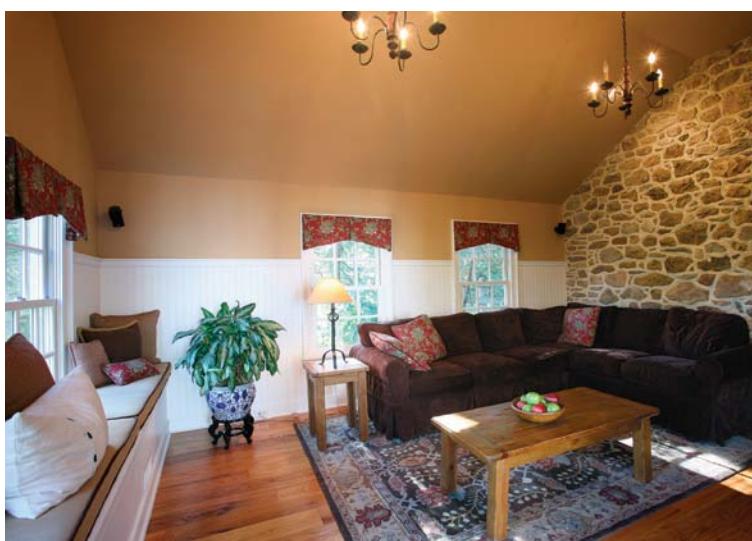
Hinting at history.

A family-room addition puts comfort first but leaves a shared stone wall uncovered as a nod to the home's original structure.

While the furnishings here are comfortably modern, we imbued this new family room with colonial-inspired details such as character-grade oak floors, reclaimed beadboard wainscot, and a long, built-in window seat with cubbies for storage. The exterior stone wall was left exposed for its textural aesthetic and for a subtle connection between this new space and the original 1776 house. □

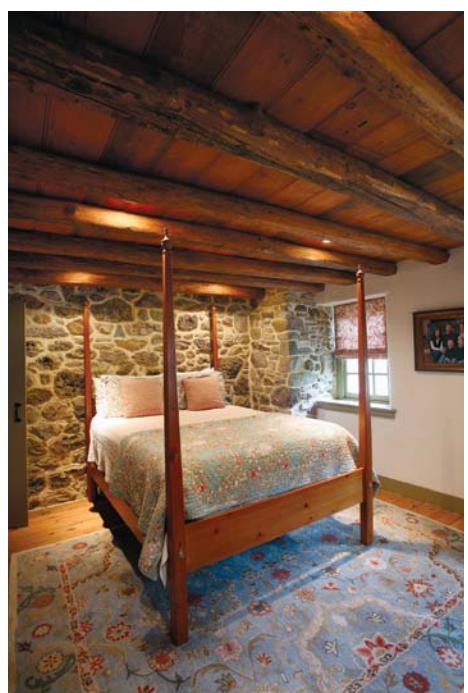
Celebration of structure.

In the master bedroom, both the stone wall and the chestnut ceiling beams are revealed.

The demolition crew stripped the interior structure down to expose thick fieldstone walls and removed several unnecessary, non-load-bearing interior partitions. Water-damaged drywall, cracked and buckling plaster, and shabby carpet were removed throughout the home to reveal beautifully aged hand-hewn chestnut beams, white-oak flooring, and stone walls. We chose to feature the few original architectural details that survived—including the stonework, original beams, and flooring—and complemented them with appropriate reproductions as we added back layers of finish. For example, the original fireplace mantels of the living room had been removed and replaced with more “modern” Victorian mantels that were later painted a bright aqua sometime in the 1960s. With no visual record of the original mantels, we drew on our research of colonial-era Pennsylvania farmhouses to customize a period-appropriate design crafted by McGinnis Millwork of Parkesburg, Pa. As storage wasn’t part of John Edwards’s master plan, we took every opportunity to develop built-in cabinetry and closets wherever we could.

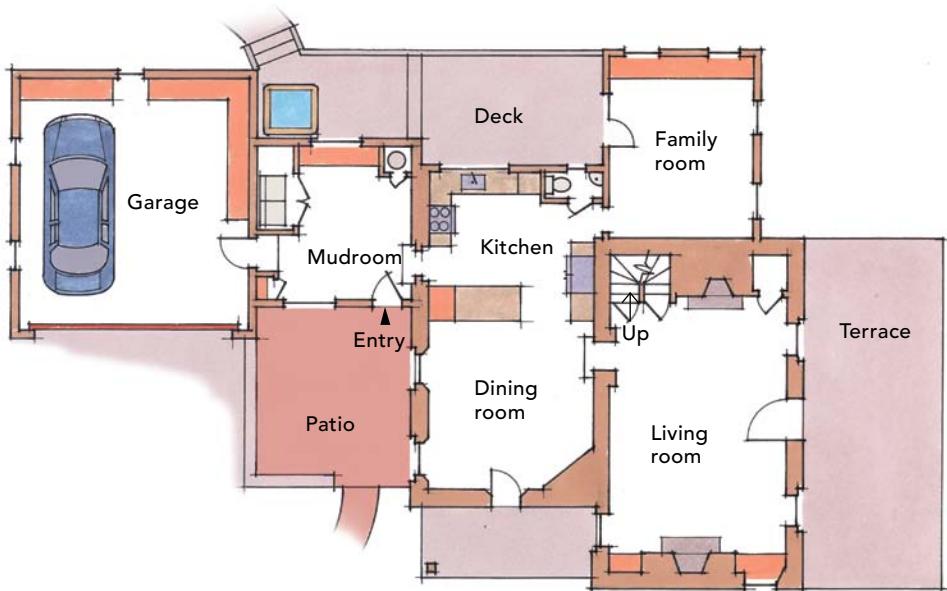
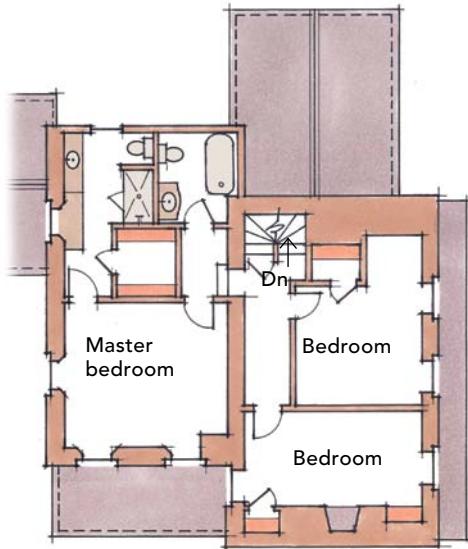
EVOLUTION OF A FLOOR PLAN

Additions and alterations spanning four centuries make this farmhouse a unique study in how a home evolves to meet changing needs. Most visible is the addition of space, with the introduction of separate areas designed for specific functions, such as dining, cooking, bathing, and later, parking the car.

In the 1960s, a garage was added, with a mudroom linking it to the main house. The 1776 space, serving as a living room, was divided. The 1820 addition became a kitchen and dining room.

A family room was added off the kitchen, along with a new patio. The kitchen and dining room were rejoined, and the partition dividing the living room was removed. The primary entrance now leads into a spacious mudroom.

Constructed of fieldstone in 1776, the original farmhouse consisted of a two-story rectangle with fireplaces on each gable end and an entrance on the long side.

A two-story addition (c. 1820), also made of local stone, provided additional gathering and sleeping space for the family as the farm grew in size.

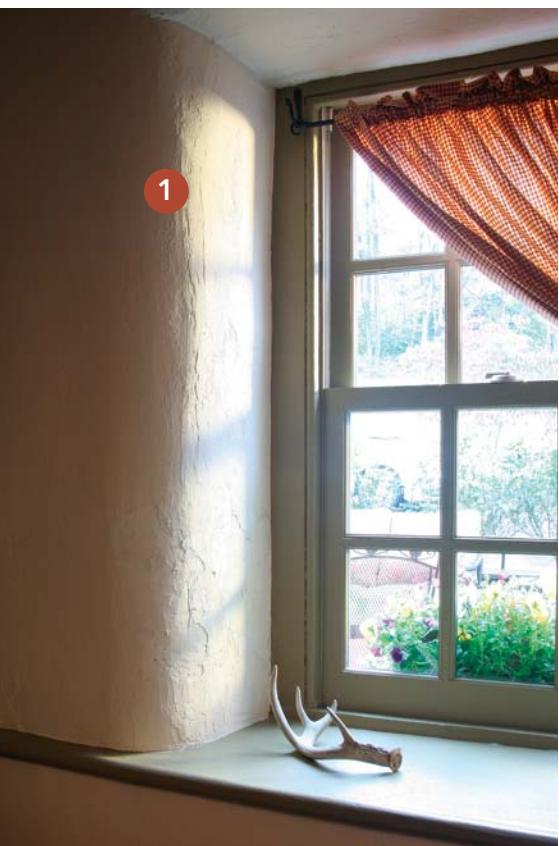
Interior

- ① Plaster on interior walls
- ② Locally forged iron hardware
- ③ Raised panel or cope-and-pattern (vertical board) walls at fireplaces
- ④ Box-winder staircase
- ⑤ Plaster firebox
- ⑥ Fireplaces at end walls
- ⑦ Brick or stone hearth
- ⑧ Wood floors, casing, and baseboards

Popular in England in the 17th and 18th centuries and subsequently adopted in the colonies, the Georgian style of this house harks back to classical forms of the Italian Renaissance. In Pennsylvania, these homes typically took the form of a two-story brick or stone structure with a gable roof and a symmetrical arrangement of windows and doors on the front. While many hallmarks of the style may have originated across the ocean, materials used here were largely indigenous. Few interior details survived in the house, but its structure offered an authentic framework upon which those details could be convincingly re-created.
