# Renovating a Chimney

## New flue liners convert fireplaces for woodstove use

by Joseph Kitchel

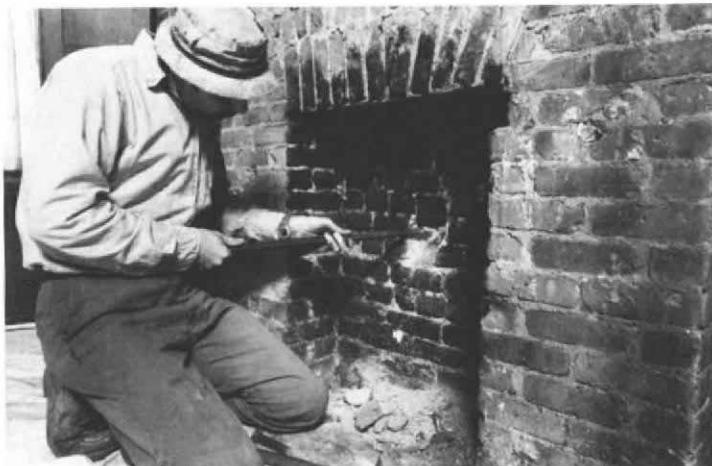
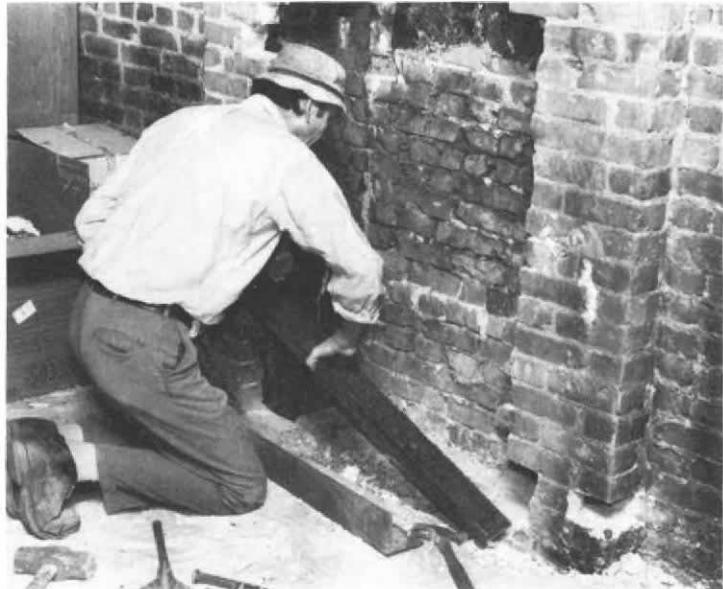
**The first step in installing new flue liners is removing bricks from the second-floor fireplace to expose the chimney cavity. Hammer, railroad spike and pry bar are essential tools. A vinyl-covered canvas dropcloth over rubber carpet padding protects the floor. At right, Kitchel aligns two pieces of angle iron, which will be cemented in place across the face of the cavity to reinforce the chimney before the new liner is installed.**

**Digging in**—Our plan was to install the flue liners in the old chimney passageway and then brick them in, restoring the wall to its original appearance. First we had to remove the facing brick layer to expose the inside of the chimney. A hammer and a sturdy, narrow cold chisel are the best tools for this job. To cope with the occasional stubborn or awkwardly placed brick, I also kept a pry bar close at hand. Generally, the old mortar was brittle and could be chipped away easily. Working from floor to ceiling, we removed the chimney wall in a staggered pattern so that the re-laid bricks wouldn't look so conspicuous. We saved all of the face bricks to use again. The entire brick wall had been

We cemented two 4-ft. lengths of 3-in. by 3-in. by  $\frac{1}{4}$ -in. angle iron across the cavity opening below the second floor. Positioned parallel to one another (the L pointing up) and joined to the cavity wall, these iron beams form a reinforcing baseplate for both flues. We set the first-floor liner between the Ls and surrounded it with a course of cement blocks, building the cavity up level with the second floor.

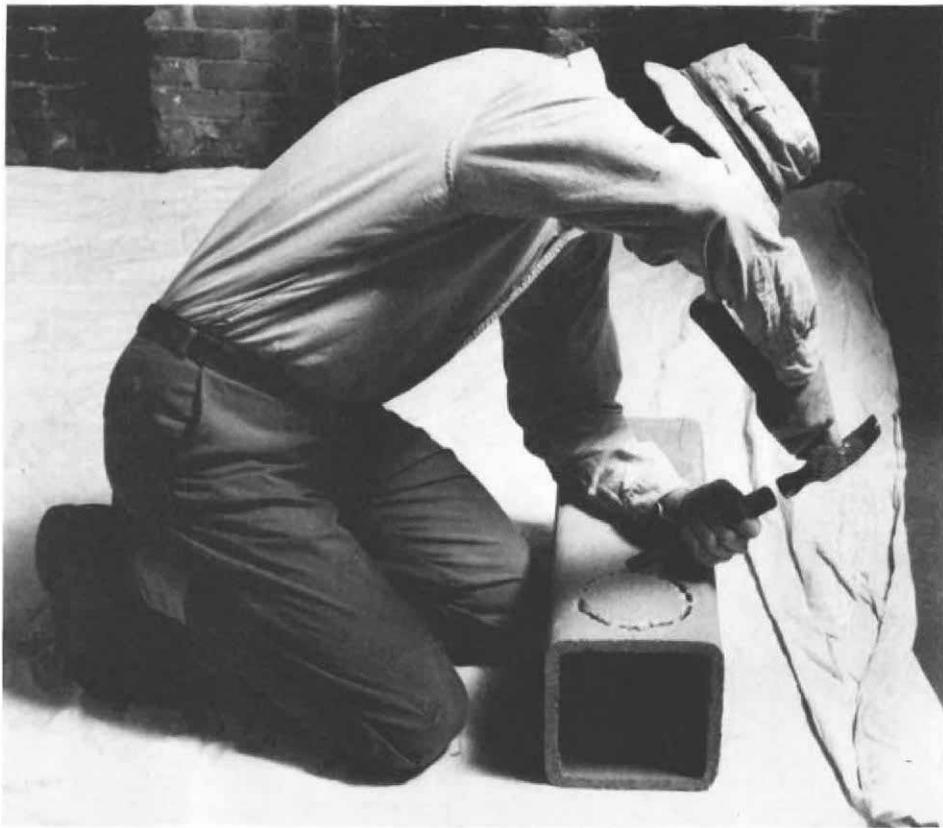
The first section of liner is cut to receive the thimble fitting, a tricky business since the ceramic material is very brittle. Closely spaced holes are first drilled along the cut-line; then the waste piece is knocked out with a hammer and chisel, as shown.

Because both the cleanout door and the stovepipe thimble are designed to fit into a square flue liner, we had to use an 8-in. square liner as the base section for the second floor flue. Cutting openings in the ceramic pipe to receive these fittings (photo top right) is a delicate job. You can

use a rotary saw equipped with a masonry blade for the straight cuts. We made the round opening by drilling closely spaced holes with a masonry bit and then carefully chiseling out the tile between the holes.

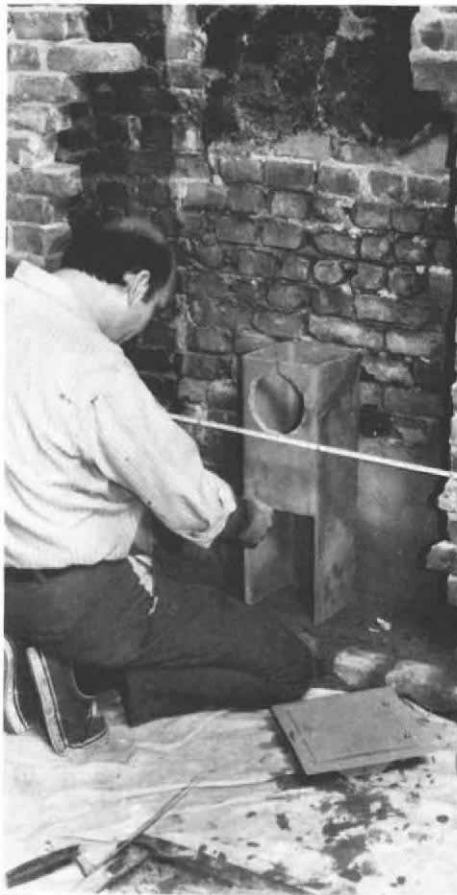
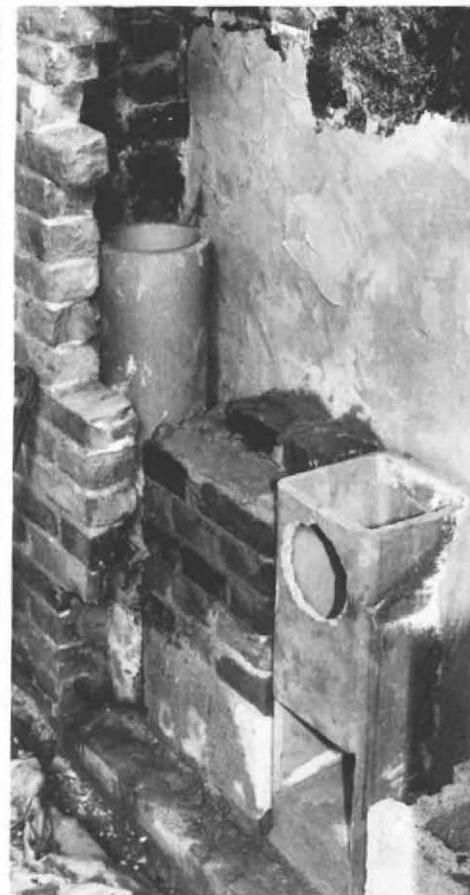
After the cavity has been built up to floor level, the first flue section can go in, left. The square opening at the bottom of the flue will receive the cleanout fitting. When both flue sections are in place, the chimney is bricked in around them, starting with a layer of cement blocks, right. The round flue section will eventually be connected to a new lining from the floor below; the square section in the foreground is for the second-floor lining. The back walls of old chimneys like this one usually require parging, or stuccoing over, before the new lining and interior brickwork can be laid in.

The next step was to brick in the chimney around both liner sections. Again we used cement blocks, since they wouldn't be visible and were easy to position and level. The solid masonry around the hearth would also hold the heat well.

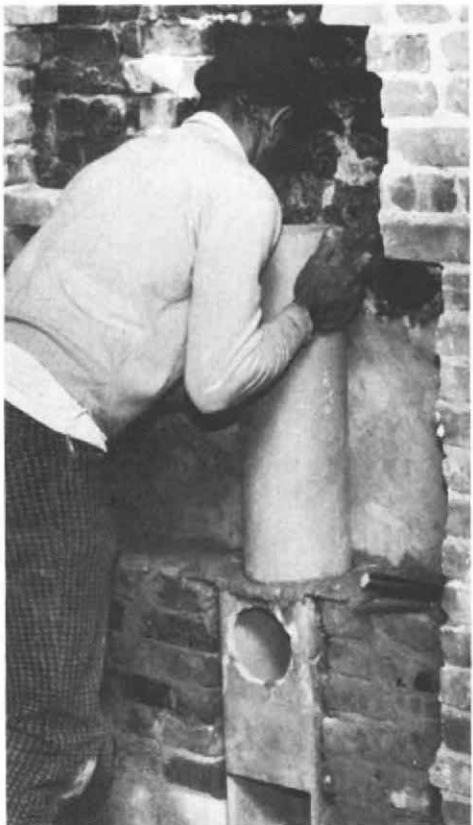
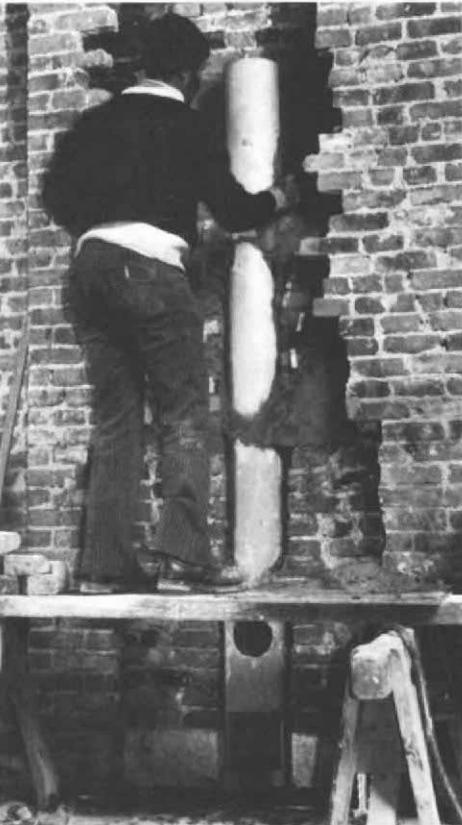
A round flue section is cemented to the square base, left. To ensure a good fit, a square piece of wire lath with a hole cut in the middle is set in the mortar between the two liners. Right, joints between round liner sections are sealed completely with mortar. The remaining interior brickwork extends to within an inch or so of the liner, allowing room for heat-induced expansion. Face ties in the last interior course will be bent into the face course as the wall is rebuilt.

Laying the first round flue section on top of the square base section was a bit like fitting a round peg in a square hole. To make the joint secure, we cut a 6in. hole (the round pipe diameter) in a square piece of wire lath and placed it between the sections. Then we covered the joint with mortar and bricked in the cavity to within an inch or so of the liner. We filled this space with loose, dry rubble on the theory that the liners could expand and contract more freely, thereby minimizing the chance of cracking. Bricks were soaked in a bucket of water before we laid them into the wall. The extra water held by each brick lets the mortar cure more slowly, providing a stronger bond that won't powder with age.

In laying up successive flue sections, we established a working plan: First, we'd check the back wall of the cavity for loose joints. More often than not this course of brickwork (the face brick of the room next-door) would need parging (stuccoing over). Then we'd set the new liner section in a bed of mortar on top of the lower section, lay up the bricks around it until we were one course above the top of the liner, and repeat the operation. Since the first liner of the left-hand flue had been set 14 in. below the first liner of the right-hand flue, the joints of the liners were automatically staggered. We laid up all the liners and their supporting brickwork first, inserting face ties in the last layer of back brick to ensure a good bond with the face course.

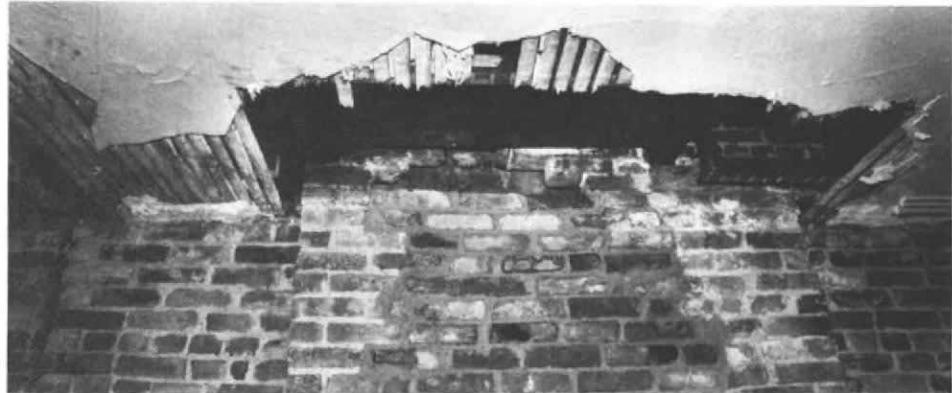
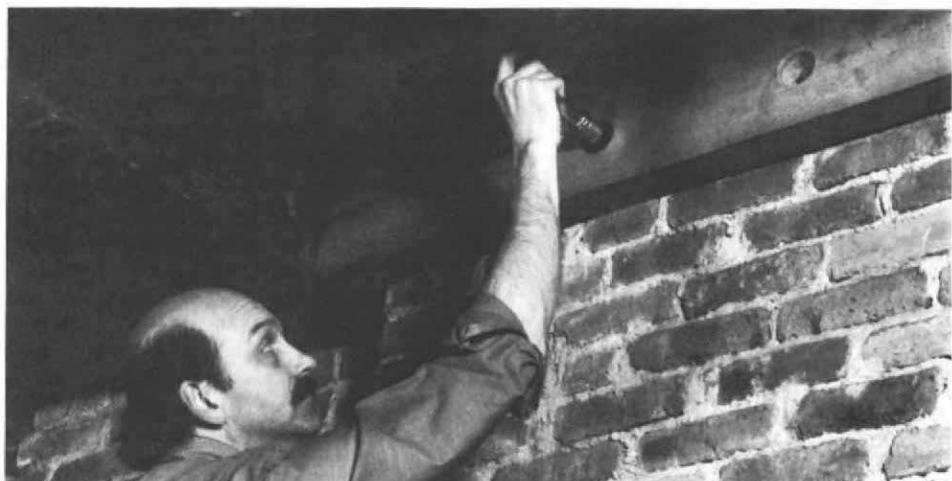
A plywood sheet, top, temporarily replaces the third-floor hearthstone. The face course below has been relaid using the original bricks and repointed to match the style of the original chimney. Above, bolts sunk in the reconstructed face course just below the third floor secure a new chimney girt, to the wall. This will support a new section of floor that replaces the third-floor hearthstone.

In reconstructing the chimney face, we had to work into the irregular pattern deliberately created when we removed the brick. Whenever we could, we matched color and texture in fitting the new brickwork into the old. We even tried to imitate the rather haphazard pointing style of the original wall. The mortar had to be allowed to slump a little in the joint before being struck off flush with the brick face. If voids appeared, we left them. This took a little self-discipline, but the result was successful.

When we reached the ceiling of the second floor we had to remove a brick arch, which supported the marble hearthstone of the third-floor fireplace. This arch had originally been installed so that the hearthstone did not touch any of the floor joists. To make it safer and easier to work on the third floor, we temporarily covered the gap left when the hearthstone was removed with a sheet of  $\frac{3}{4}$ in. plywood. Later on, when the masonry work was complete, we could frame in a new section of the floor, since no stove or flue was planned for this level. With all this in mind, I sunk three bolts in the reconstructed chimney face just below the floorline to hold the new chimney girt that would support the flooring, as shown at left.

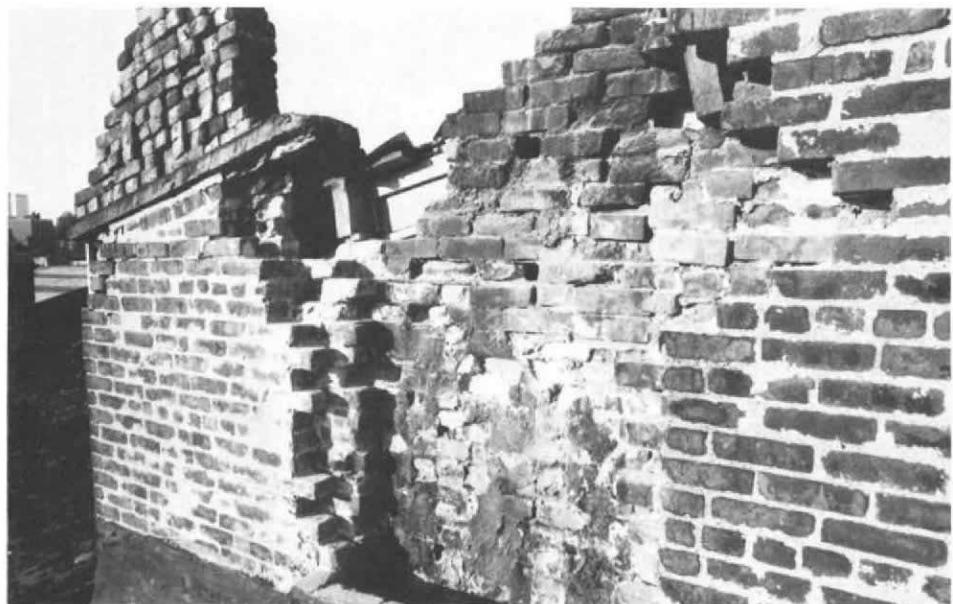
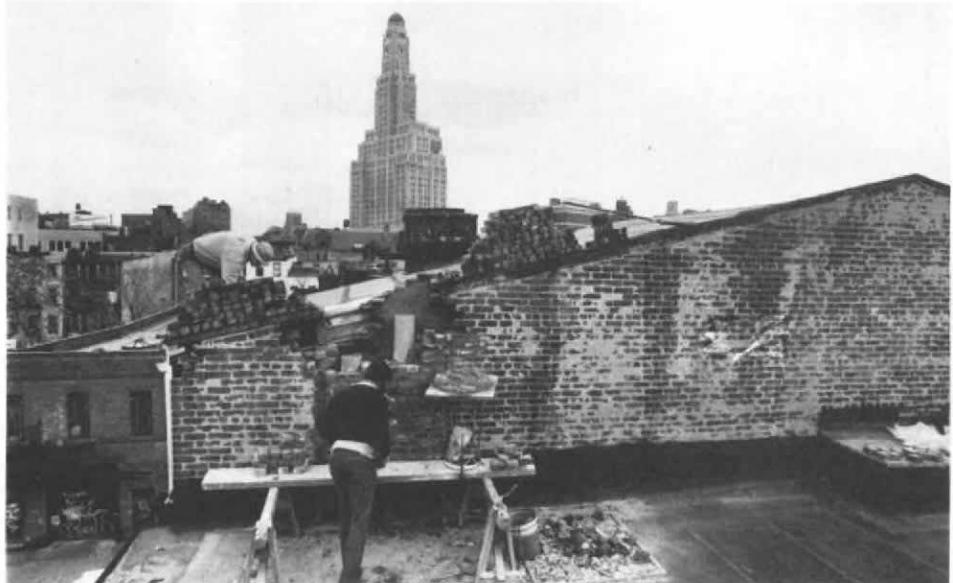
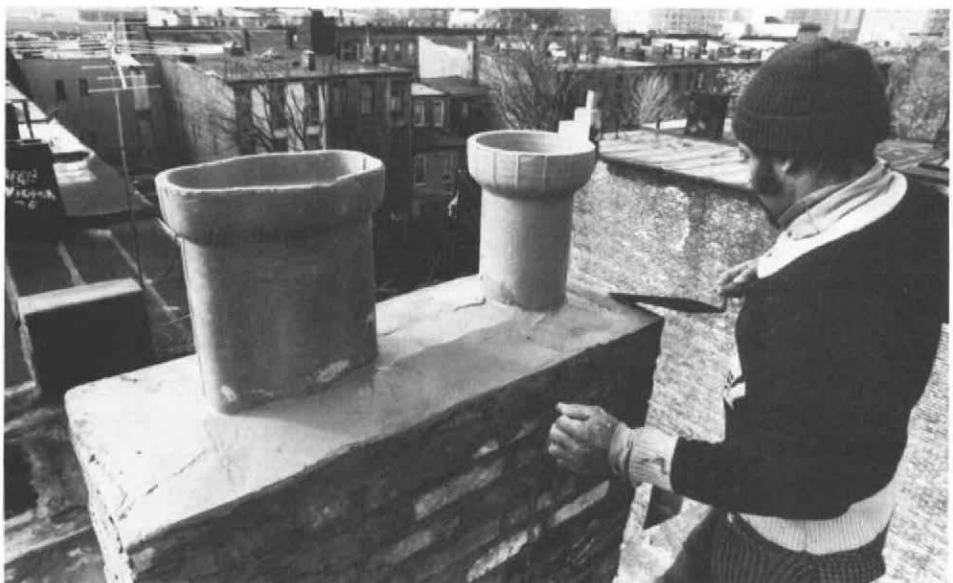
The chimney cavity, top, hollowed out at the roofline in order to accommodate the two flues. Only the top part of the chimney has been removed; the flashing joint where chimney meets roof remains intact. Center, flue-pipe installation proceeds on the roof just as it did inside the house, the only difference being that some of the adjacent wall has to be rebuilt as well. Once the final flue sections have been bricked in, the chimney gets a sloped cap, above, so that water will run off. The stucco finish on the exposed brick provides additional protection from the elements.

**On the roof**—The chimney wall continued above the roofline, separating our flat-roofed building from the higher gable-roofed building next door. Above the flashing, we discovered that the brickwork was not in very good condition; even the wall on either side of the chimney needed to be rebuilt. We carefully dismantled the damaged areas and cleaned out the chimney cavity above the roofline. Now all we had to do to finish the job was to install the remaining flue sections and to rebuild the chimney and wall around them.

To protect against downdrafts caused by wind deflecting off the gables, a chimney should extend well above the roofline. We built ours up about 3 ft., topping off the two flues with the bell end of a sewer-tile section and a wall-capping tile. Decorative chimney tile manufactured specifically for this purpose is four to six times more expensive than the substitutes we used. (The wall-capping tile has perforations cast into it, since each cylindrical section is meant to be divided in two. We used the paired pieces together to make the final flue piece.) High temperature resistance would not be a consideration here, since the stoves we were planning to install have internal baffles that prevent most of the heat from going up the chimney along with the smoke.

We extended the tiles about 16 in. above the brick line and topped the brickwork with a sloped cap, mixing the mortar just as we had throughout the job. The exposed chimney had been quite weathered before we rebuilt it, so we decided to give the entire chimney face above the roof line a stucco finish, as additional protection from the elements.
