Detailing Decks Over Living Space

When the roof pitch is shallow enough to walk on, clear drainage paths and careful waterproofing are essential

by John Phelps

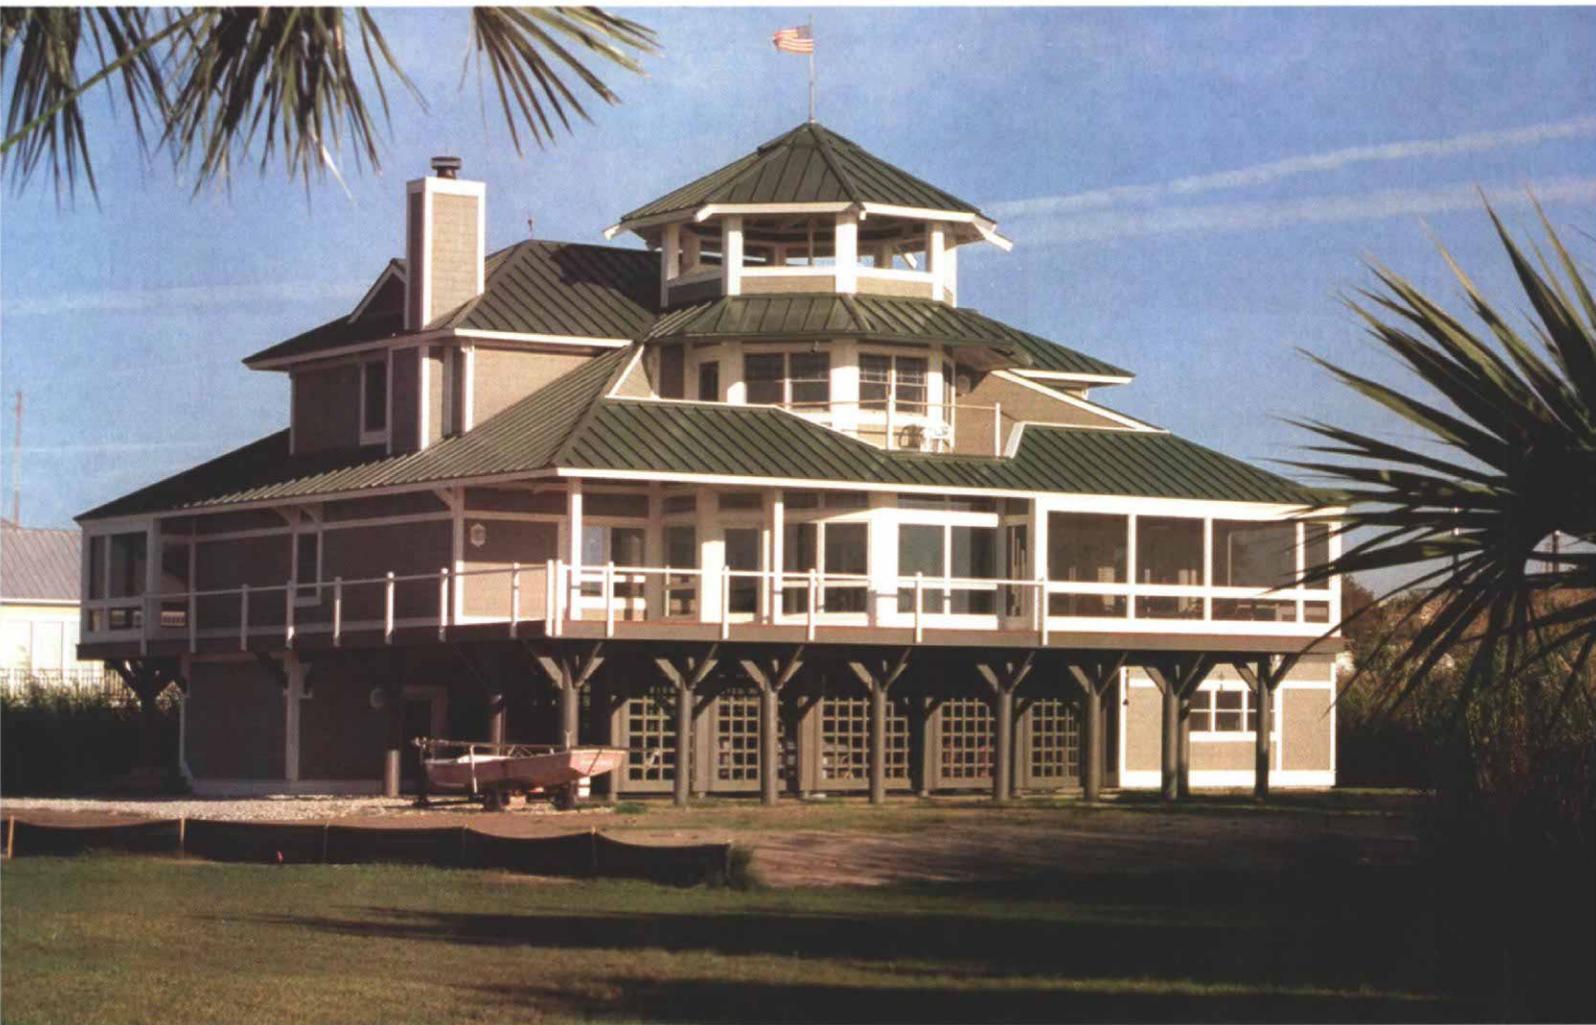
The second-floor and third-floor decks were the problem. With a footprint limited by wetlands, this house on the Florida coast rose up, not out. Consequently, two decks at the central tower, or crow's nest, had to be built above finished interior spaces.

Charlie and Sally Williamson's lot on Apalachicola Bay looked plenty big until I saw the wetlands survey. I realized then that we would have to build up instead of out. But a multistory house meant two decks built over fin-

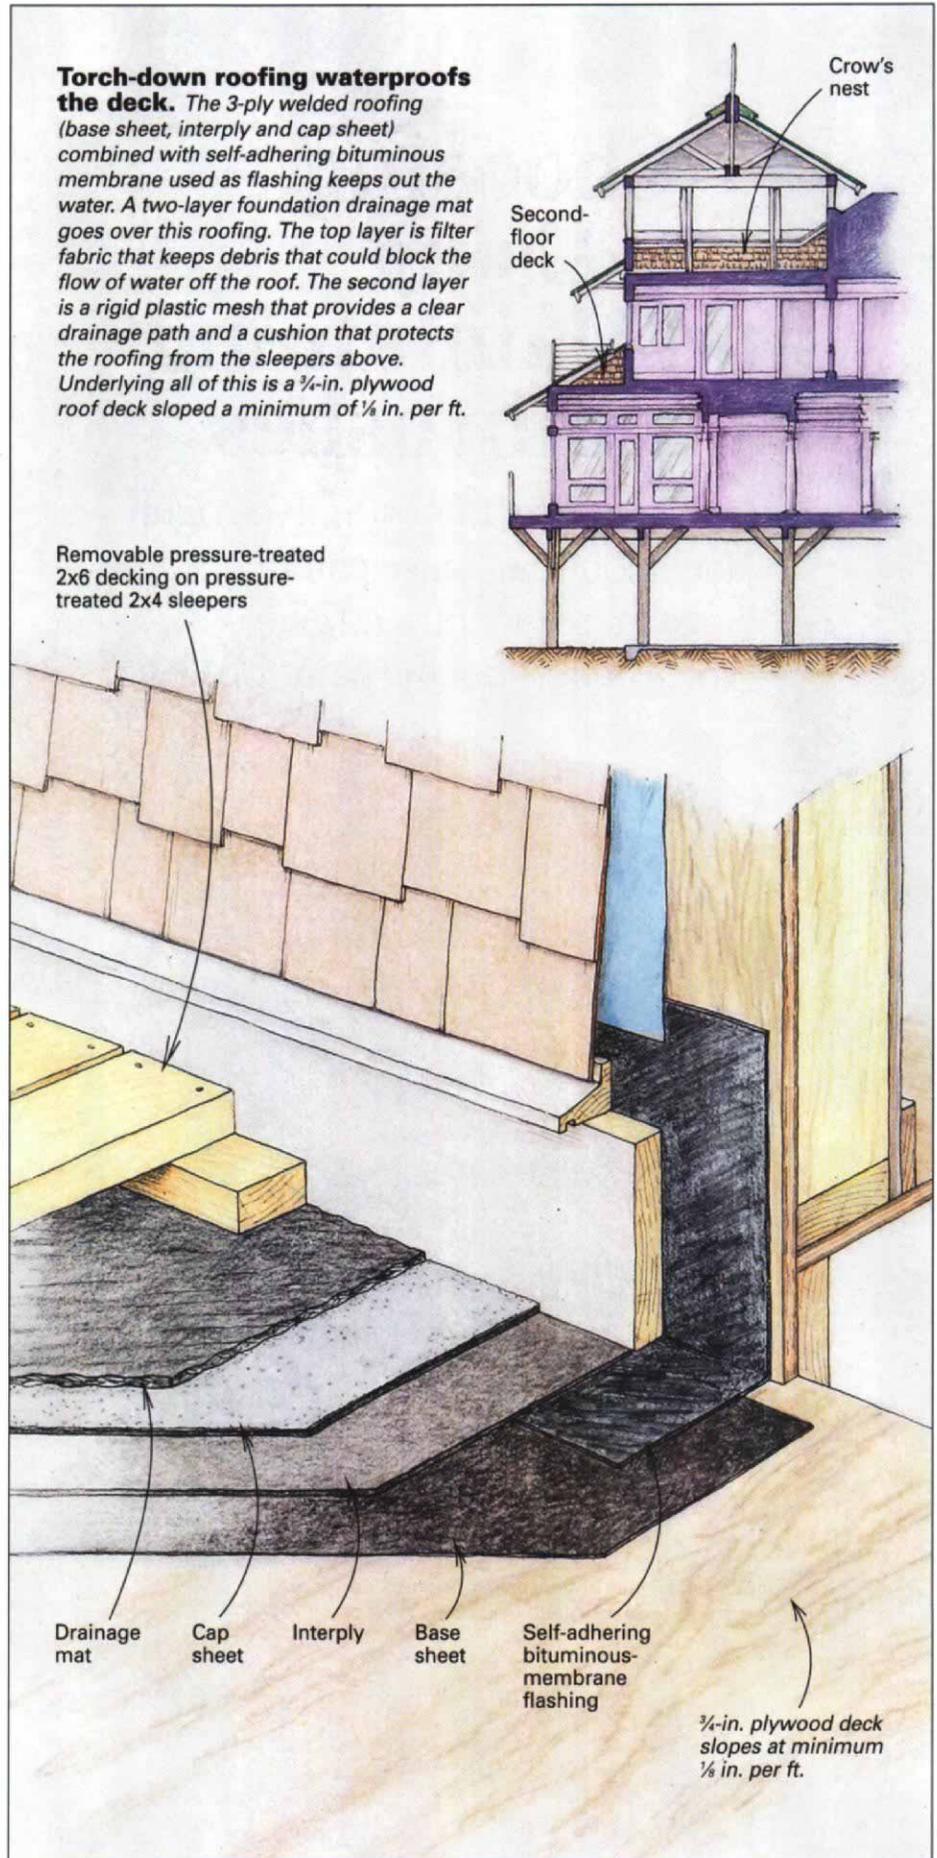
The second-floor deck simply drains onto the roof below. But the crow's nest deck is enclosed by kneewalls, and the roof over the deck below actually comes above the crow's nest floor. We pitched the deck toward this roof and raised the bottom plate of the kneewall, forming a scupper to drain the water. It drains under the kneewall into a gutter that has been mounted beneath the roof overhang below.

A foundation drainage mat provides extra protection—The roofing that Charlie recommended is a 3-ply, heat-weld system (Johns Manville, 717 17th St., Denver, CO 80202; 800-654-3103) installed over the plywood decking. All the exterior walls that intersect decks are wrapped with Polyguard 650 (Polyguard Products Inc., P.O. Box 755, Enns, TX 75120; 800-541-4994), a self-adhering bituminous membrane consisting of a high-strength polyethylene backing laminated to a thick (60-mil) layer of rubberized asphalt. We brought the Polyguard about 6 in. onto the base sheet of the roofing to serve as flashing and went over the Polyguard flange with the remaining two layers of roofing.

Next, we installed a layer of J-Drain 1000, a $\frac{1}{4}$ -in. thicksheet of crushproof plastic mesh core wrapped in filter fabric (JDR Enterprises Inc., 292 S. Mam, Suite 200, Alphretta, GA 30043; 800-843-7569). The J-Drain is laid loose on top of the roofing. Normally used as a drainage mat around foundations, in this case the J-Drain provides a layer of padding that protects the underlying waterproofing membrane, and it lets water drain under the sleepers that are supporting the deck.

Two-by-six decking screwed to pressure-treated 2x4 sleepers forms the walking surface. The decking can be unscrewed to inspect the roof below. The sleepers run parallel to the slope of the deck to allow drainage.

This composite of materials provides a waterproof membrane that will flex and not crack as the wood framing deflects under load. Should leaks occur, the deck and J-Drain can be lifted and the roof inspected and repaired.
