Salvaging a Small Bathroom

A donated sink and cast-off roofing slates meet up with a refurbished claw-foot tub in this remodeled bathroom

BY KIMBERLY GOFORTH-GILL

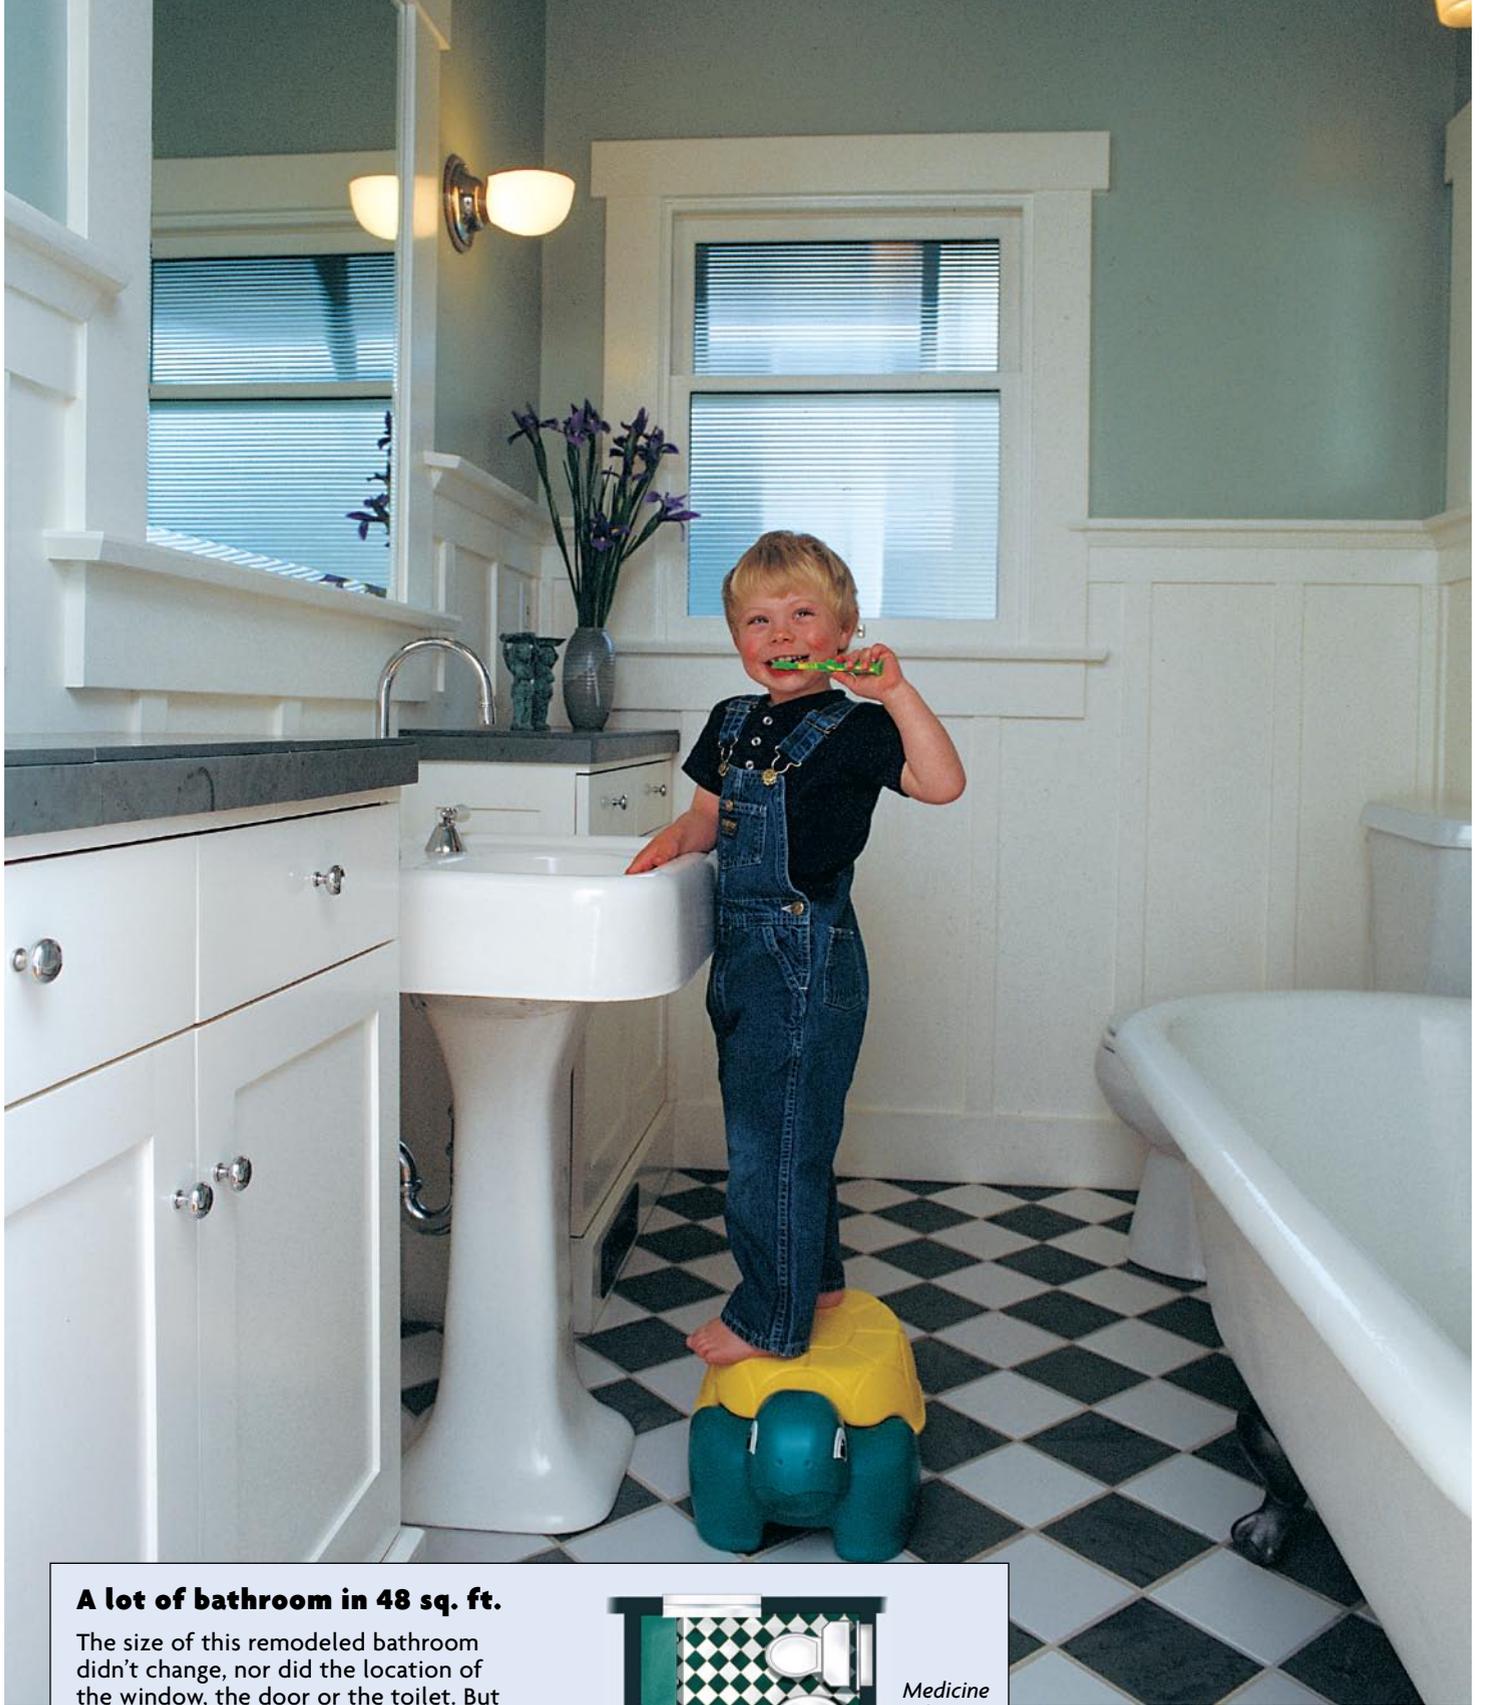
A lot of bathroom in 48 sq. ft.

The size of this remodeled bathroom didn't change, nor did the location of the window, the door or the toilet. But the original claw-foot tub turned around, providing a plumbing wall for the shower head, and the door swing was reversed.

The painted wainscot was designed to complement the style of our Craftsman house and to tie the room together visually (photo facing page). It also provides a durable, easily cleaned surface behind the tub and toilet. The panels are medium-density overlay plywood with wood battens hiding the seams.
