# Protect Your Home With a Basic Seismic Retrofit

Strengthening a home in earthquake country means anchoring it to its foundation and adding site-built shear walls

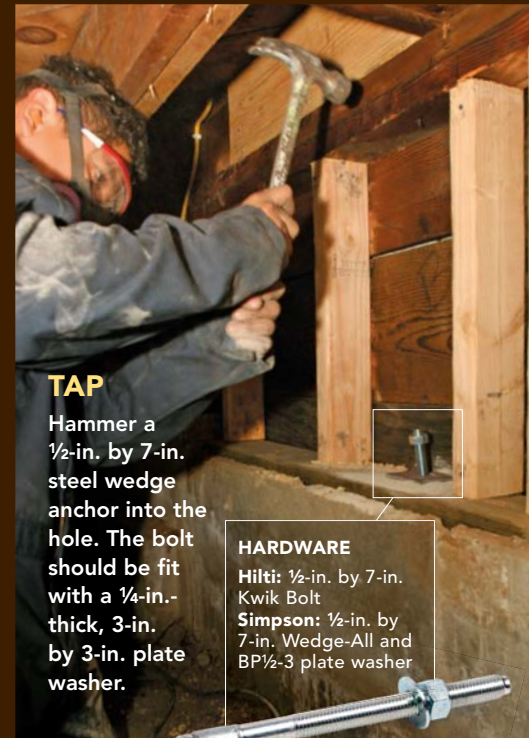
### TAP

Hammer a ½-in. by 7-in. steel wedge anchor into the hole. The bolt should be fit with a ¼-in.-thick, 3-in. by 3-in. plate washer.

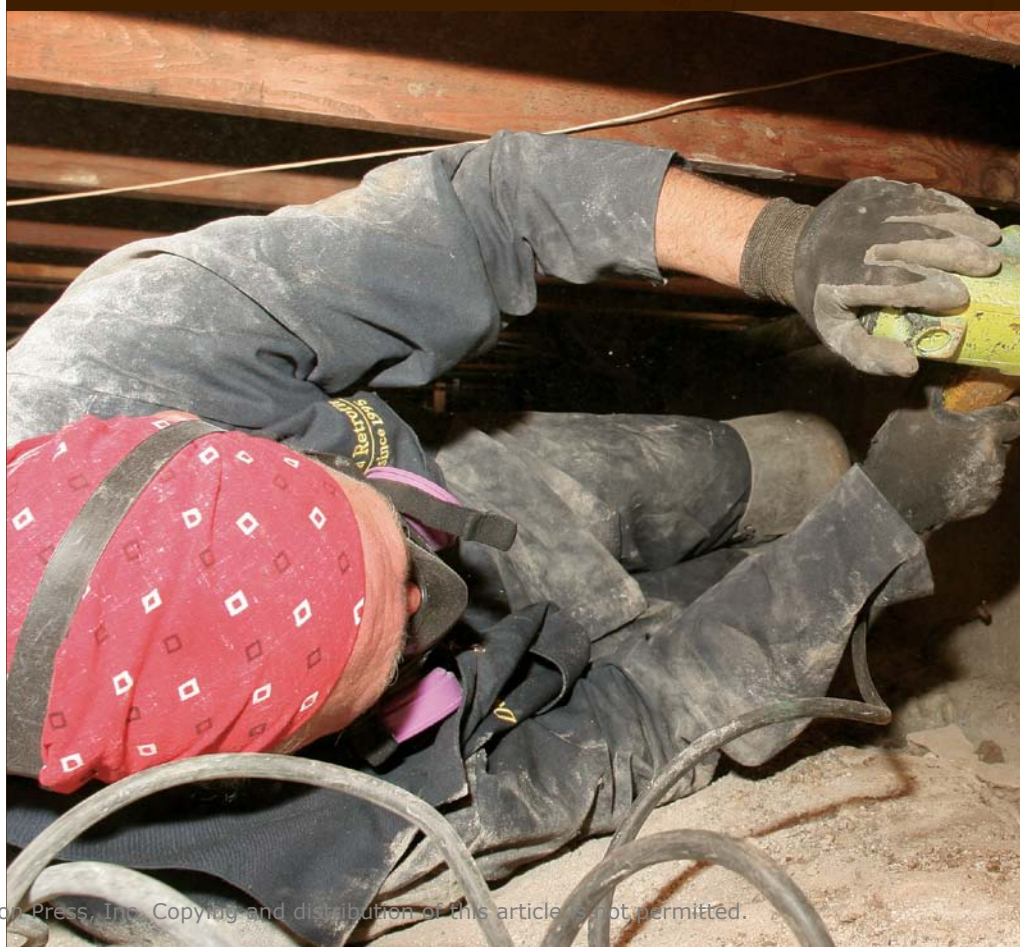
### TIGHTEN

Use an impact driver or wrench to tighten the bolt. Wedge anchors have shear ratings of roughly 700 lb. in wood and perform well. Epoxy anchors are better, but are needed only when the concrete is porous or deteriorated.

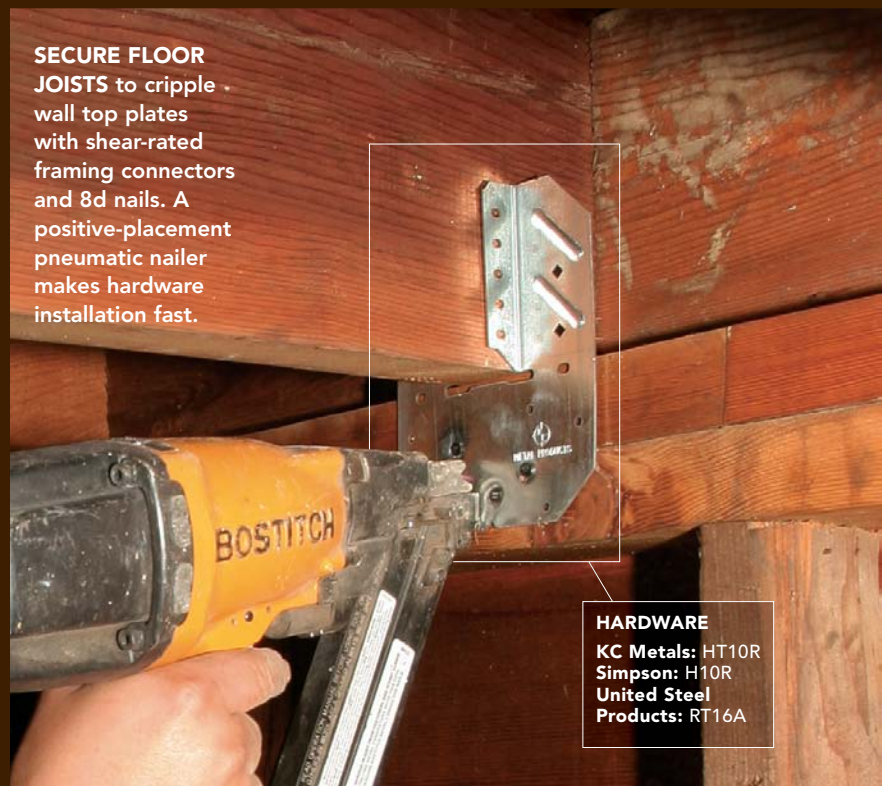
**SECURE FLOOR JOISTS** to cripple wall top plates with shear-rated framing connectors and 8d nails. A positive-placement pneumatic nailer makes hardware installation fast.

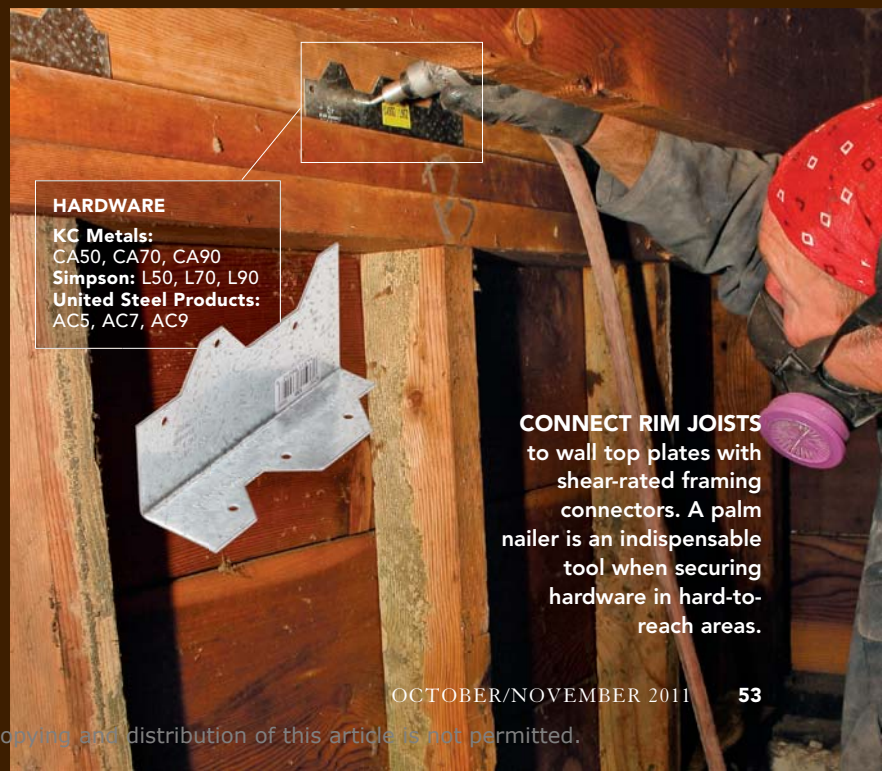
**CONNECT RIM JOISTS** to wall top plates with shear-rated framing connectors. A palm nailer is an indispensable tool when securing hardware in hard-to-reach areas.

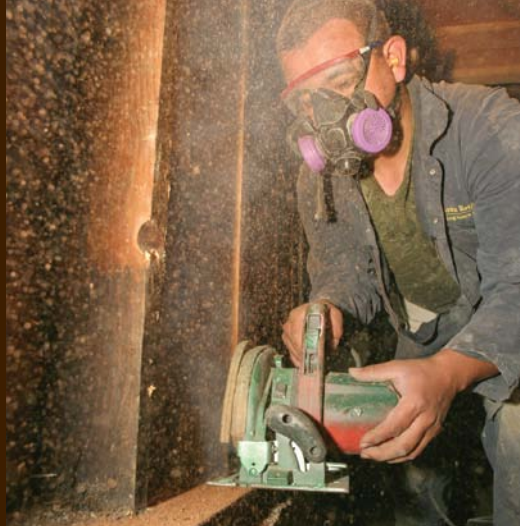
**1** **Cut the mudsill flush with the studs.** This allows the plywood to be edge nailed against an even surface. This is best accomplished with a tool like the Closecut saw by Clemenson Enterprises Inc. This photo shows a saw modified with the FlusSa attachment.

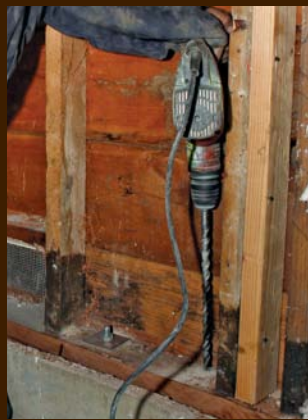
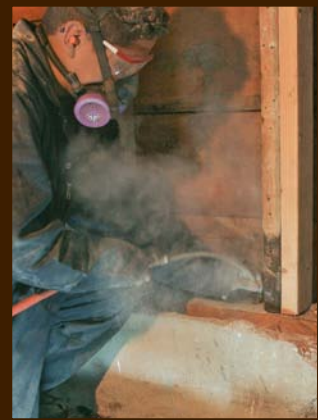
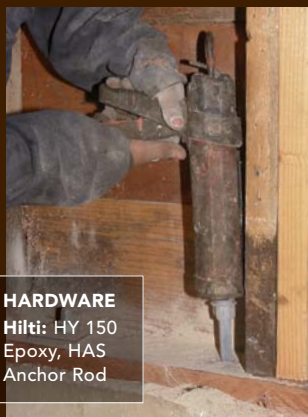
**2** **Drill and prep holes for hold-downs.** With a rotary hammer drill and masonry bit, drill an  $1\frac{1}{4}$ -in. hole at least 12 in. deep. To ensure a proper bond between the epoxy and the threaded rods, plunge each hole with a bottle brush, then blow compressed air into the hole to remove masonry dust. Repeat this process three to four times before dispensing epoxy into the hole.

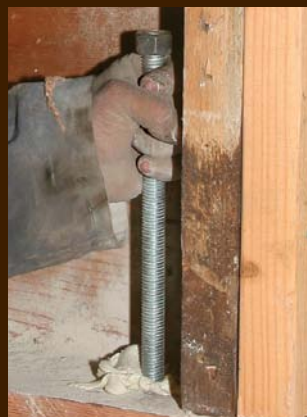
**3** **Set the rods.** After filling the holes with epoxy, set the  $\frac{5}{8}$ -in. all-thread rods. Twist the rods to ensure the epoxy finds its way between each thread. The epoxy used is quick setting, and the nut will be ready to tighten within an hour.

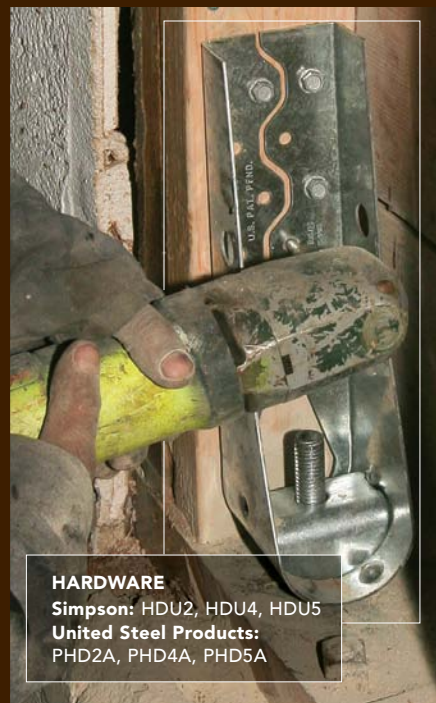
**4** **Secure the hold-downs in place.** When the epoxy for each rod is set, attach the hold-down to the stud with screws before placing the nut on the threaded rod and bolting the assembly to the mudsill.

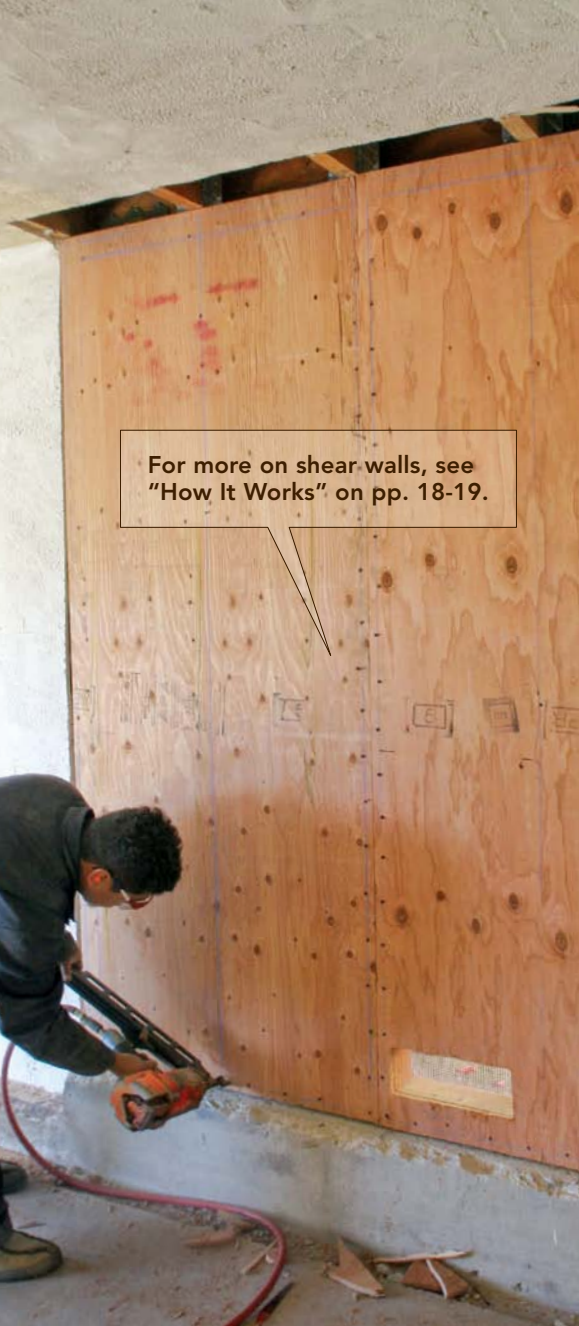
**5 Attach the plywood.** With all the hardware in place, attach 1/2-in. five-ply structural grade 1 plywood to the studs with 8d nails spaced every 3 in. Nailing schedules vary based on engineered plan.

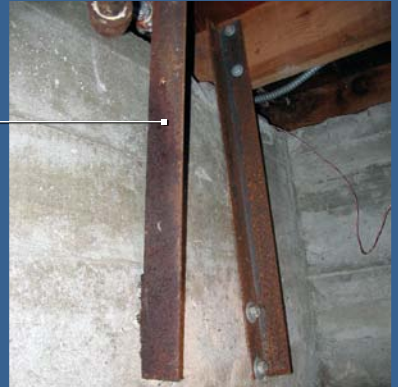
#### Homemade hardware

**Retrofit:** Using angle iron to prevent wall from sliding off foundation

**Problem:** Custom-made connectors require costly custom engineering. This piece of angle iron will act like a lever when the wall moves and will shear off the bolts.

**Solution:** Simpson's UFP10 hardware or anchor bolts are better suited for this application.

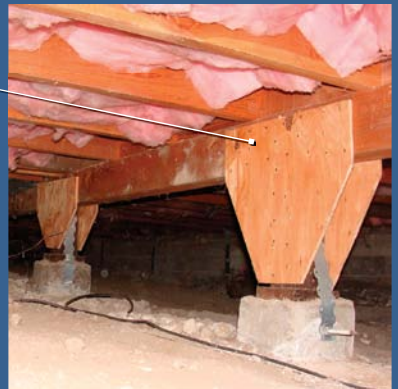
#### Expensive connections that do little good

**Retrofit:** Attaching posts to girders with gussets or specialty hardware

**Problem:** For this connection to come loose, the floor framing would have to move quite a bit—which simply means you should have spent more effort strengthening the building perimeter.

**Solution:** It's much more cost-effective to construct shear walls and to strengthen connections around the perimeter of the house to keep it in place than it is to spend money on expensive hardware connections between posts and girders in a crawlspace.

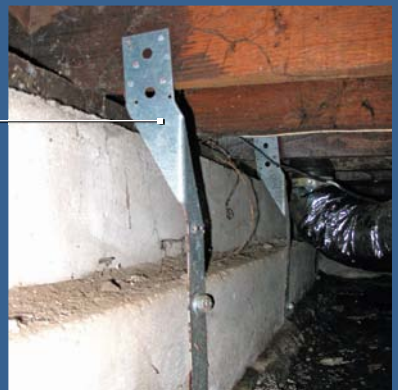
#### Stock hardware used improperly

**Retrofit:** Using hardware that resists uplift in situations where shear is the main concern

**Problem:** Hardware developed for hurricanes is often misused in seismic retrofits. The straps shown here have a rated lateral load of 185 lb. That's not strong enough.

**Solution:** The UFP10 has a lateral load rating over seven times greater than each of these straps.
